I Wonder What's Down Under?

Condition Assessment and Rehabilitation of Critical Sewer Siphons

Michael Wilson, P.E., SESD
David Polcari, P.E., CDM Smith

January 2023

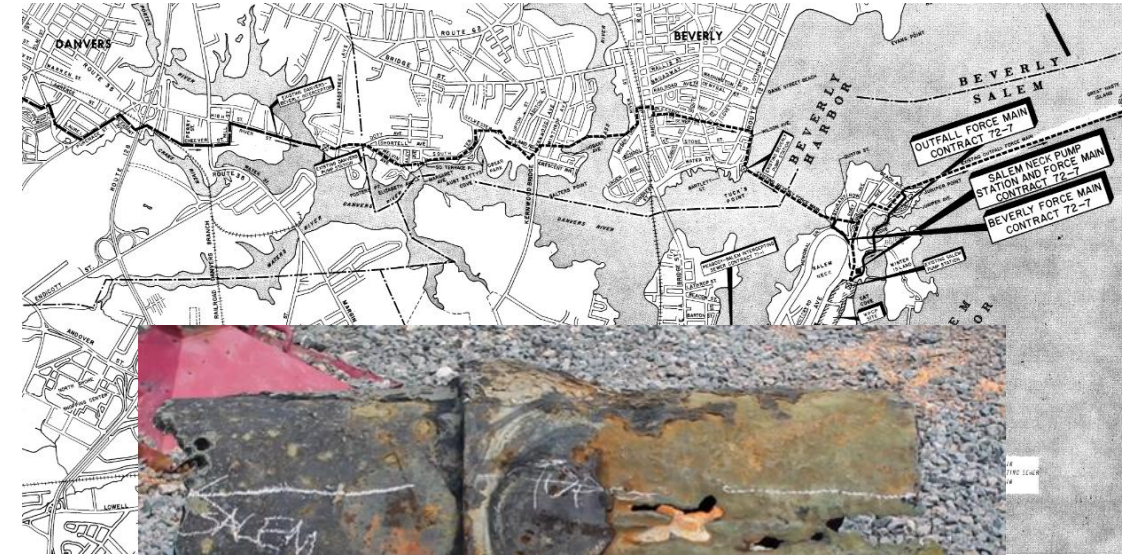
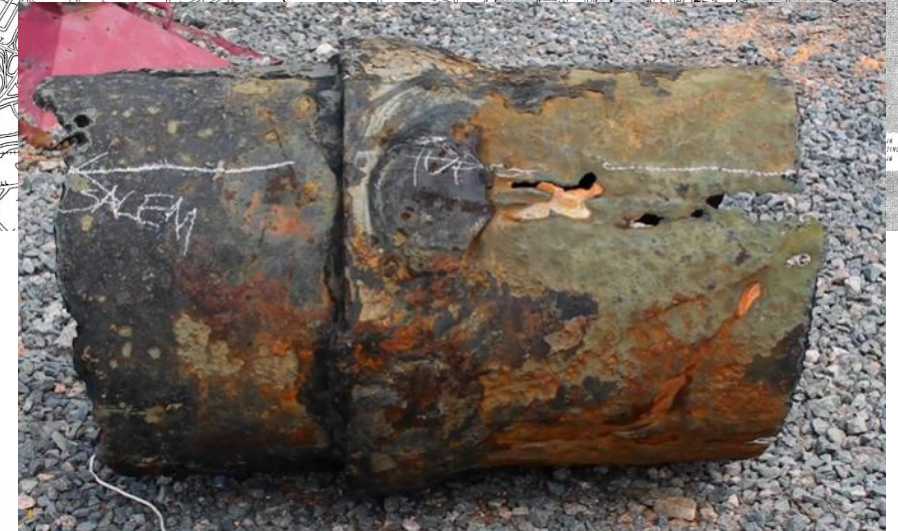
Project Drivers and Background

- District Operates Several Subaqueous Pipelines – Siphons, Force Mains
- 2013 – Failure and Replacement of Marblehead Force Main
- 2017 Collection System Assessment Plan
- Danvers Siphons Identified as a High Priority Assessment Project
- Primarily Concerned about External Corrosion

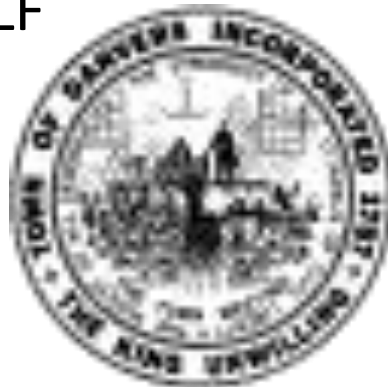
Danvers Siphons

- Owned and Maintained by the District Serving the Town of Danvers
- Crossing Porter River
- Single Barrel 24-in CI Siphon 1920's – Approx 750lf
- Triple Barrel 24-in DI, 24-in DI, 16-in DI 1970's Approx 950 LF

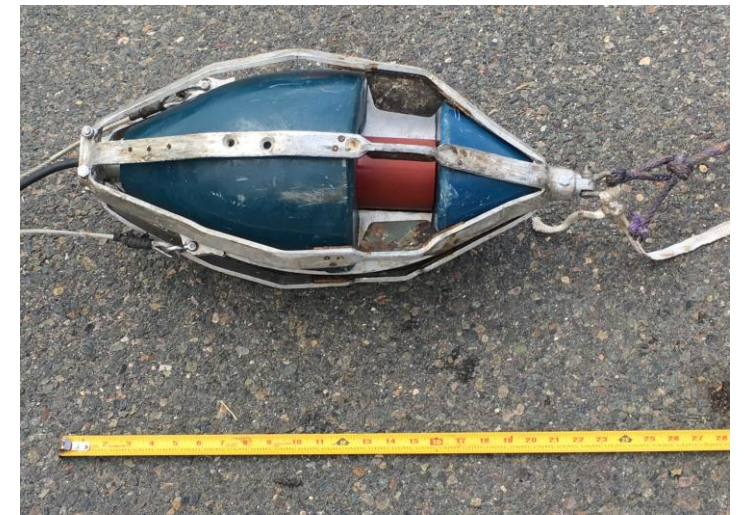
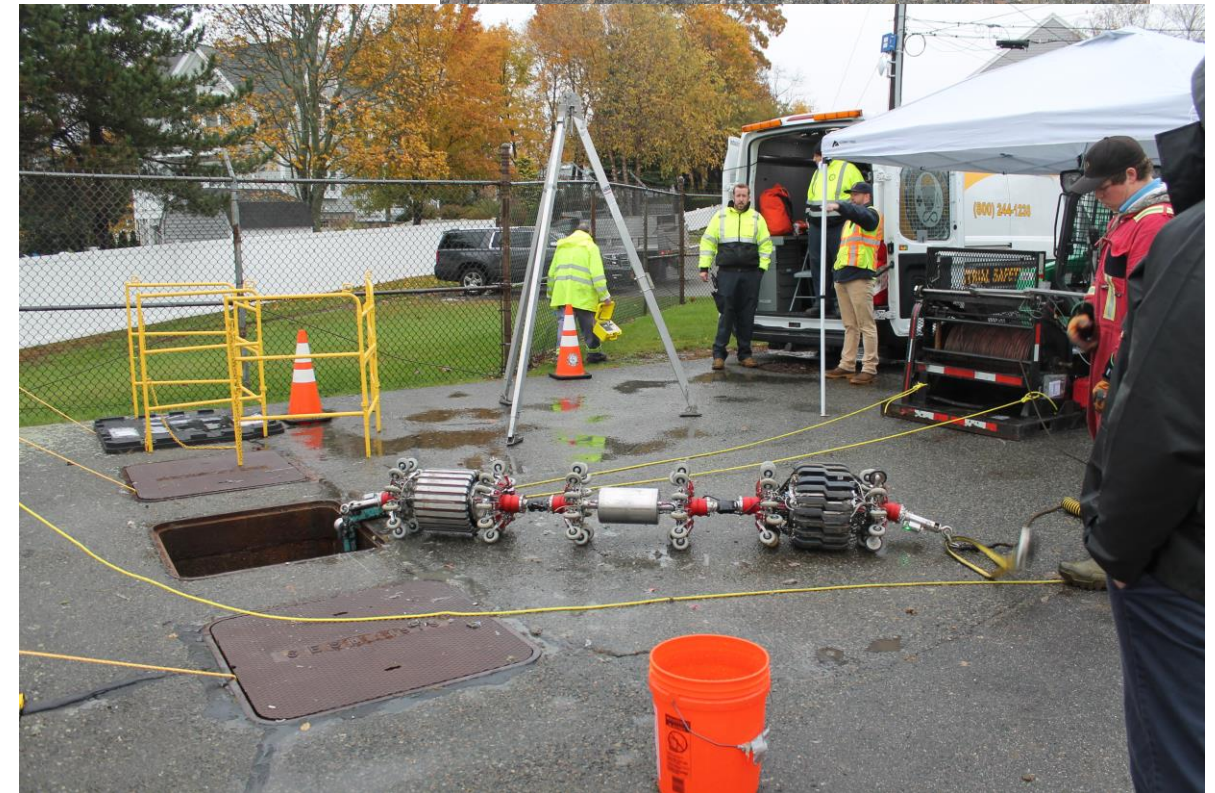
Condition Assessment Approach

- Began in 2018
- Dual Approach
 - Sonar Inspection
 - Wall Thickness Assessment

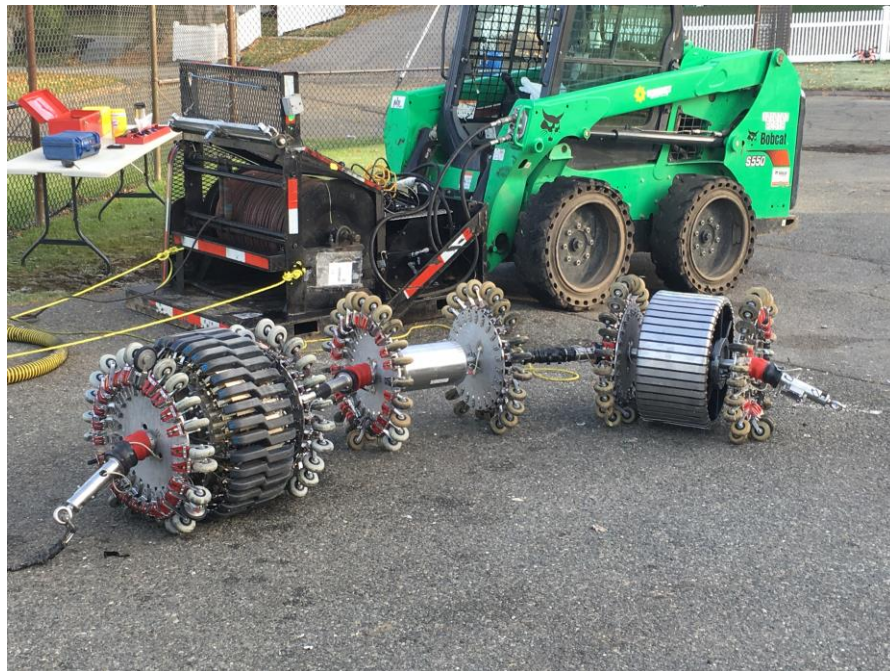
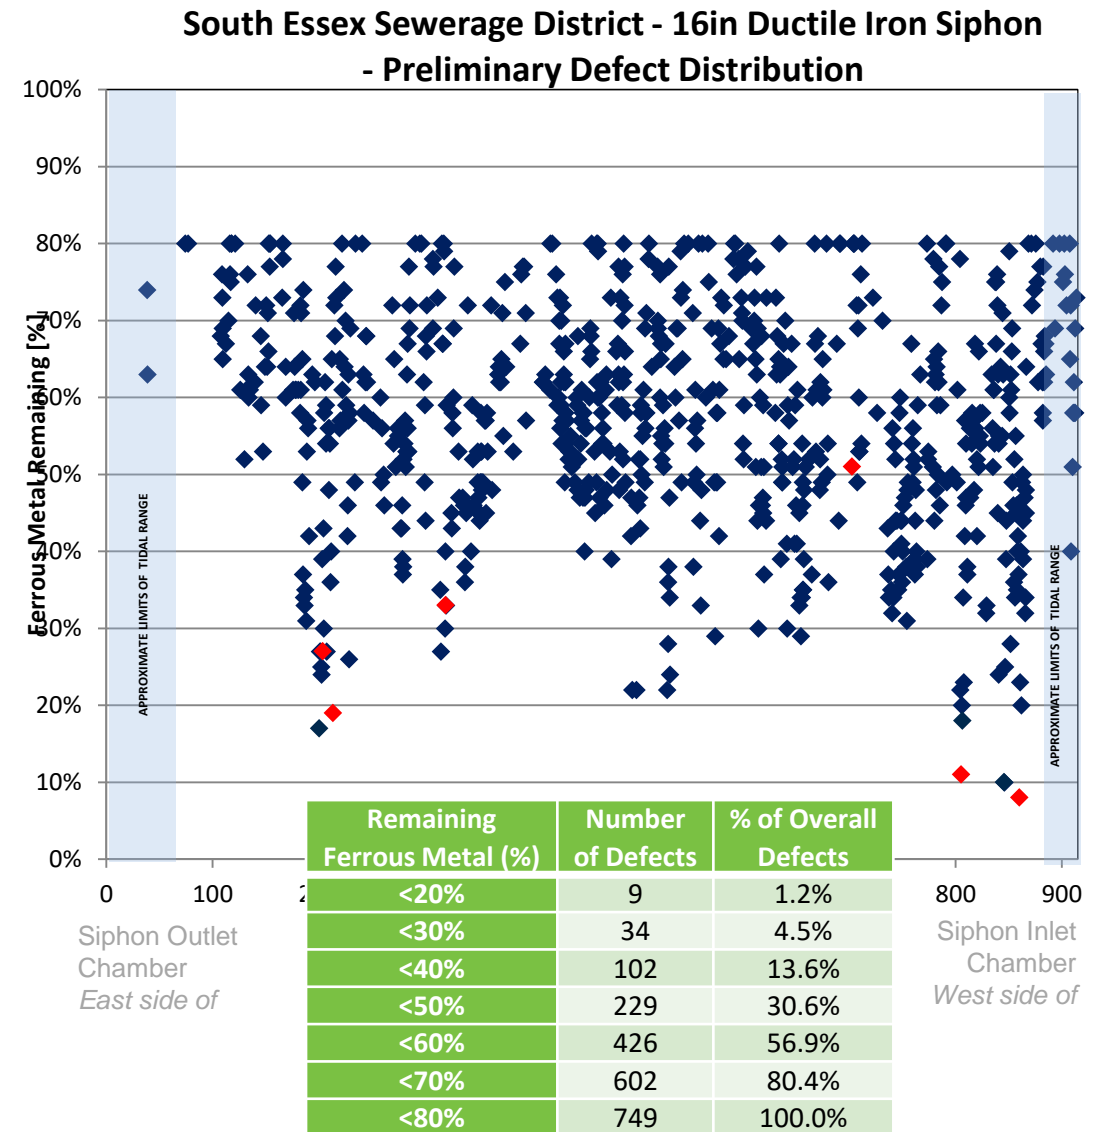
Pipe Wall Condition Assessment

- PICA See Snake Remote Field Testing
- Electromagnetic Evaluation of Pipe
- Detects Wall Loss, Corrosion, Graphitization
- 16-in DI and 24-in CI Siphons were inspected

- Sedimentation and Wall Loss Identified in Siphons
- Structural Rehabilitation Recommended as a Proactive Approach
- Alternatives Evaluated
 - CIPPL
 - Slip Lining
 - Swage Lining
- Primary Evaluation Criteria
- Selected Alternative
- Next Steps

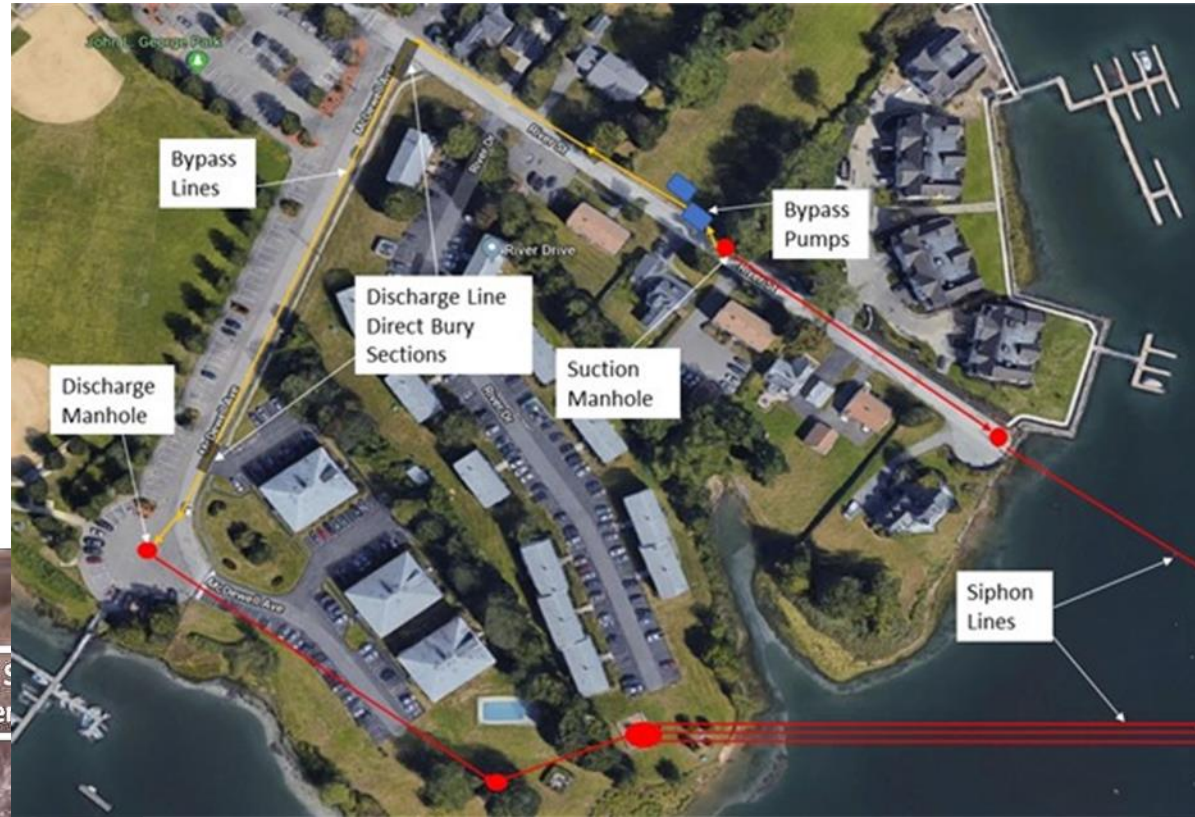
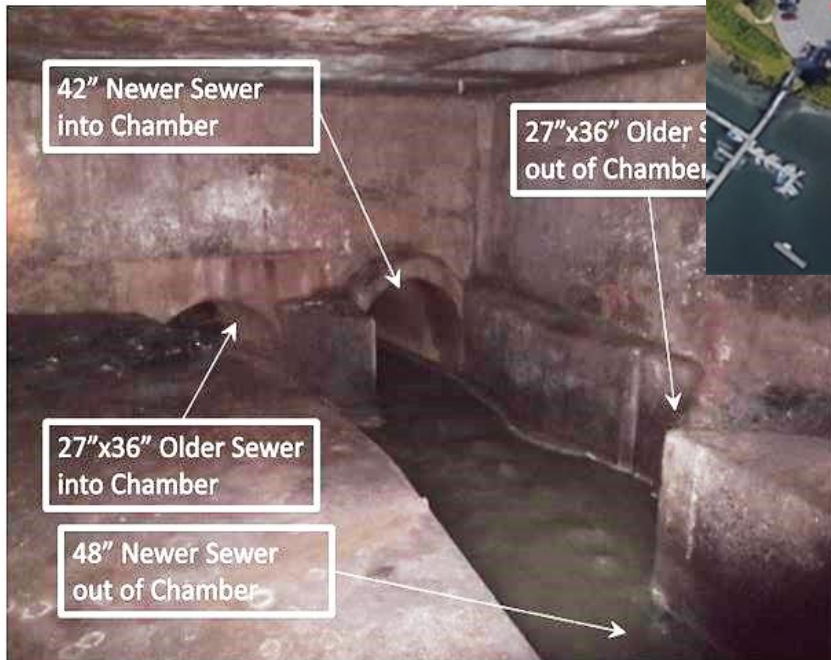
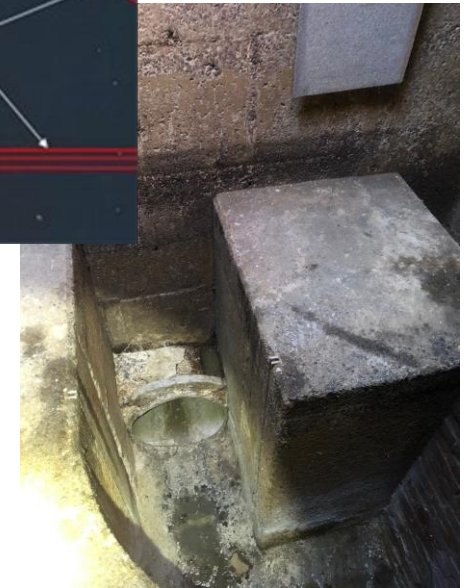
Design Phase

- Order of Lining
- Bypass / Flow Diversion
- Access / Coordination
- Unknown Conditions

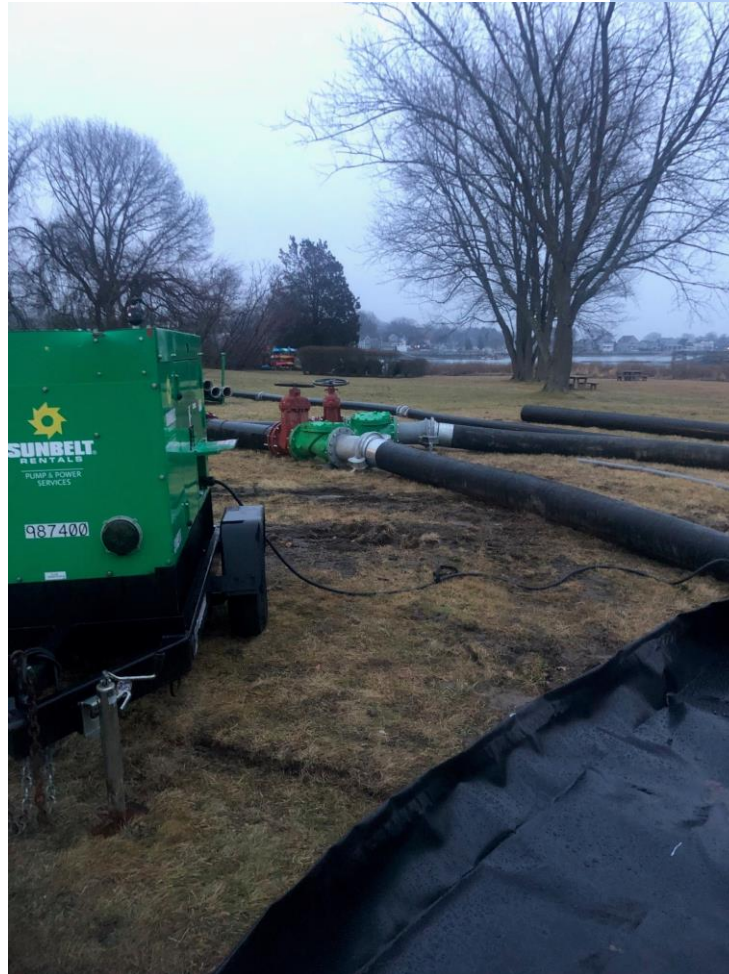
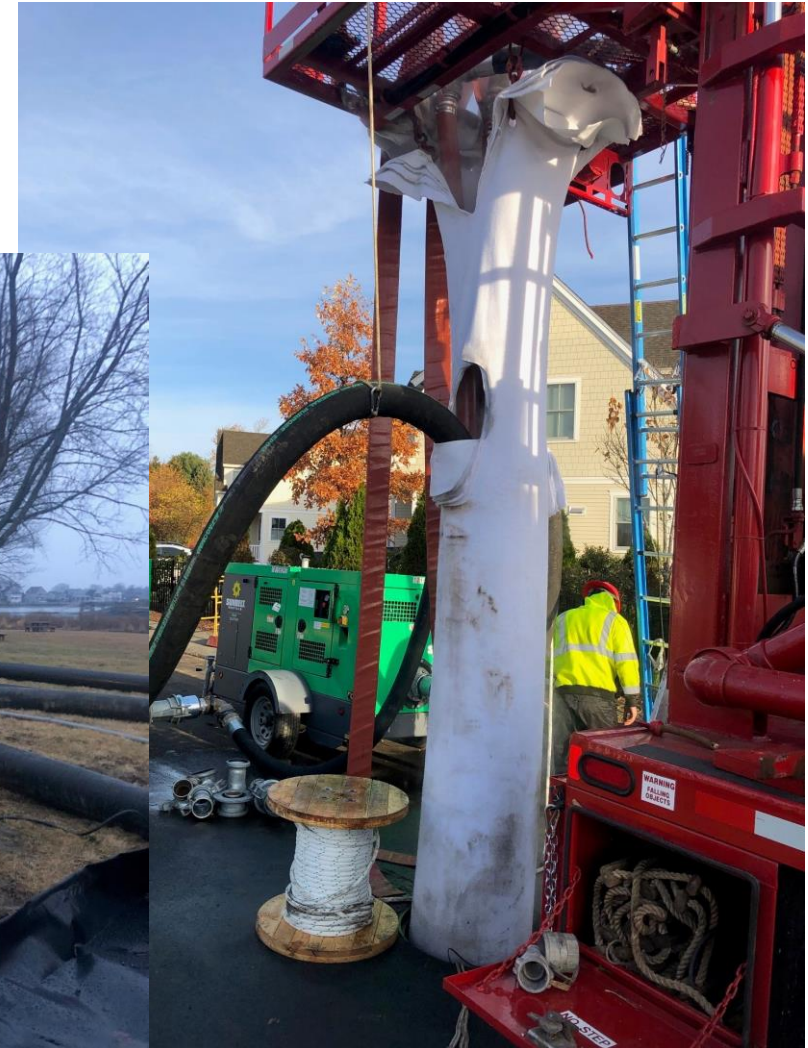
Construction Phase

- Preparatory Activities
 - Cleaning
 - Dewatering
 - Inspection
- Bypass / Flow Diversion
- Major Construction Activities

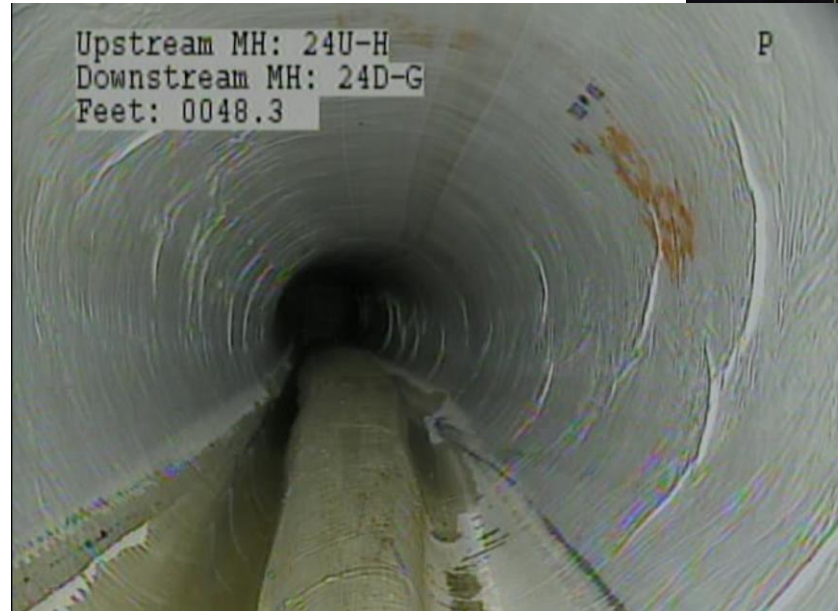
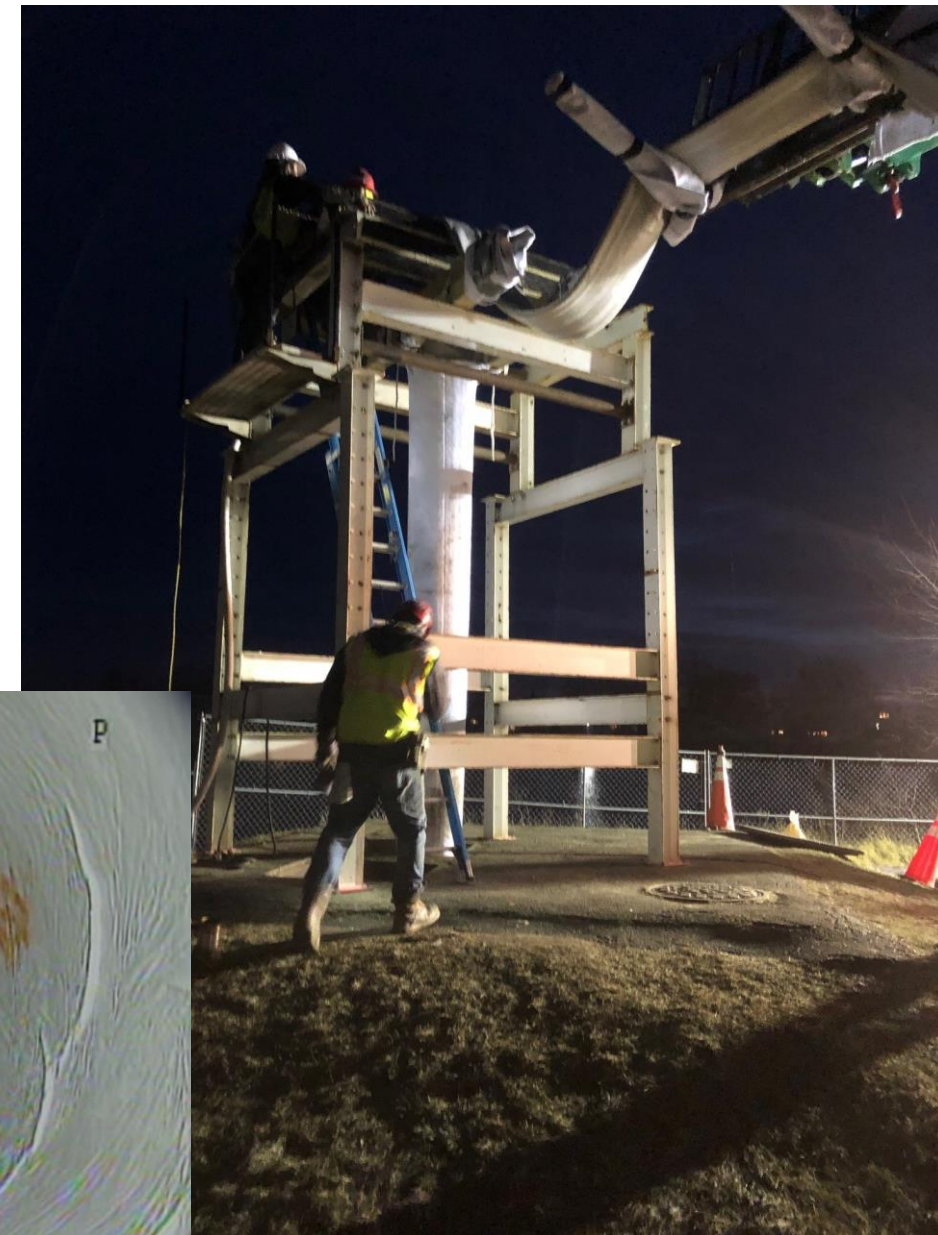
Construction Challenges

- Cleaning
- Dewatering
- “Lift” Area in Installed Liner
 - 12 ft area
 - Recured portion, substantially corrected lift,
 - Extended Warranty
- Acceptance Testing
