AECOM

Rebuild or Replace? It Depends

NEWEA Annual Conference – January 23, 2023

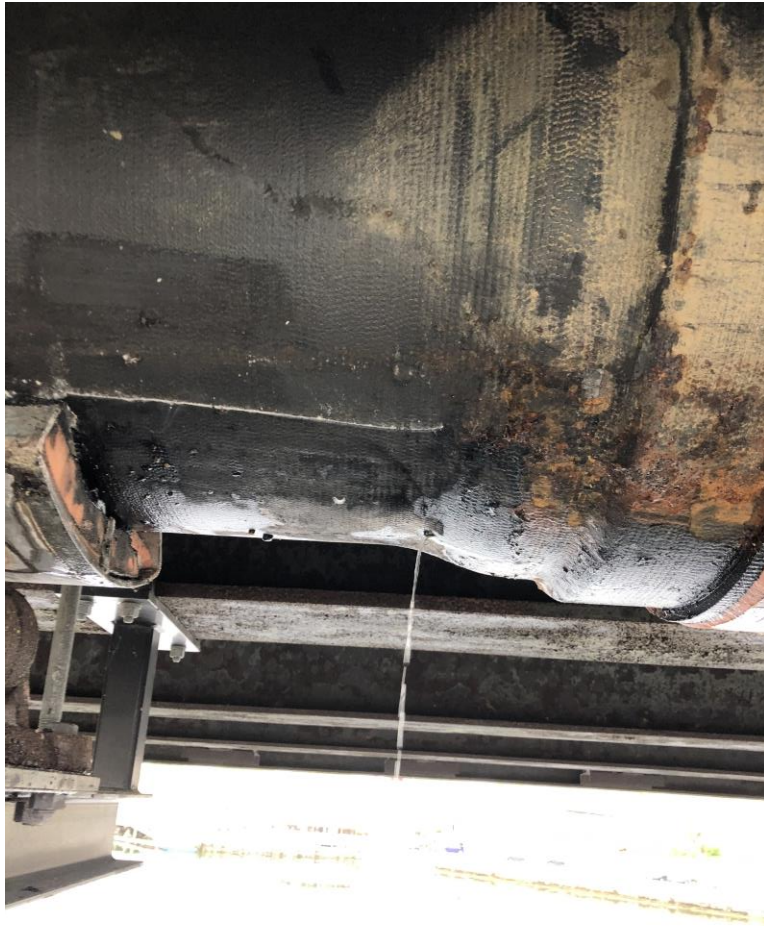
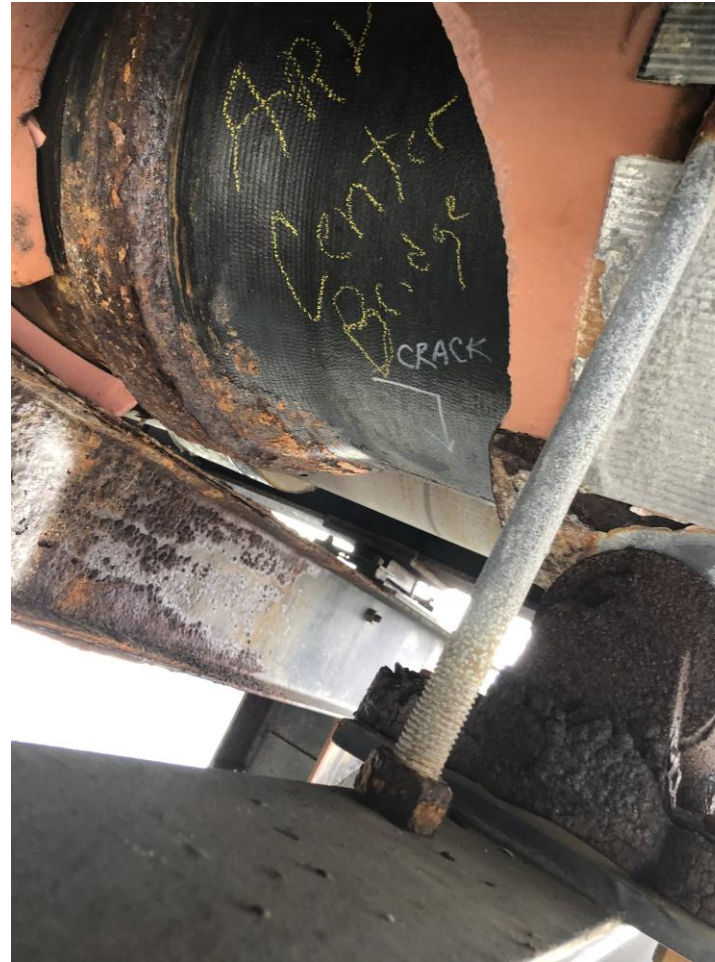
Initial Force Main Leak

- May 15, 2020 – Leak discovered in 24” FM under Peirce Island Rd. Bridge
- 24” FM isolated and removed from service
- Two major areas of concern:
 - Leak at STA 0+45
 - Crack at STA 1+34

- Leak repair details consisted of cutting out damaged piping and replacement with new glass-lined pipe.
- Emergency repair contract executed
- Required construction of suspended scaffolding and coordination with Harbormaster, USCG, and State Police

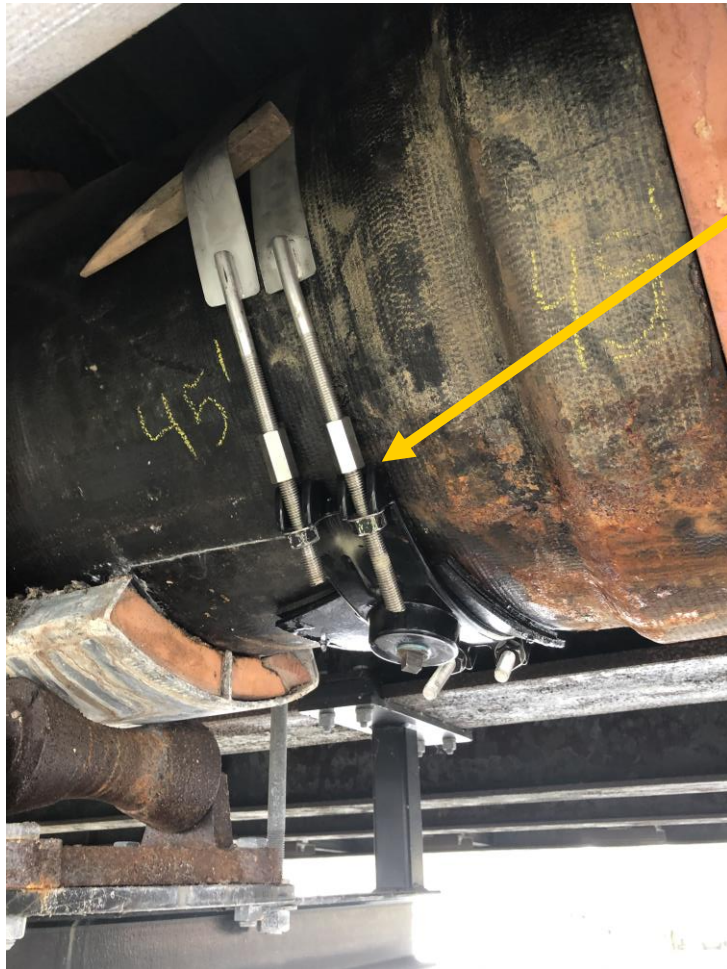
Temporary saddle

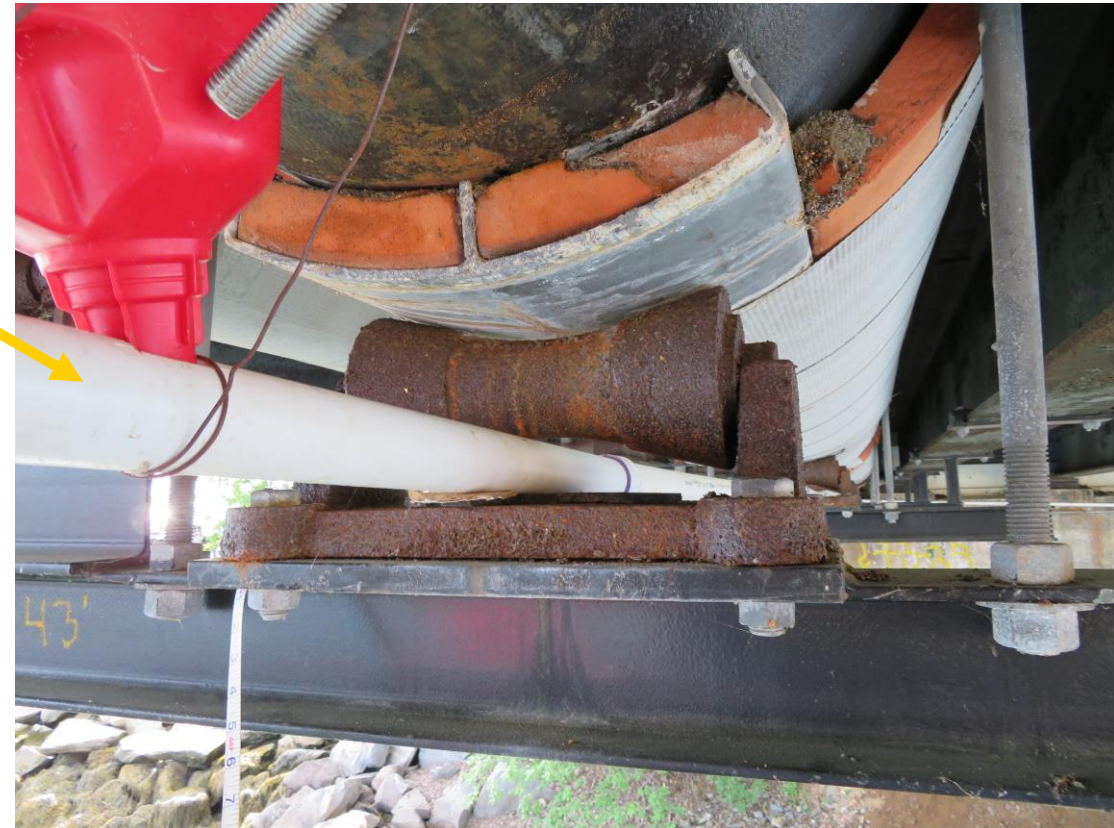
Temporary drain pipe

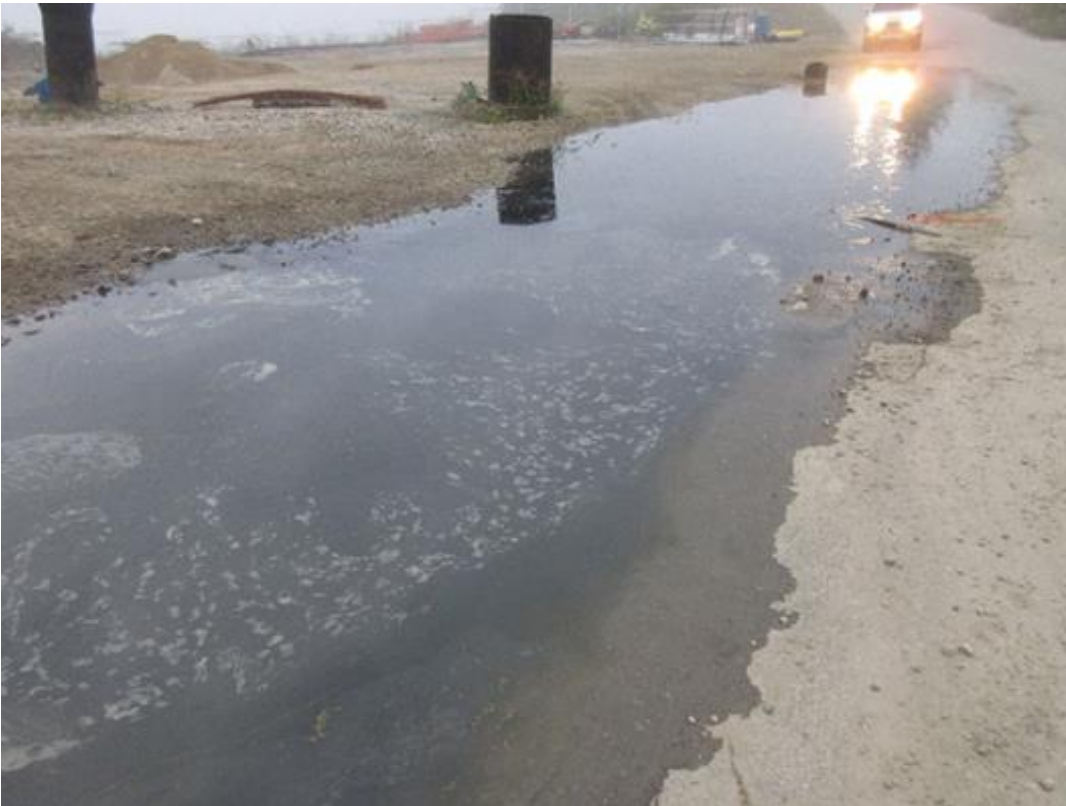
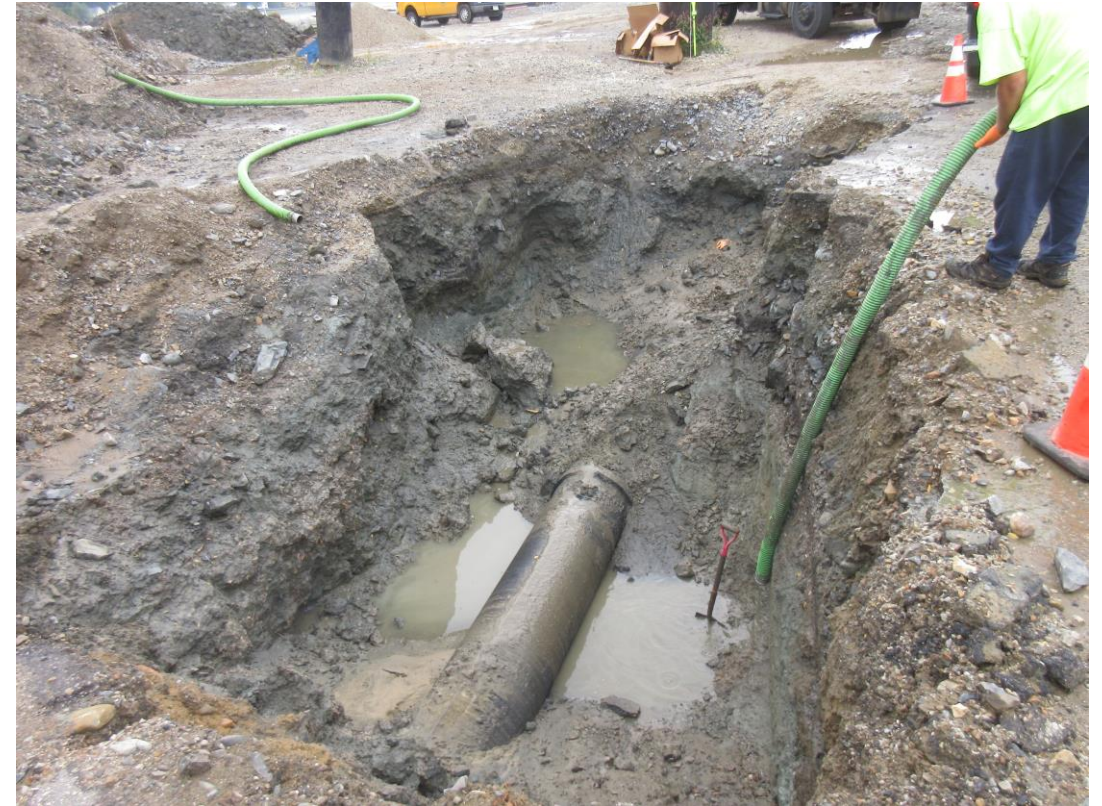
Force Main Failure

- September 10, 2020 – Leak discovered near former snow dump in 24” FM
- Subsequent internal video inspection showed multiple leaks – not economical to repair

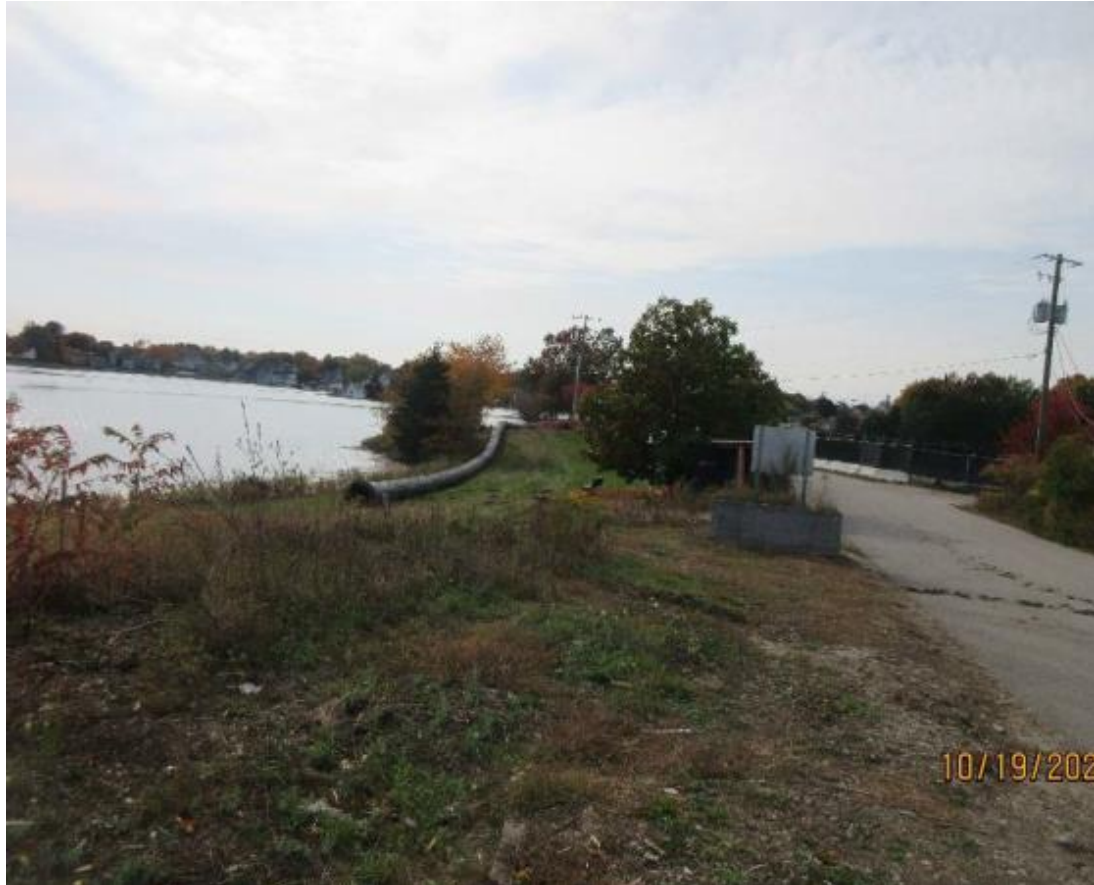
Temporary Force Main

- Temporary 30” HDPE Force Main Installed October 2020

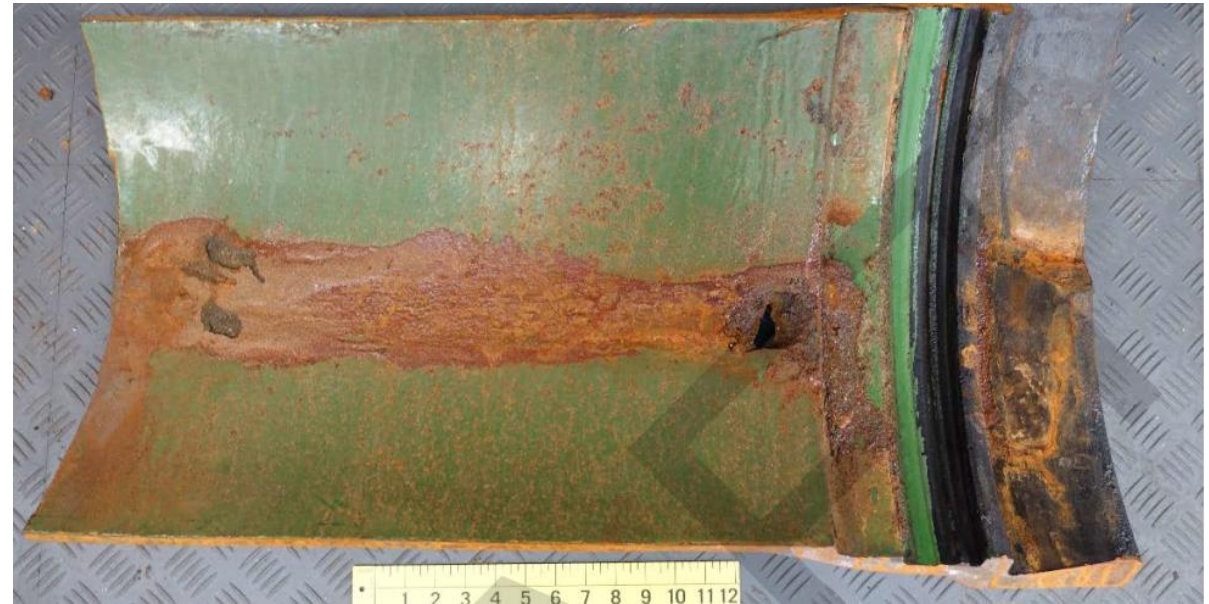
Failure Analysis

- Conducted in concert with Corrosion Probe, Inc.
- Minimum scour velocities not achieved during dry weather resulting in sediment buildup
- Resuspension of grit during wet weather causing abrasion-erosion of linings
- Once linings breached, under-deposit corrosion of ductile iron
- Cyclic dry-weather sediment build-up followed by wet-weather resuspension causes fresh ductile iron to be exposed and eventual perforation of pipe wall
- Cement mortar lining failure more widespread than glass lining

- Corrosion occurred on both cement lined and glass lined pipe
- How to prevent this in the future?

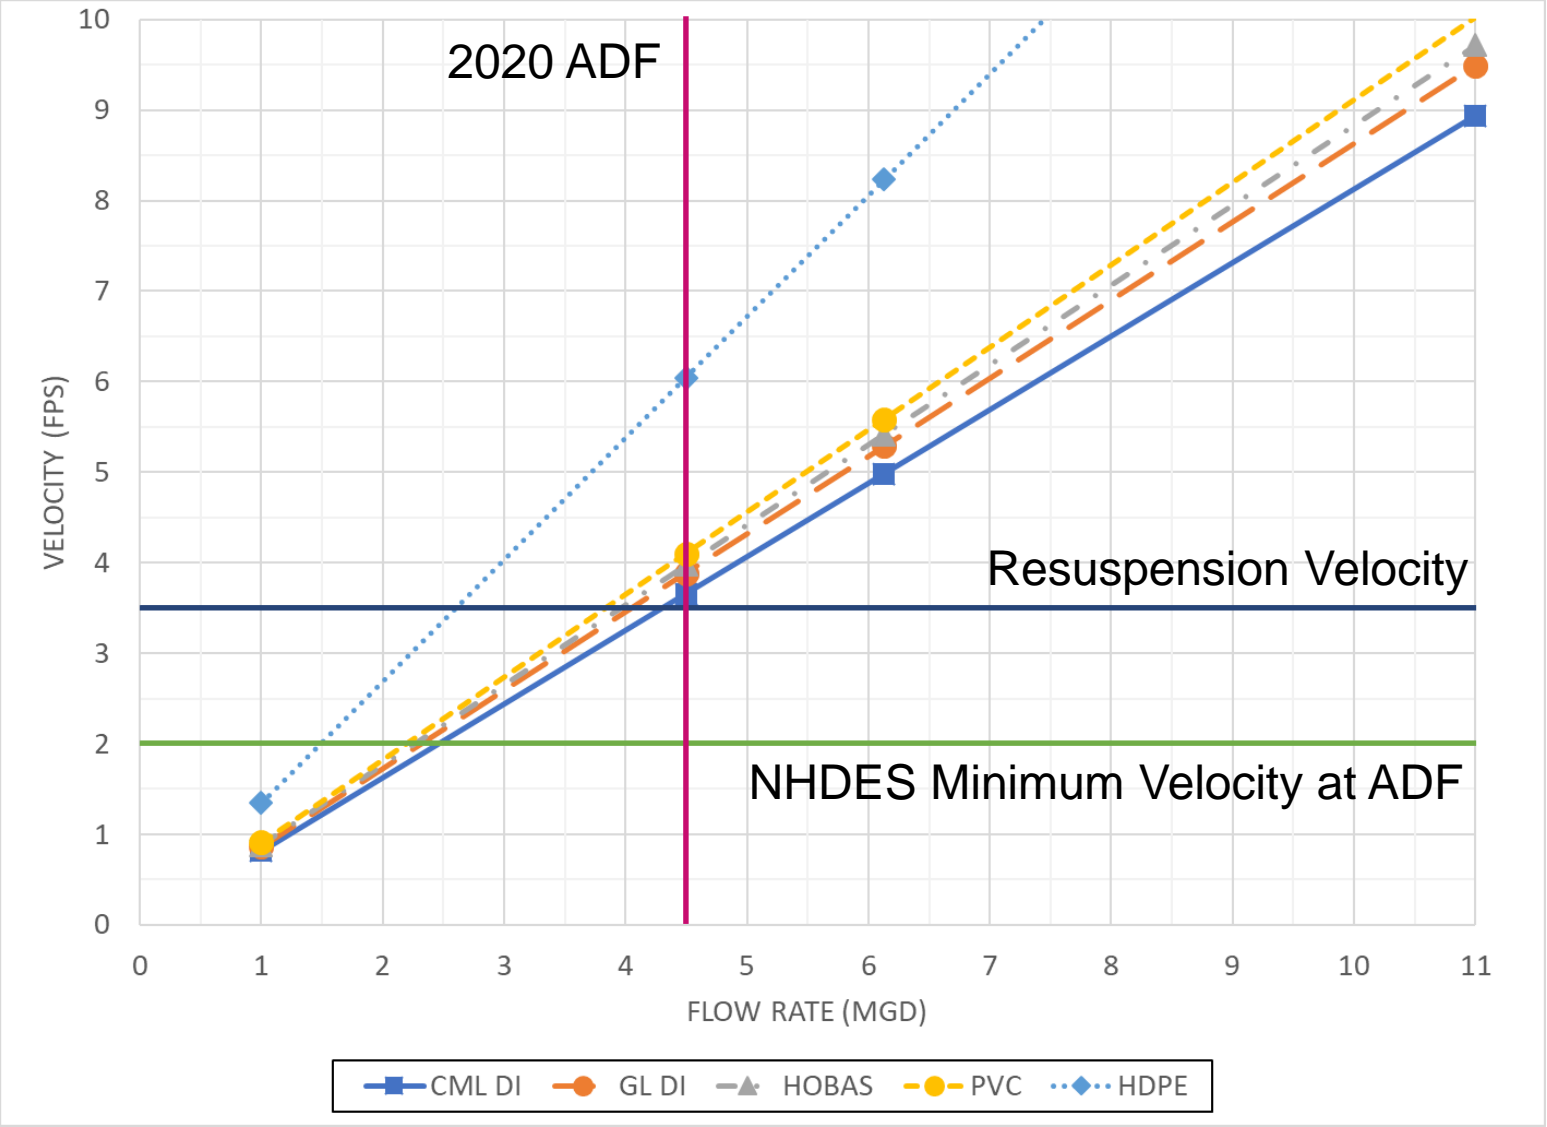
Velocities in an 18” Force Main (Running Alone)

- Similar inner diameters to existing piping desired to minimize impacts to existing pump station
- HDPE's thicker sidewall impacts selection – 20" & 30" HDPE equivalent to 18" & 24" DI
- Long-term recommendation to operate one force main at a time during dry weather to increase fluid velocities & limit deposition
- Using only 20" HDPE would result in poor pump performance

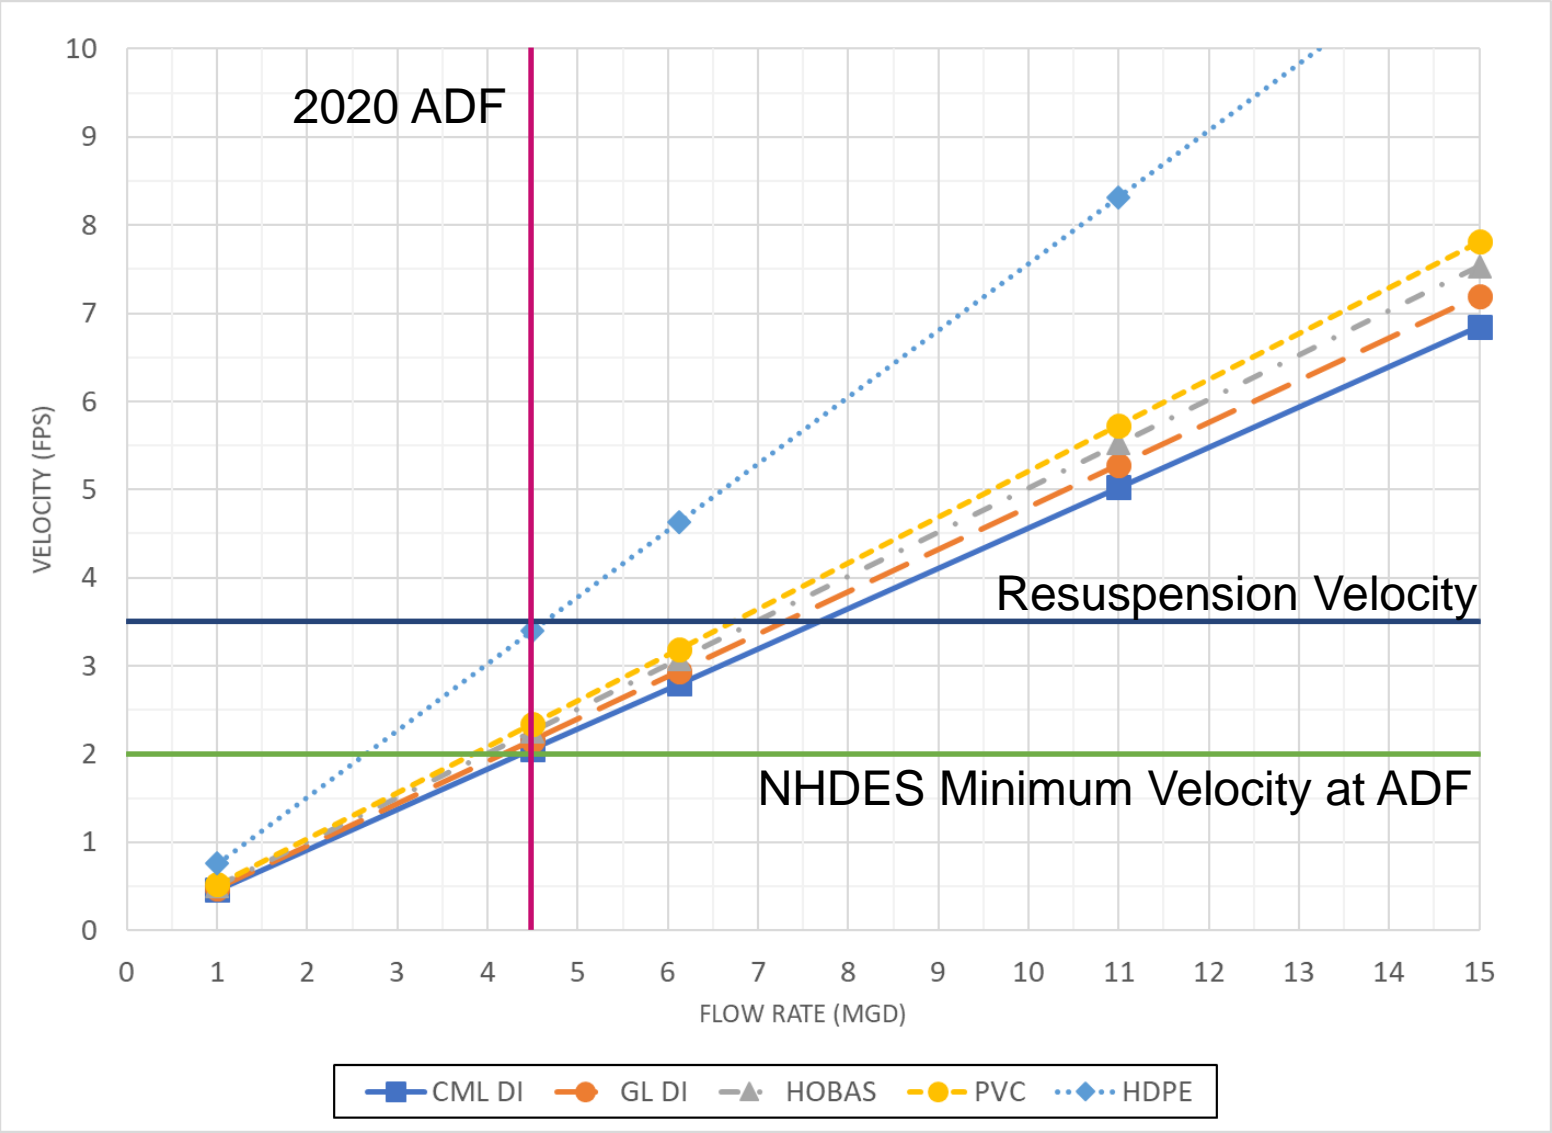
Velocities in a 24" Force Main (Running Alone)

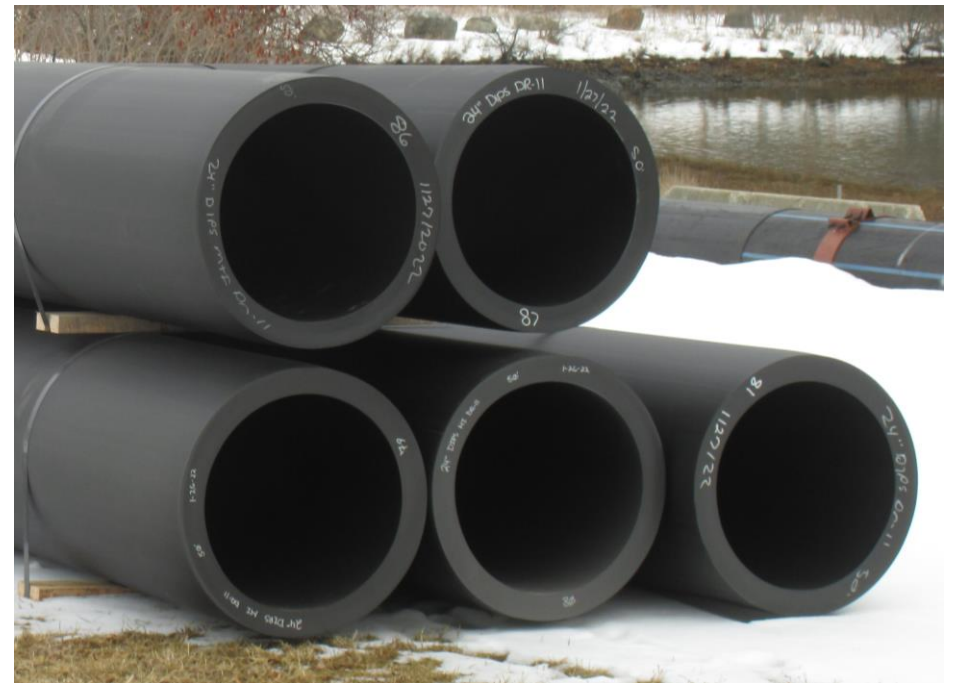
Twin 24" HDPE Force Mains (DR 11)

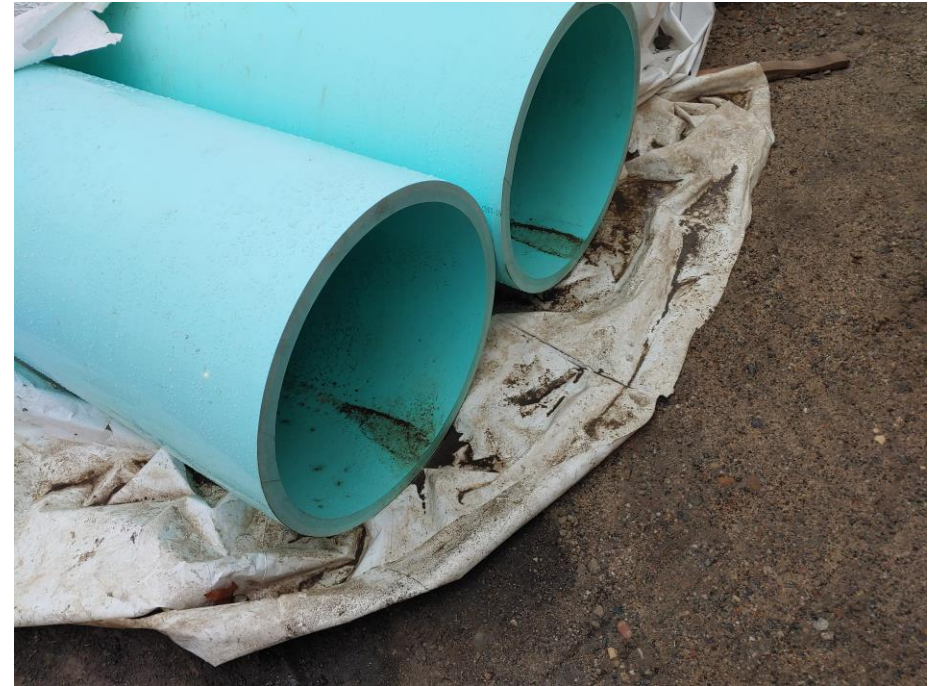
20" Fusible PVC Slipliner

- Replacement with Glass-Lined DI? **Corrosion concerns**
- Replacement with HDPE? **Support, thermal expansion & hydraulic concerns**
- Lining? **Host pipe integrity concerns**
- Bridge scheduled for replacement within 10 years – short-term solution desired
