Monroe County Investing in the Future

**NYWEA/NEWEA Joint Spring
Technical Conference & Exhibition**

Session 6.2
Thursday, June 8, 2023

FEV WRRF

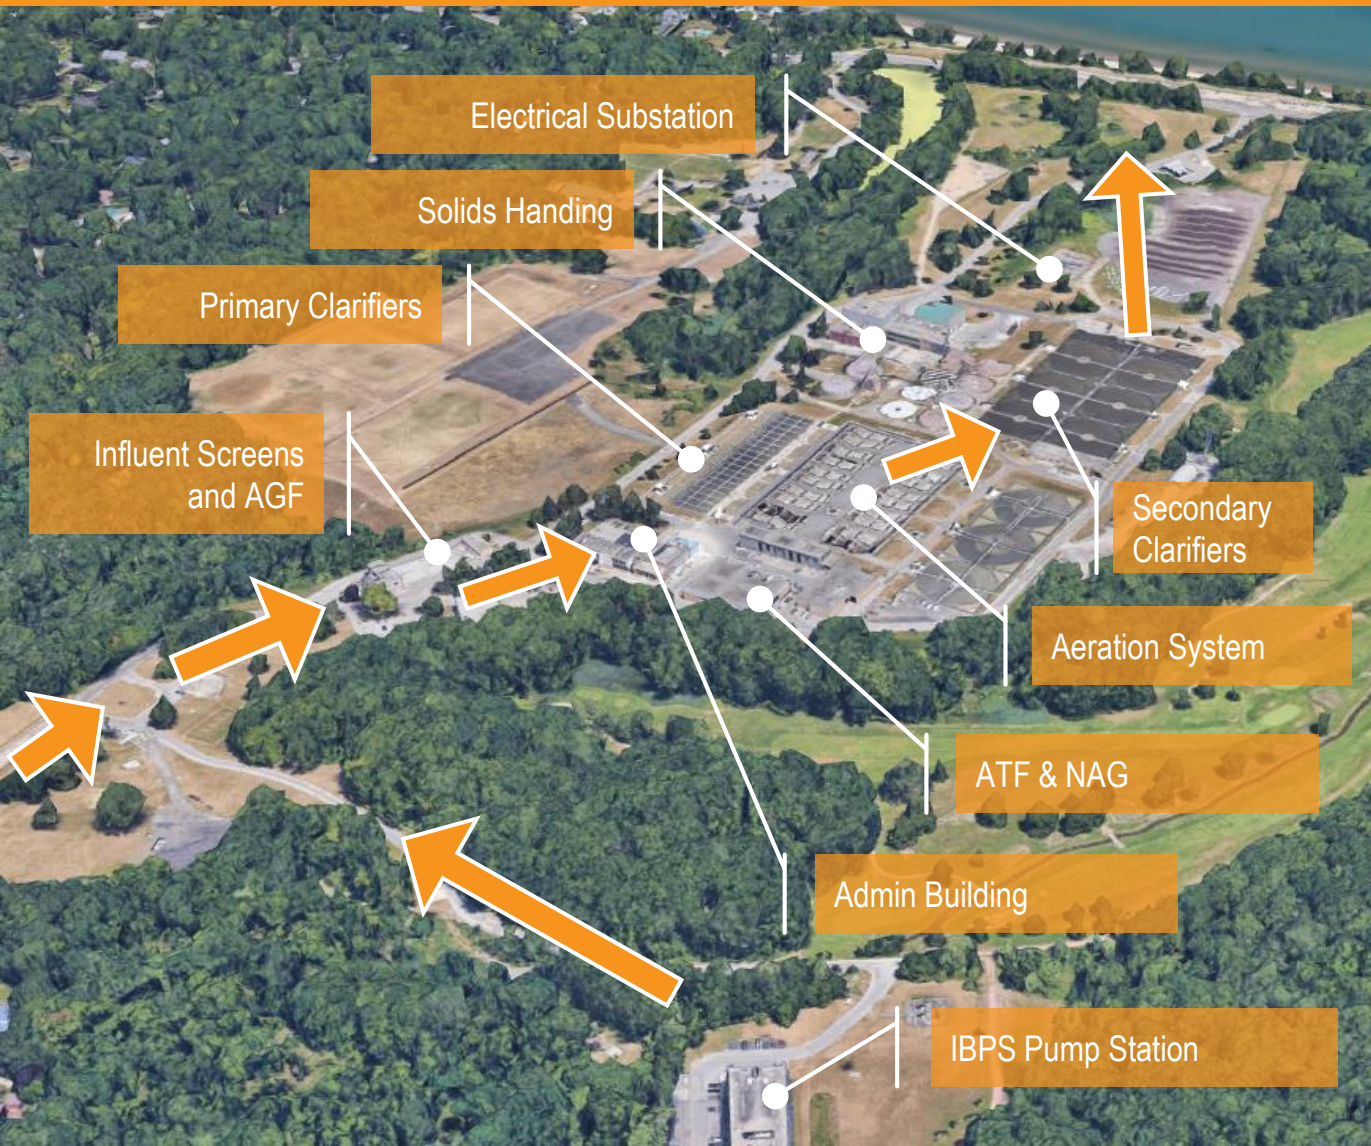
- Rochester, NY
- Original construction 1900s, last major upgrade in 1970s
- Combined sewer
- Permitted for 135-mgd
- Peak influent of 600-mgd
- Effluent limits:
 - Phosphorus -1.0 mg/L
 - TSS - 30/45 mg/L; 85% removal
 - SS - 0.3/0.5 ml/L
 - BOD - 30/45 mg/L; 85% removal

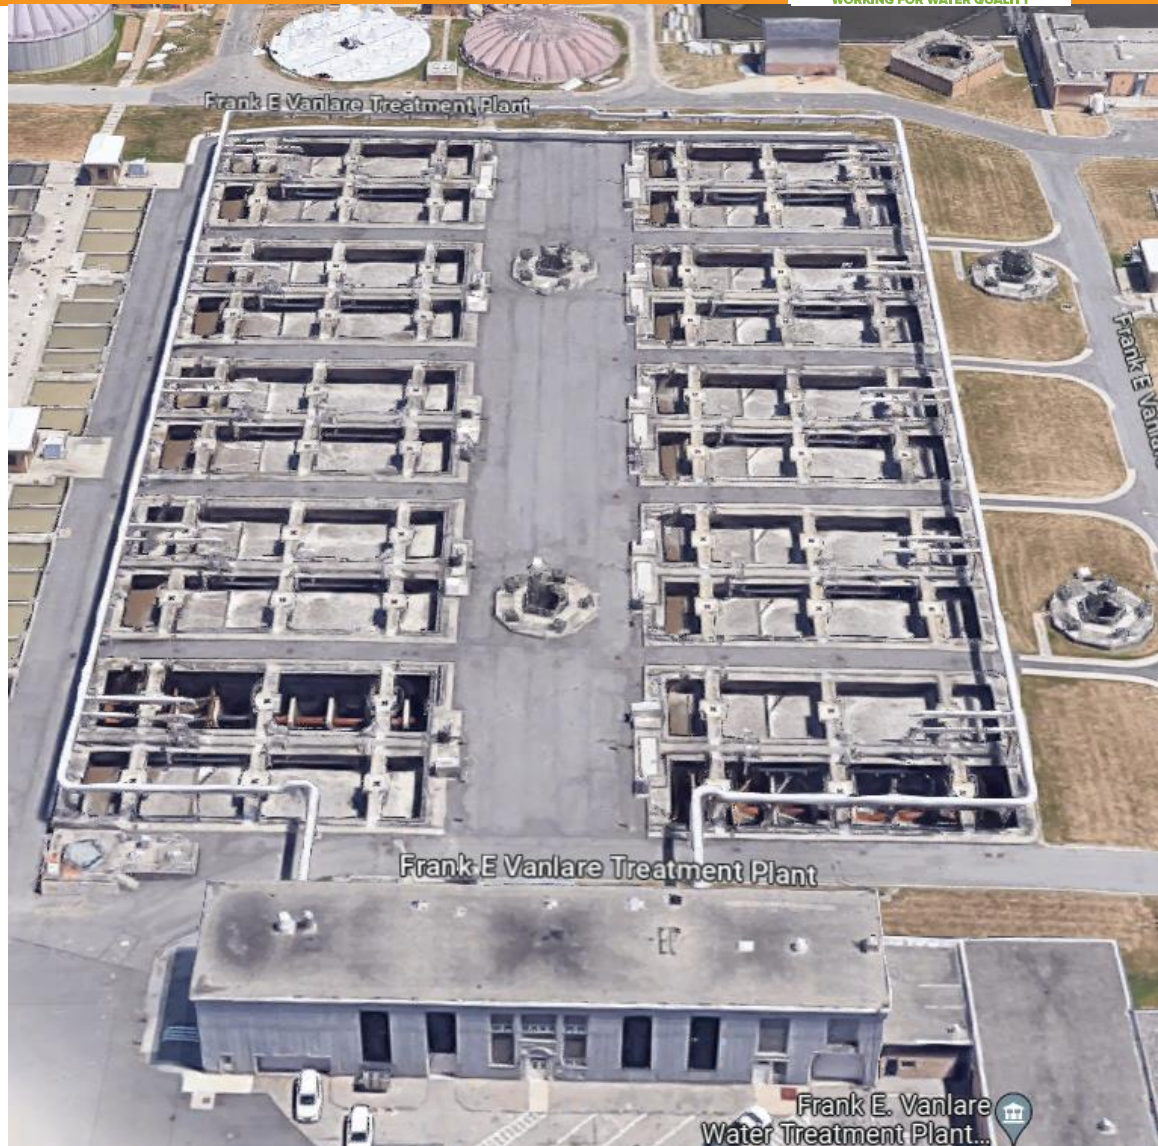
Aeration System – Existing Conditions

- 20 Aeration Basins
- 4 Quadrants
- 10 Centrifugal Turbo Blowers
- 900 to 1200 SCFM per Basin
- 3.0 mg/L Dissolved Oxygen
- Non-aerated Selector
- Plug Flow

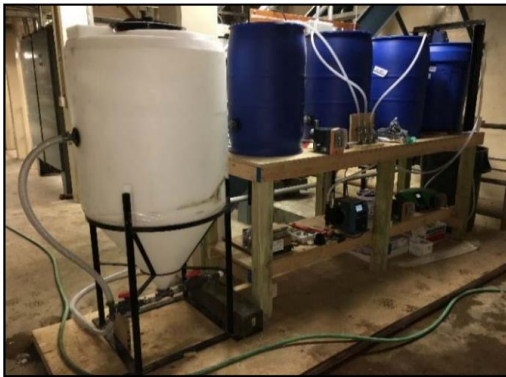
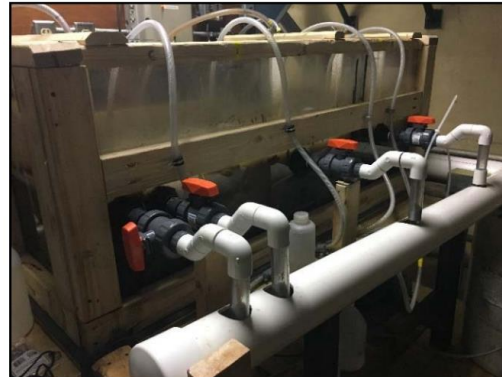
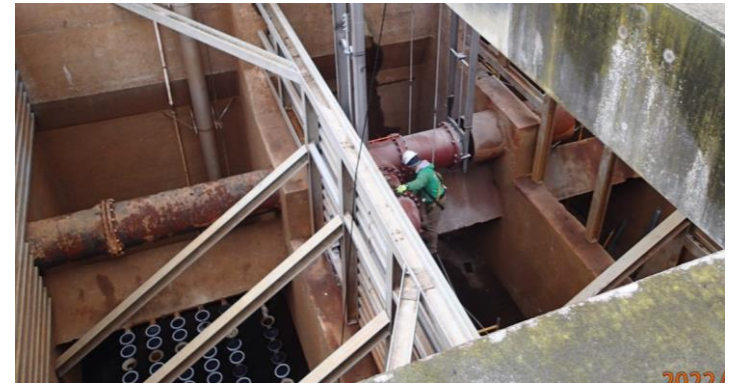
Aeration System – The Solution

- Complete Mix, Full Air – 8 Basins
- 2 Additional Blowers
- Automation of Influent Gates
- New Programming Implemented for Blower and DO Control

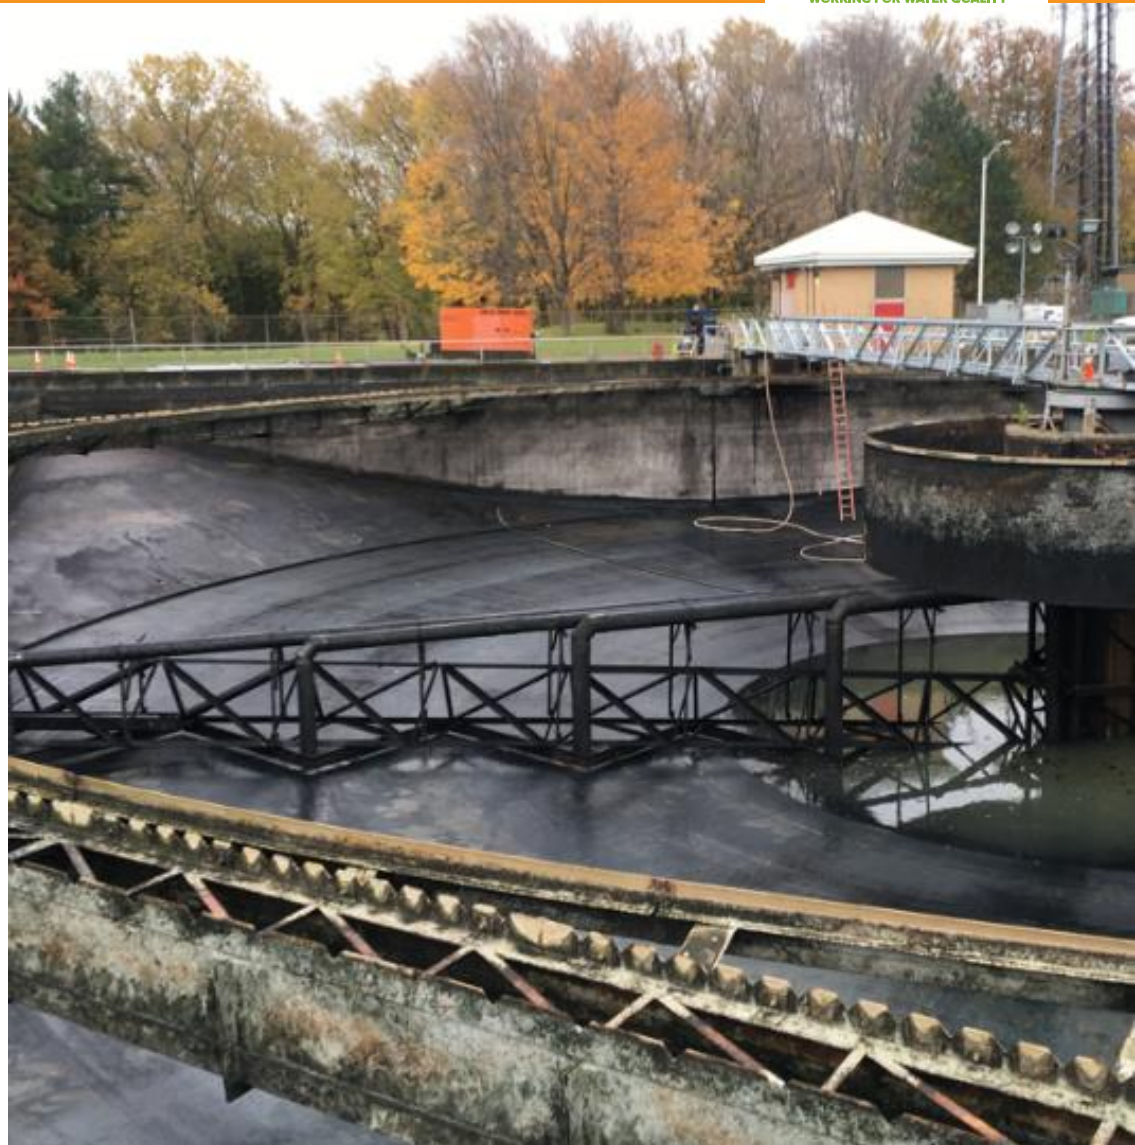
Secondary Clarifiers – Existing Conditions

- **Existing Secondary Clarifiers:**
 - Six 145-foot diameter squircles
 - Installed in 1970s - beyond useful life
 - Circular collector mechanism
 - No corner sweeps – corner infills in 1990s
 - 14.5-foot side water depth
 - Cone bottom with slope of 1 to 12-feet
 - Center feed
 - Peripheral effluent
 - Scrappers with draft tubes
 - WAS hopper at center

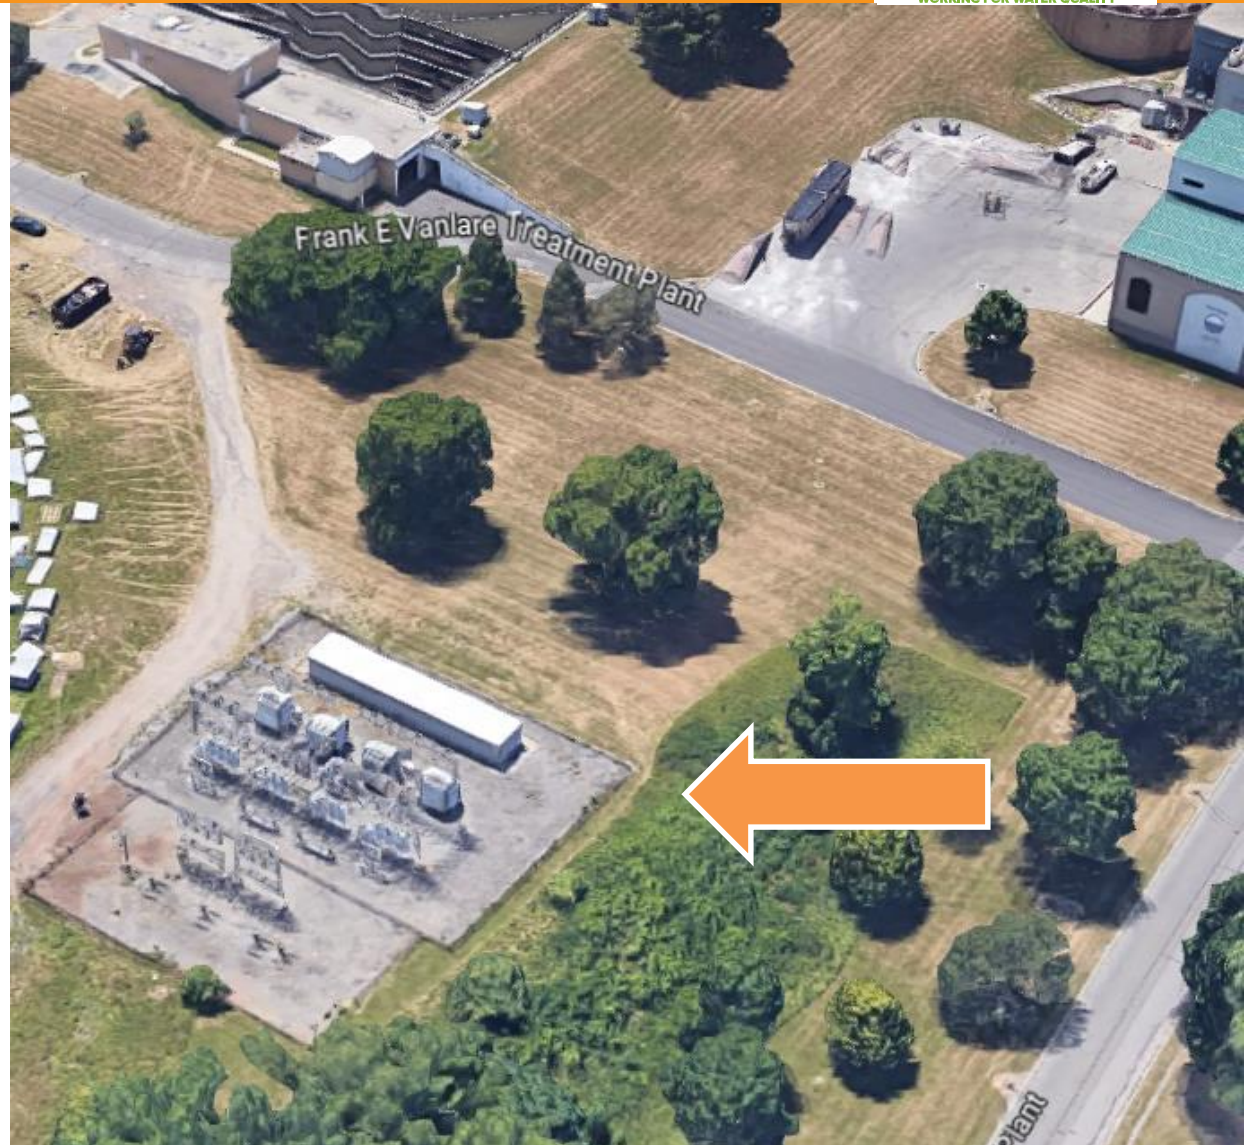
Electrical System – Existing Conditions

- Original installation in the 1980s
- Two incoming 34.5kV RG&E circuits (same source)
- Oil circuit breakers and air switches located in outdoor overhead structures
- 4 outdoor 7500kVA transformers - 34.5kV service to 4160V
- 5kV MV distribution switchgear located inside metal enclosure
- MV cabling throughout facility to stepdown transformers

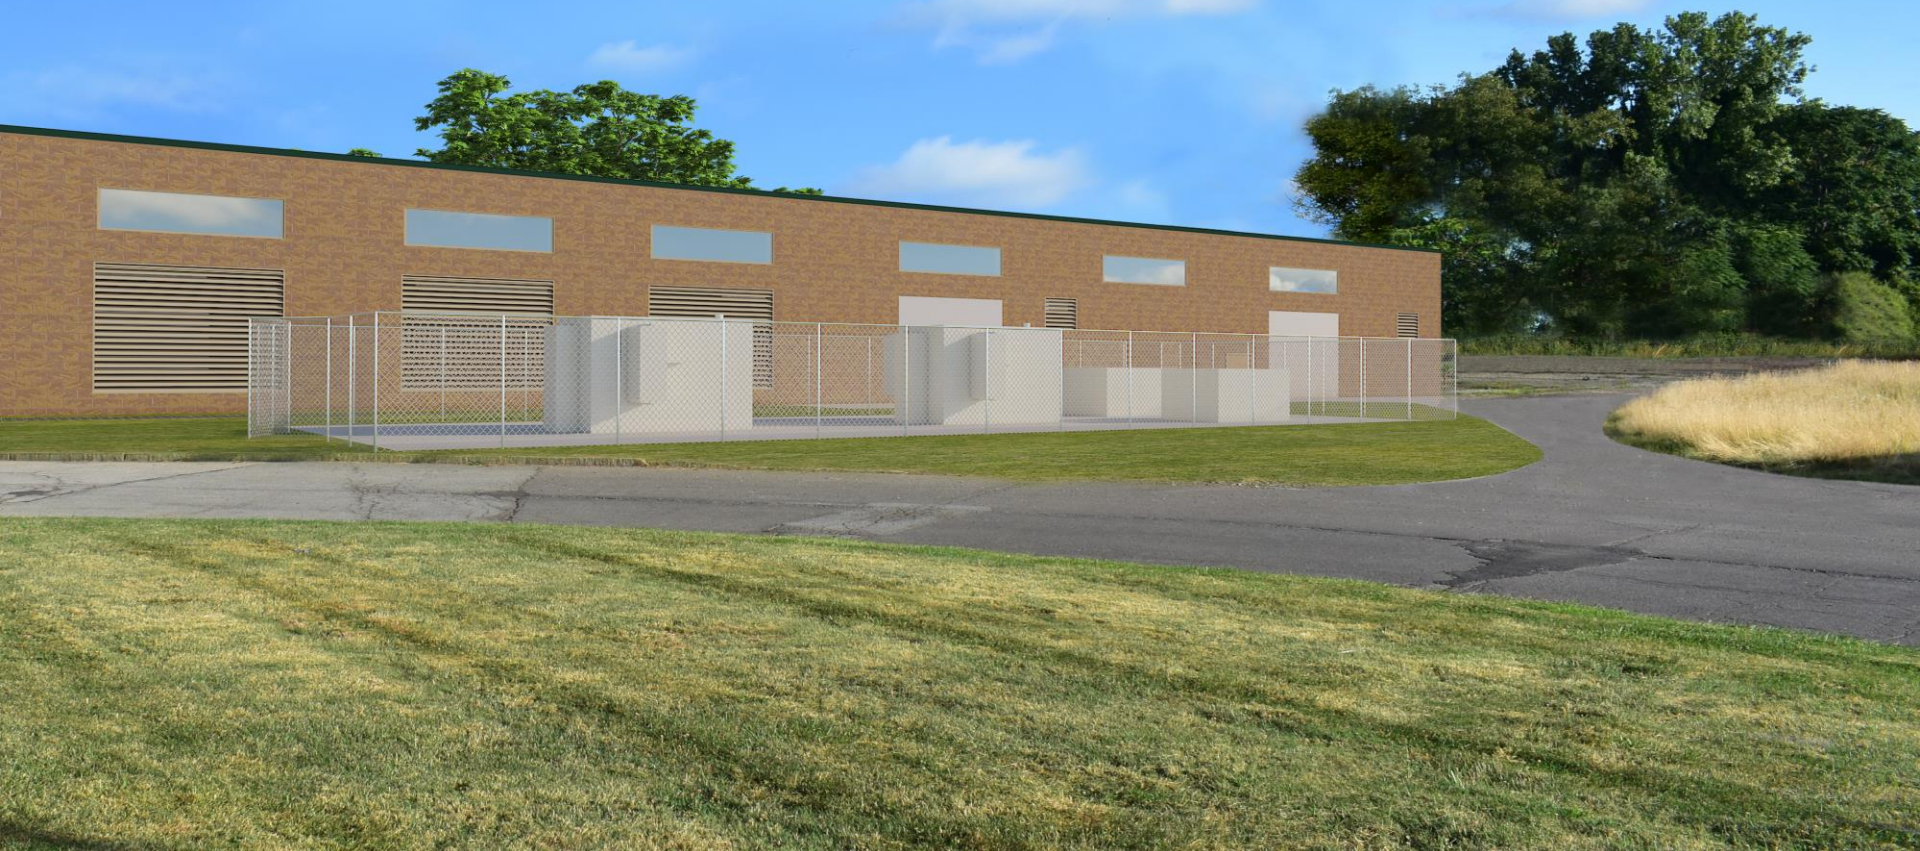
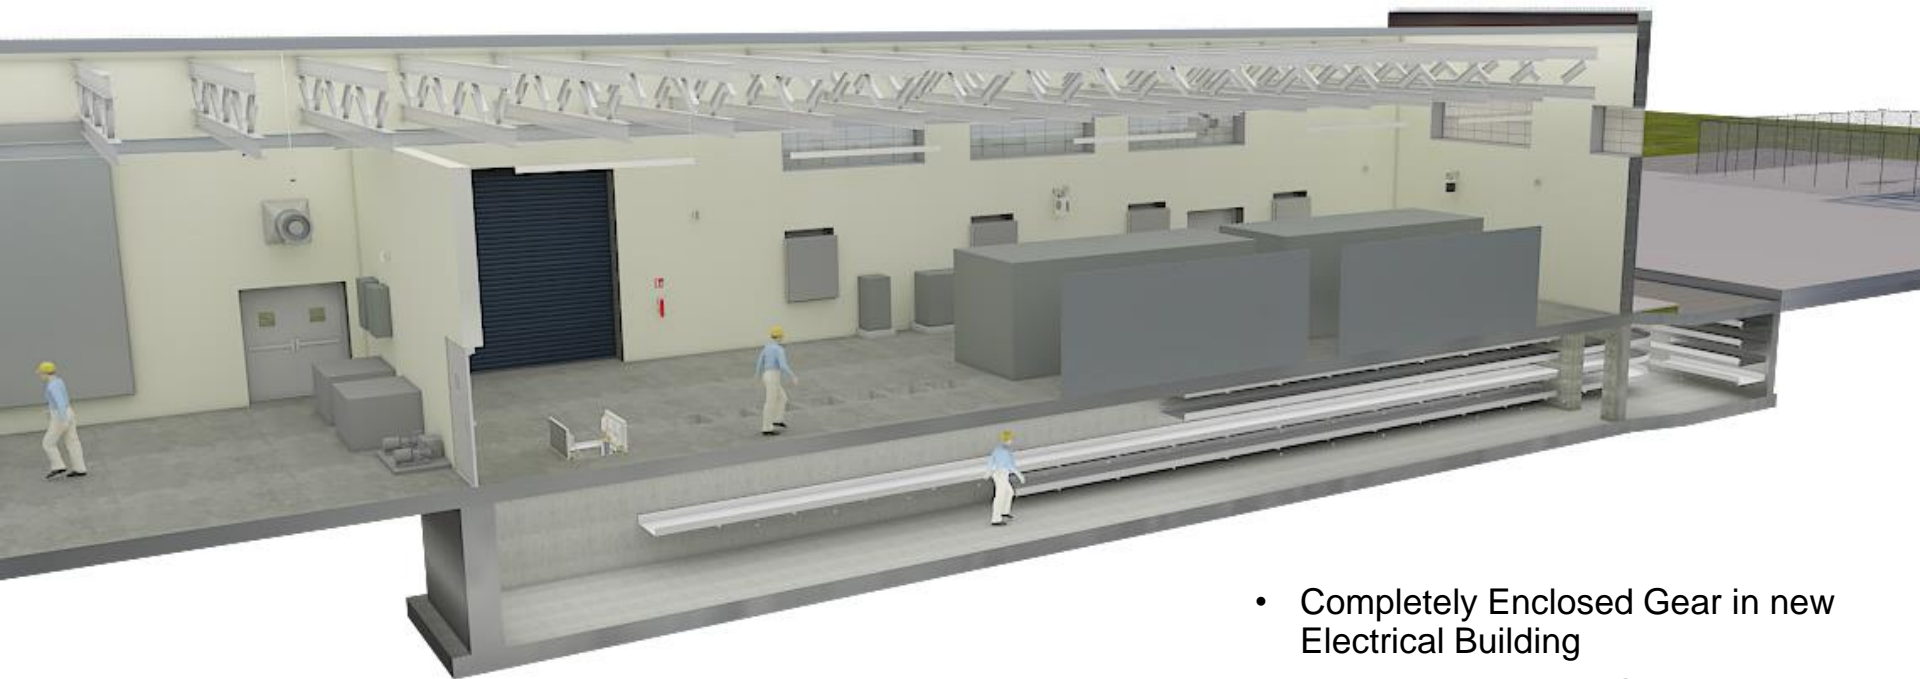
Electrical System – The Solution

- Completely Enclosed Gear in new Electrical Building
- New 38kV and 5kV Gear
- 2 New 7500kVA Transformers
- Provisions for Future Standby Power
