## Innovation in the Field

### Using Geospatial Video to Enhance Data Collection

## Hare Snipe Watershed Study

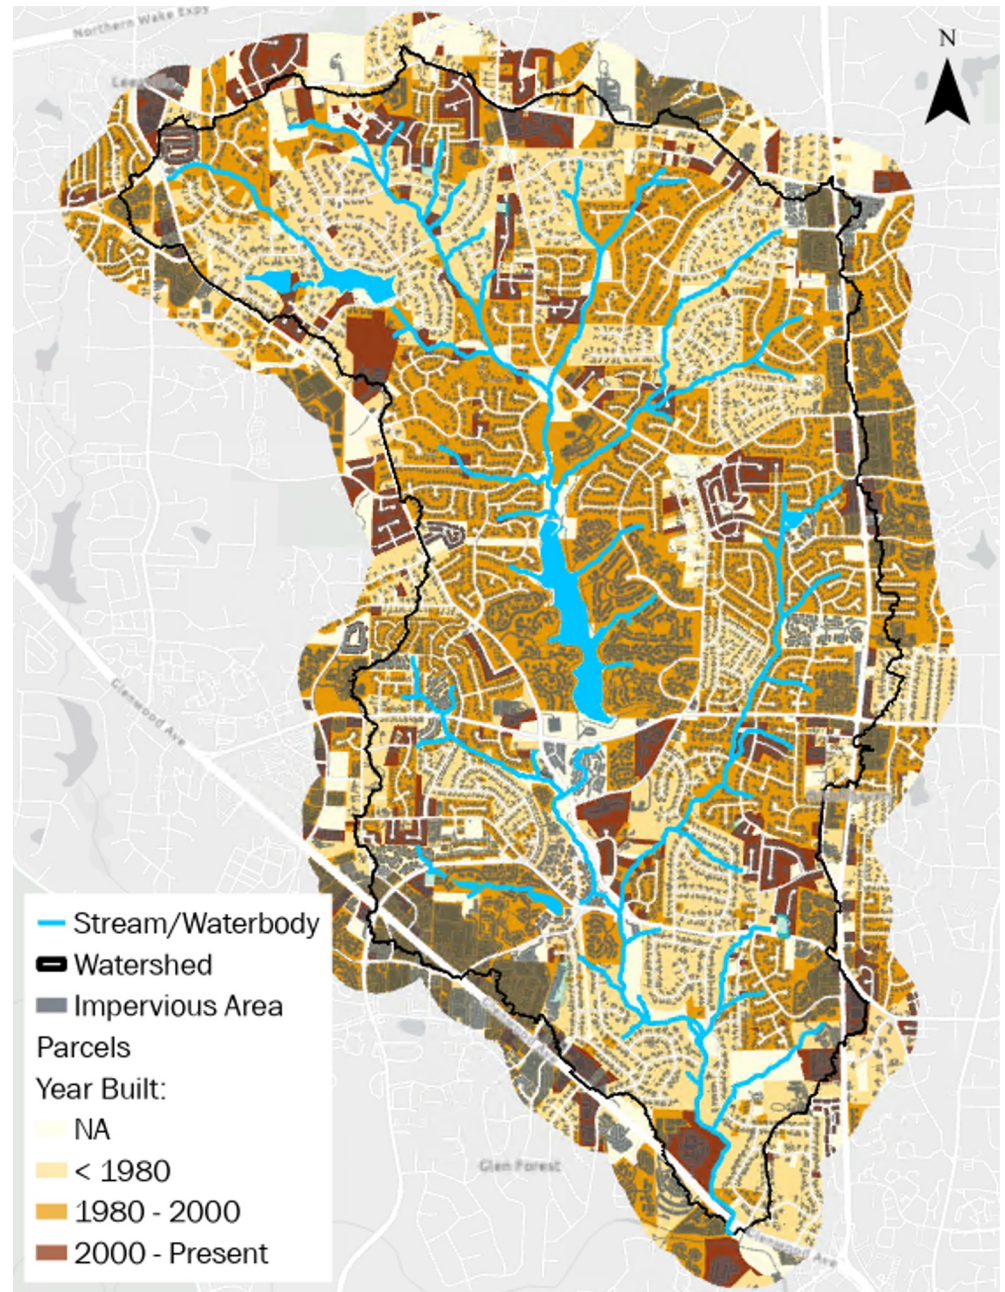
# Watershed Characteristics

- 7.3 square miles
- ~30% impervious cover
- ~ 22 miles of streams
- 6 waterbodies (including Lake Lynn)
- Impaired for benthos
- No TMDLs

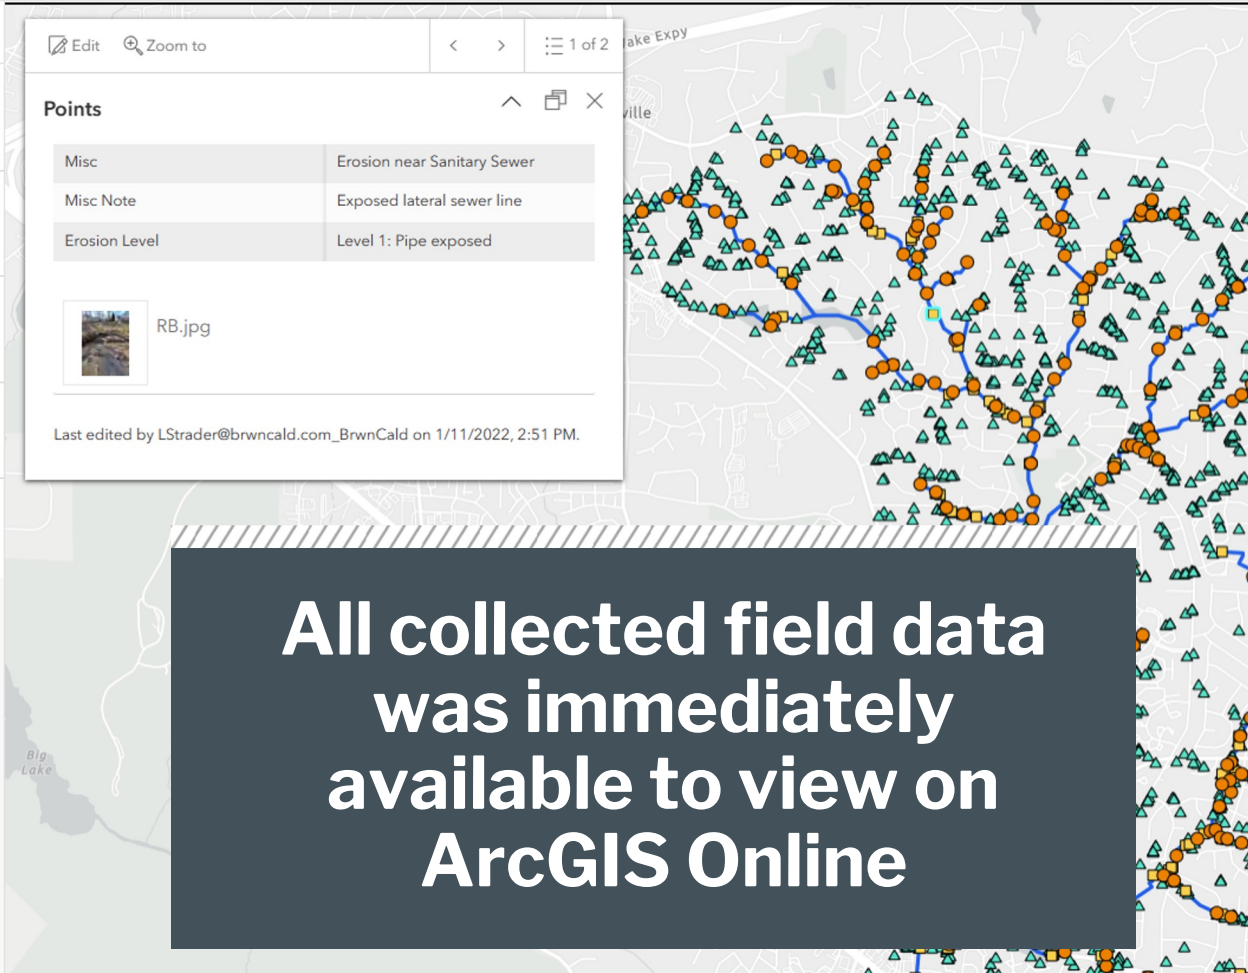
# Data Availability

Misc	Erosion near Sanitary Sewer
Misc Note	Exposed lateral sewer line
Erosion Level	Level 1: Pipe exposed

**All collected field data was immediately available to view on ArcGIS Online**

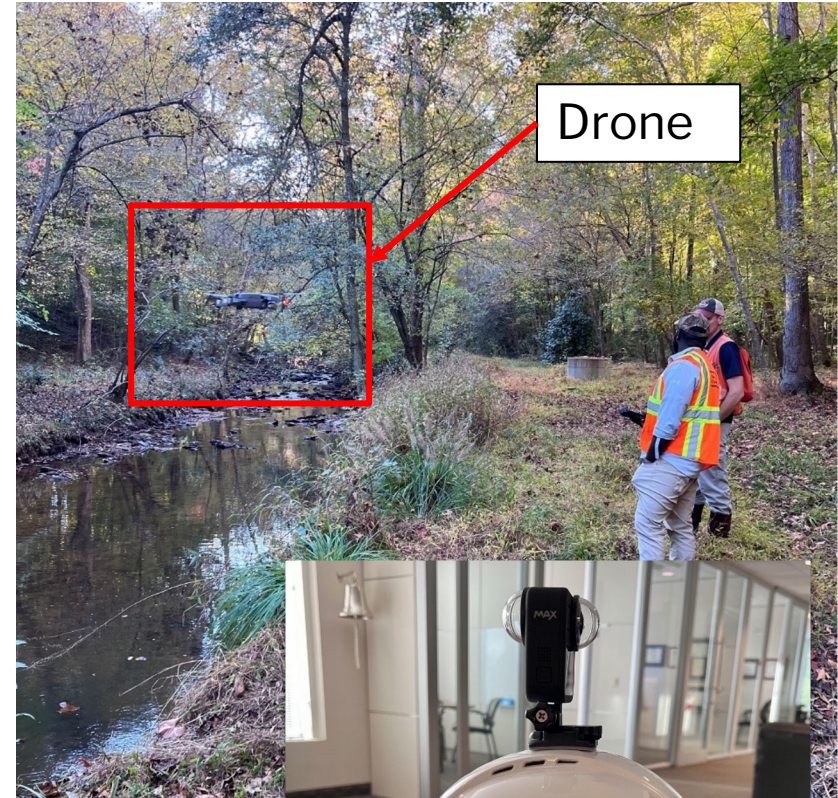
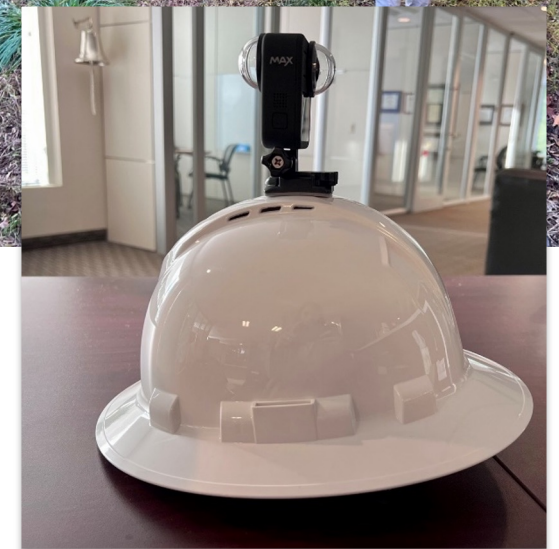
# Collection of 360° Stream Footage

- Two methods for recording footage of each assessed stream segment were tested:
  1. 360° camera mounted on a drone
  2. 360° camera mounted on a hardhat and worn by field staff

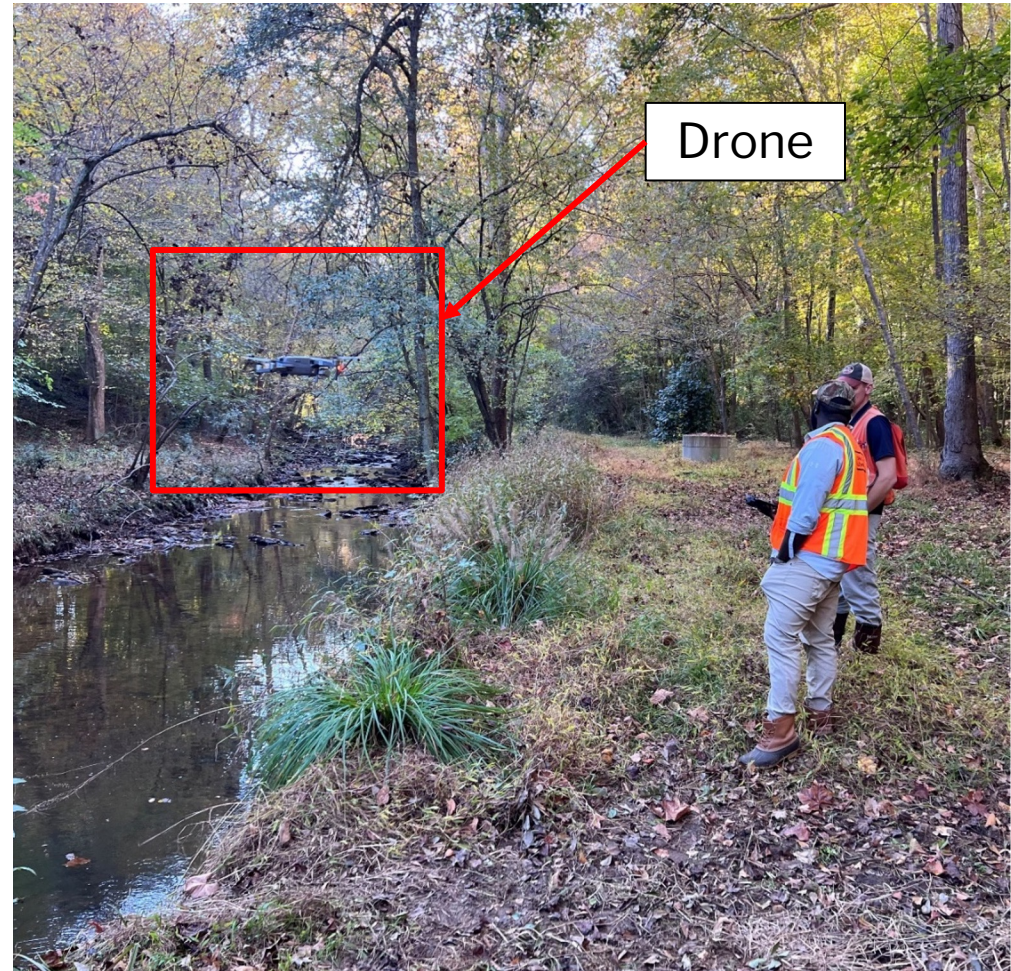
# Drone-Mounted Camera

- Benefits:
  - Footage could be recorded while stream assessments were being conducted
  - Did not require field staff to enter streams

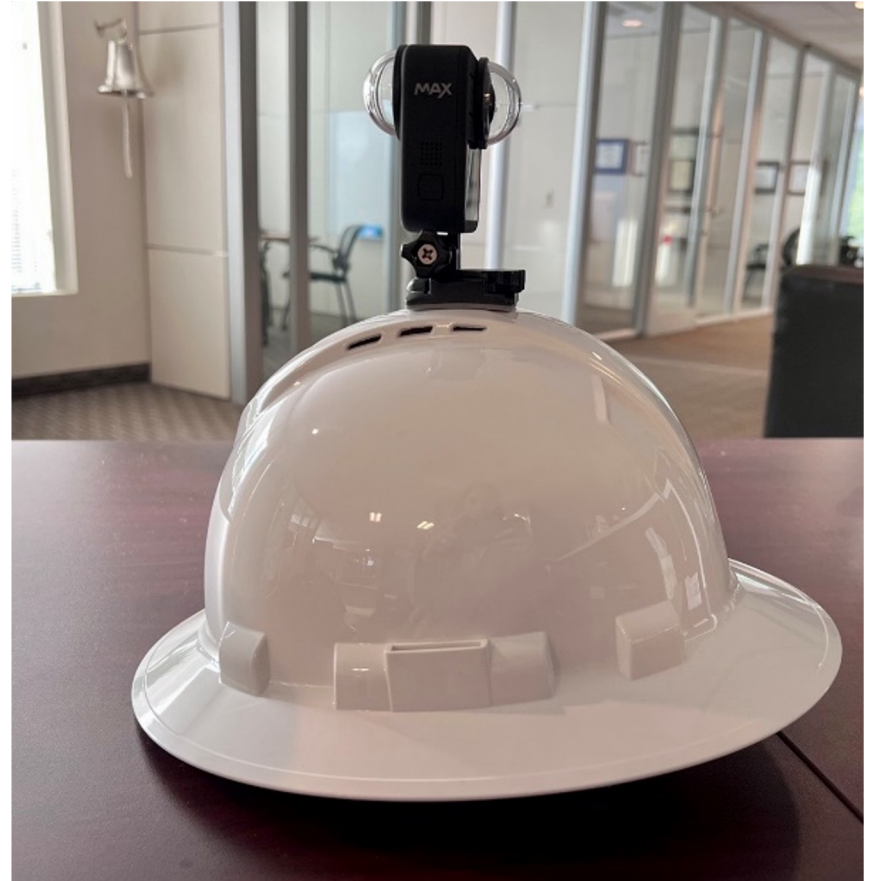
# Hardhat-Mounted Camera

- Benefits:
  - Footage could be collected by any field staff member
  - Camera was easy to install and was less likely to be damaged while recording footage

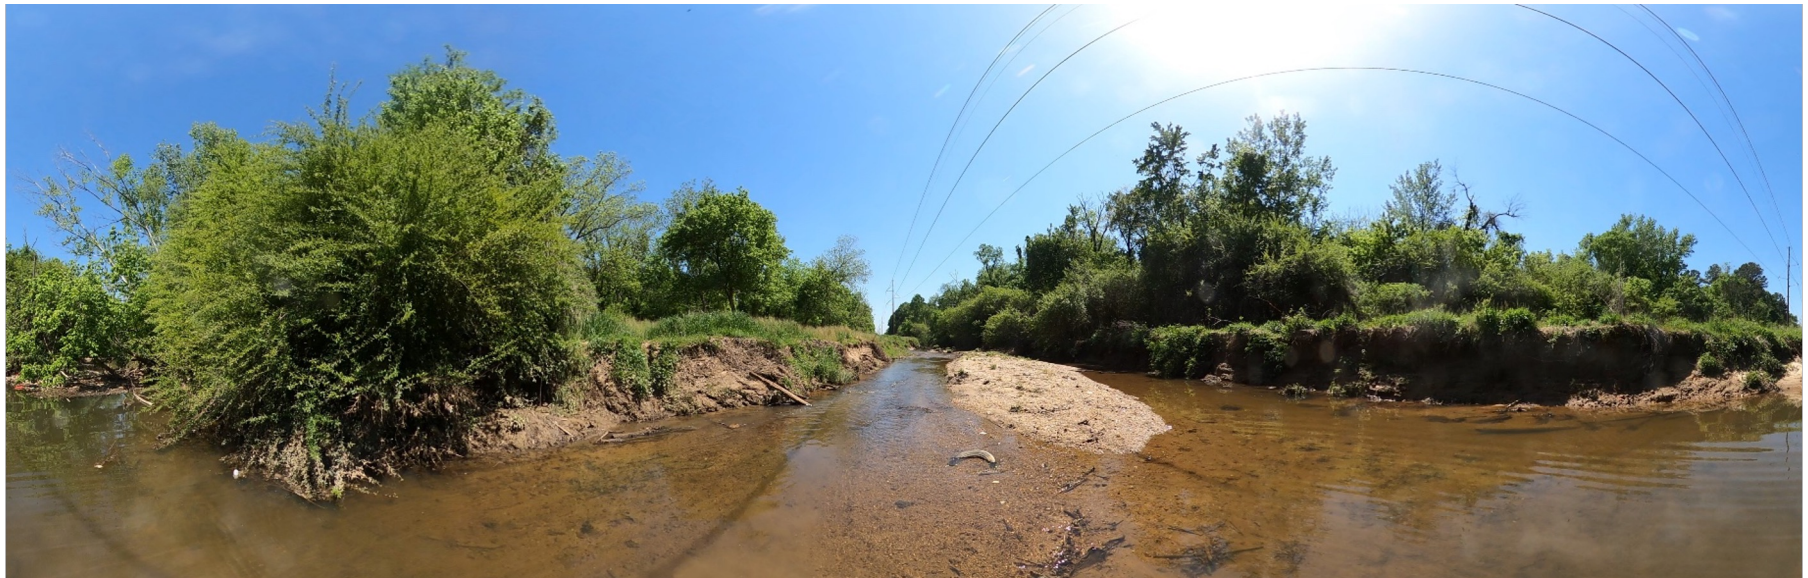
# 360° Camera Setup

- GoPro MAX camera
- Waterproof
- GPS Capabilities
  - Video footage is linked to specific locations along each stream segment

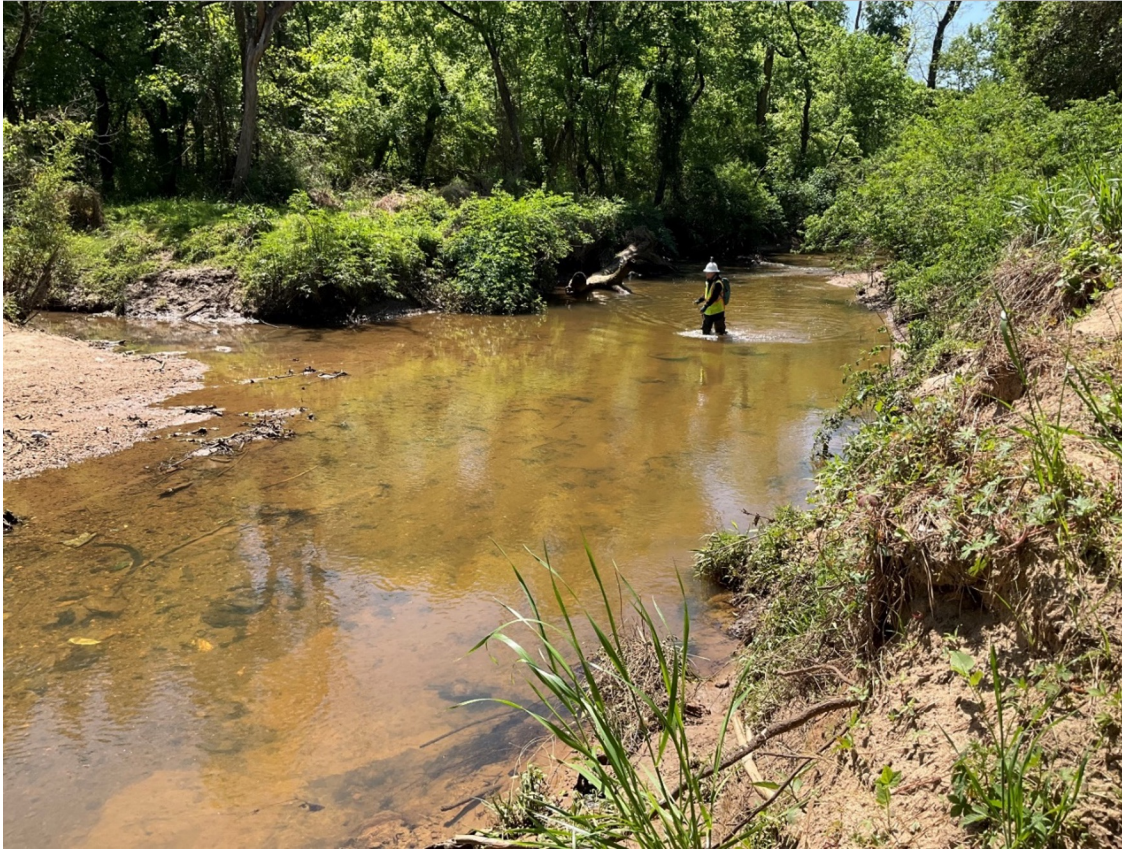
# Camera Methods

- Field staff collected stream condition information while walking upstream
- Footage of stream was recorded while walking downstream

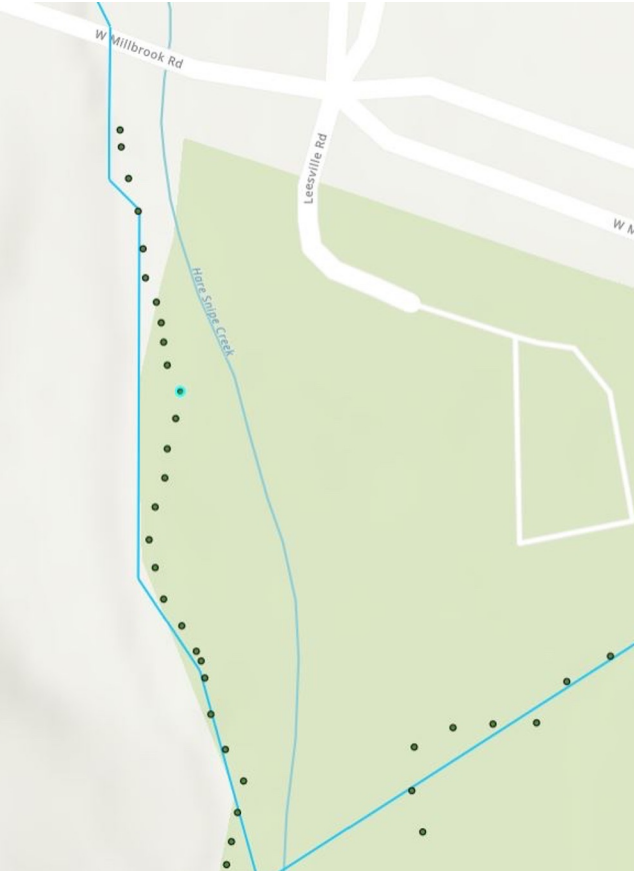
# Accessing the Footage

GPS_Lat_	35.861641
GPS_Long_	-78.695442
GPS_Alt_	88.272000
GPS_2D_sp	1
GPS_3D_sp	1
fix	3
precision	216
altitude_s	MSLV
cts_date_G	
timestamp_	0.000000
Alt_ft	0.000000
VideoName	GS010044
timestamp1	100.000000
duplicate_	
is_duplica	0
VideoURL	<a href="#">View</a>

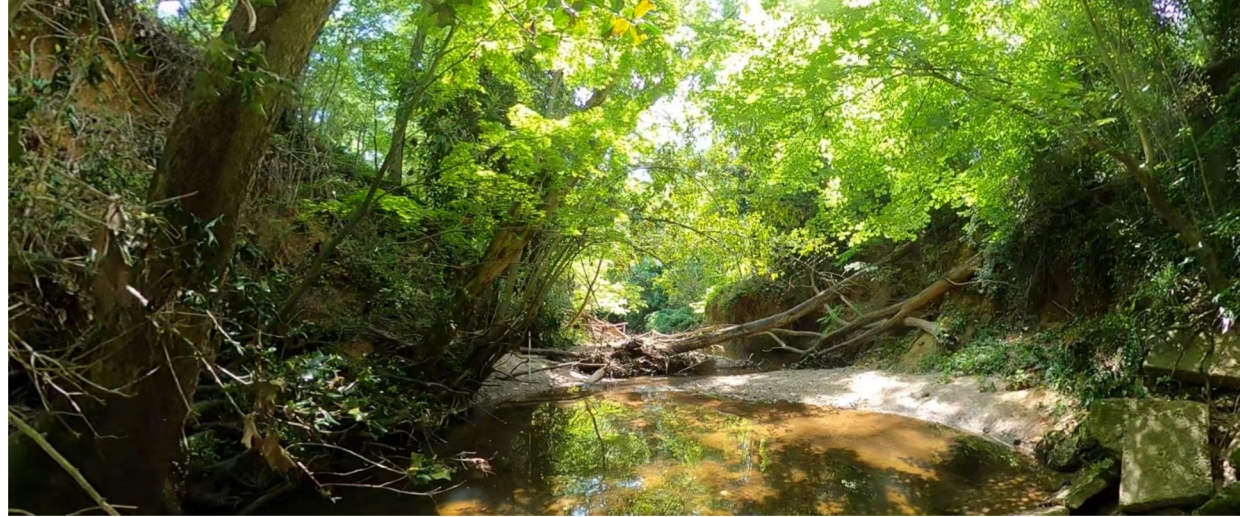
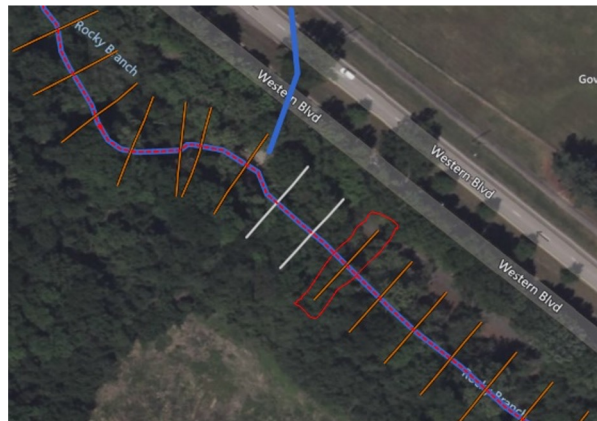
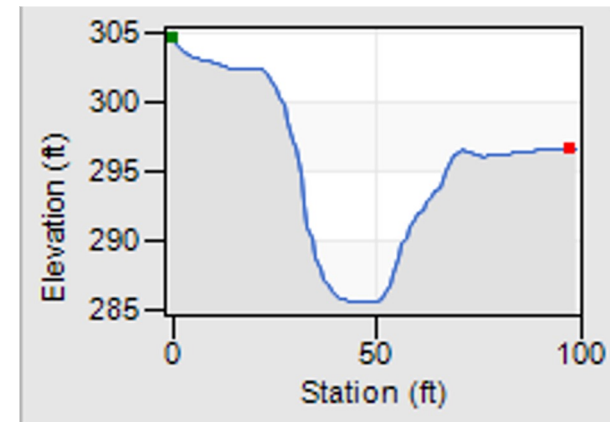
# Water Quantity Modeling

- Stream observations used to identify potential stream constrictions
- 360° footage used to validate elevation data
  - Verified that steep streambanks were being captured in the model
