Managing Your Siphons: A Lesson in Maintaining and Rehabilitating Critical Infrastructure

City of Nashua, NH

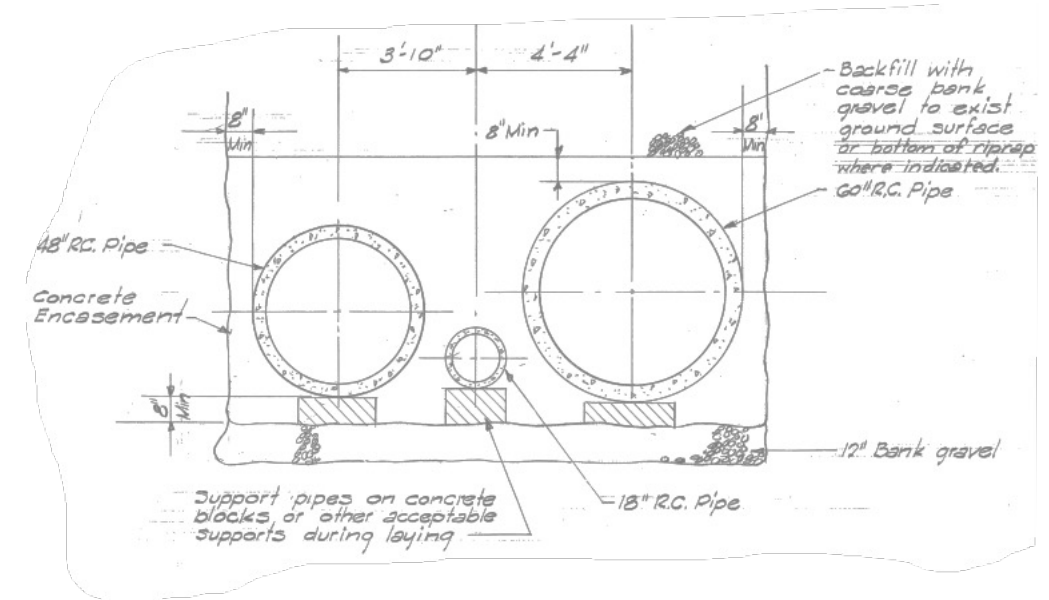
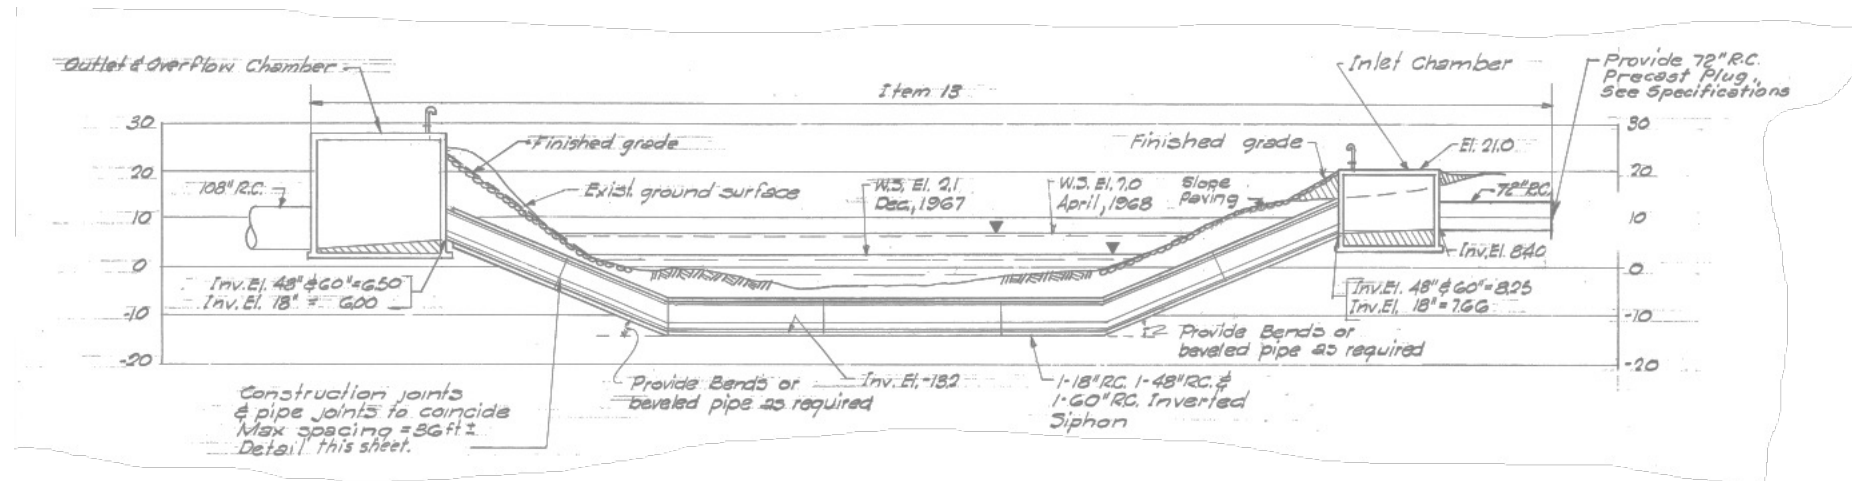
- Nashua's Inverted Siphons
 - Installed between 1968 and 1982, ranging in size from 6 to 60-inch barrels
 - Used at river crossing in lieu of pump stations
- Prone to Fats, Oils, and Grease (FOG) build up and debris impaction, particularly at pipe bends

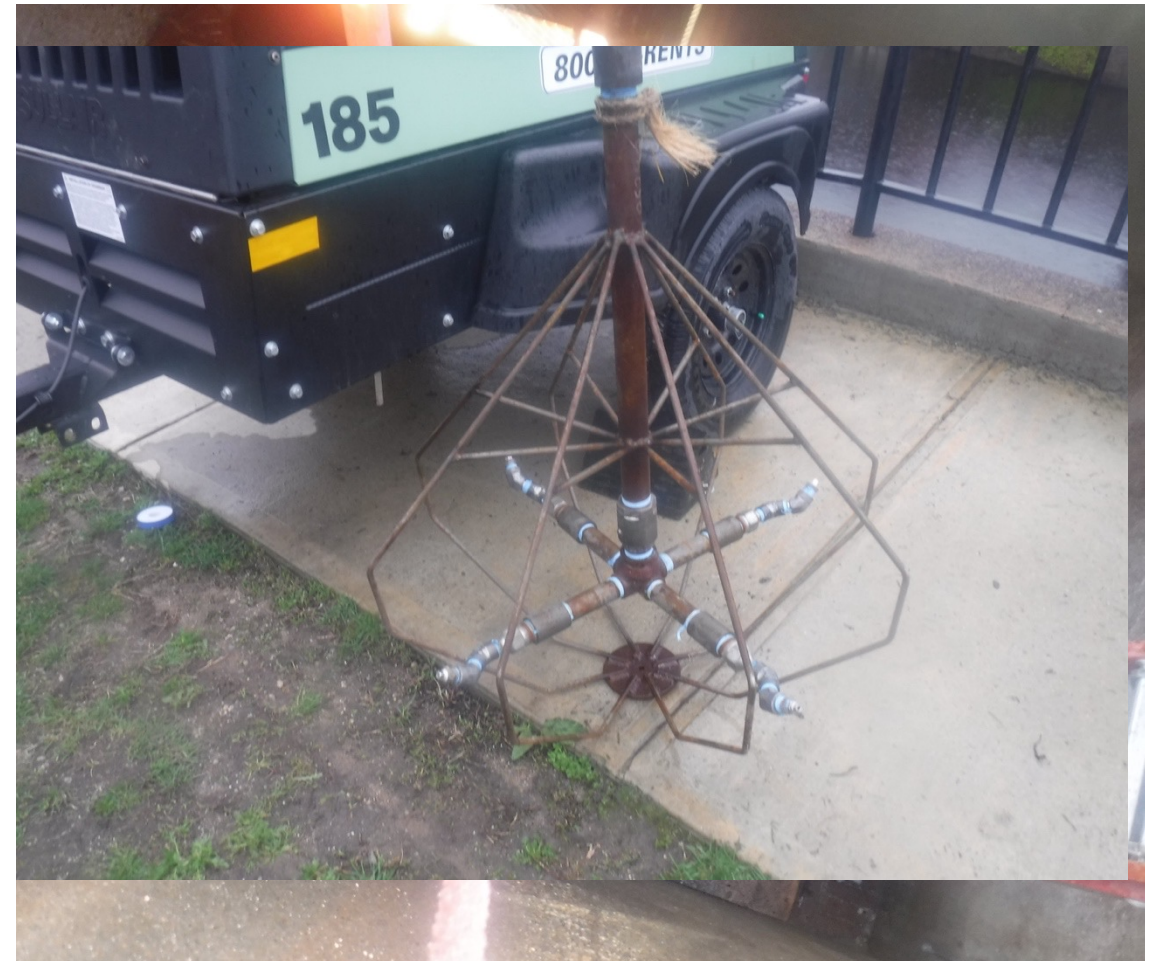
- All 8 inverted siphons were cleaned and inspected over a 2-year period
 - CUES Digital Universal Camera (DUC) used on first 4 siphons
 - Traditional high-resolution camera used on remaining 4
- Crews encountered various challenges when cleaning:
 - Depth of structures
 - Pipe sizes
 - Lack of prior maintenance
- Innovative approaches to cleaning:
 - Customized vacuum tubes, manned entry, uncommon cleaning equipment

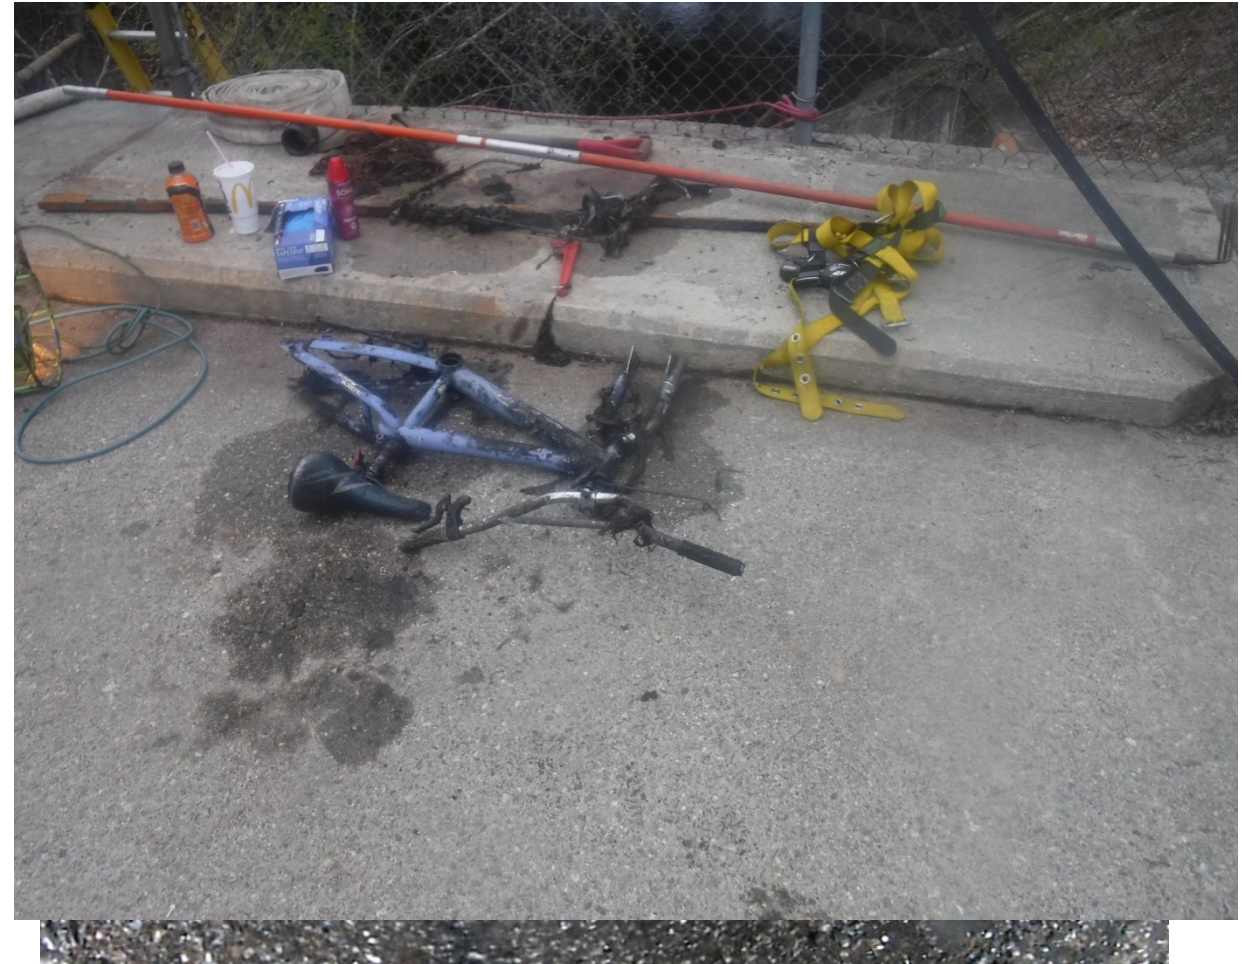
- Coordination with City of Nashua, private utilities, and residents was key to project success
- As anticipated, inspections found the barrels to be in various states of operability:
 - Heavy grease build up in most barrels
 - Several barrels completely occluded with debris
 - Many defects requiring repair

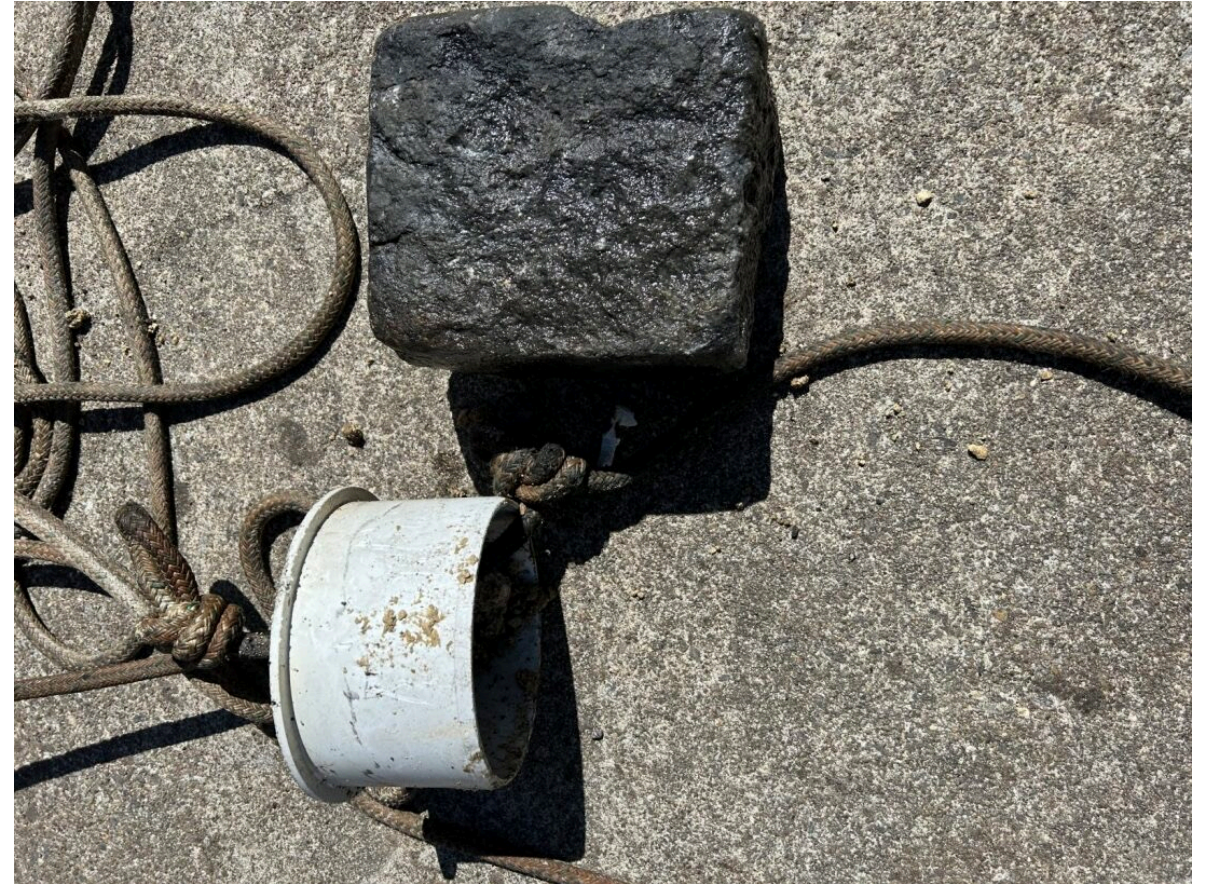
- Prior to rehab, designated barrels were cleaned and inspected
 - In just 3-4 years, barrels exhibited heavy grease build up and large debris, including rocks, sand, ragging, and more
- Again, crew relied on less common equipment and techniques to clean siphons
 - Pneumatic rock hammers, pigging, specialized vacuum hoses, etc.

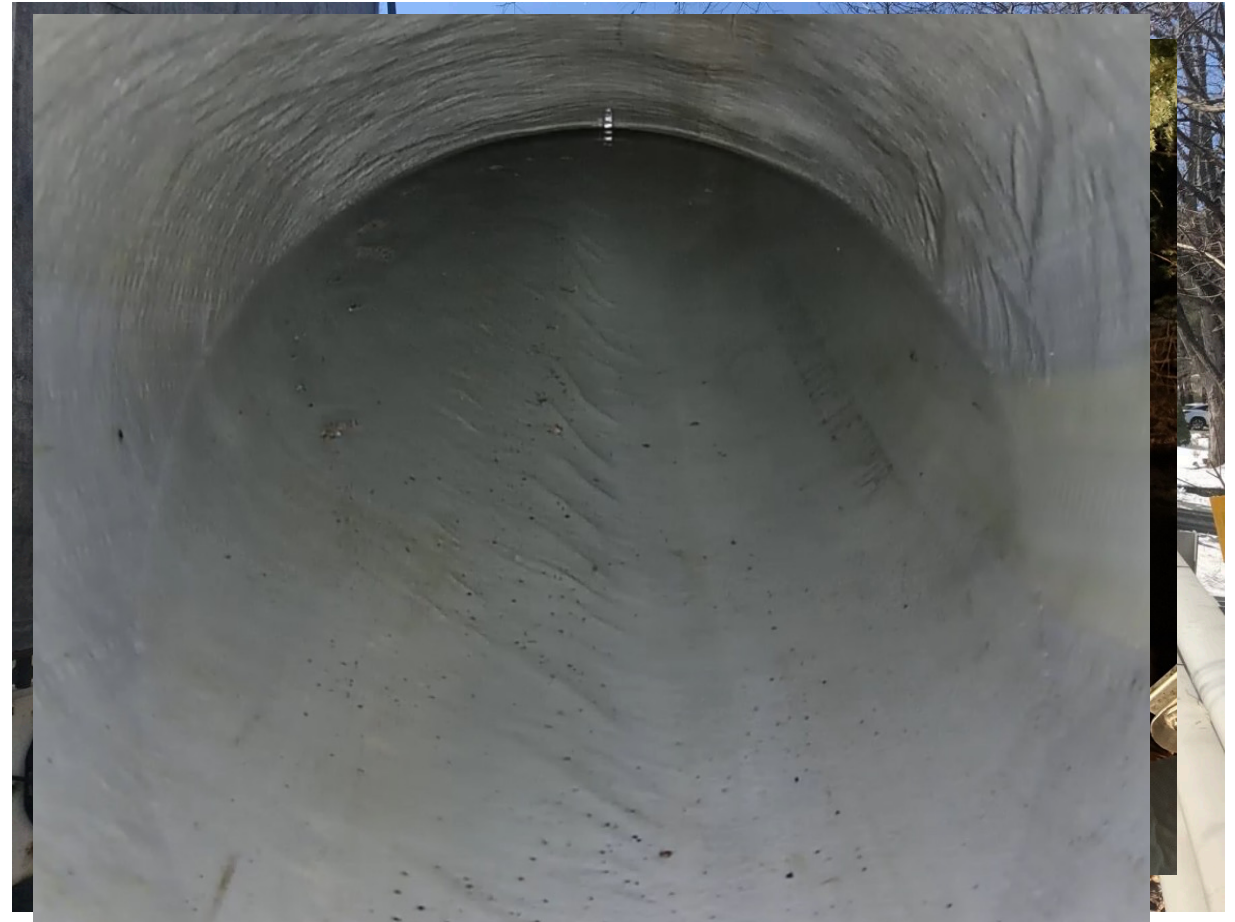
- After cleaning and dewatering, heat tracing wires were fed through the invert of the siphon
 - Used to track temperature of water throughout cure to ensure proper curing of liner
 - Continuous-length heat trace provides more reassurance in cure
- Liner inverted using water from nearby hydrants or jet trucks
- Once liner was inverted, water was circulated through the liner and a boiler to maintain specified temperatures for the duration of the cure
- Water was allowed to cool down prior to release downstream to the treatment plant

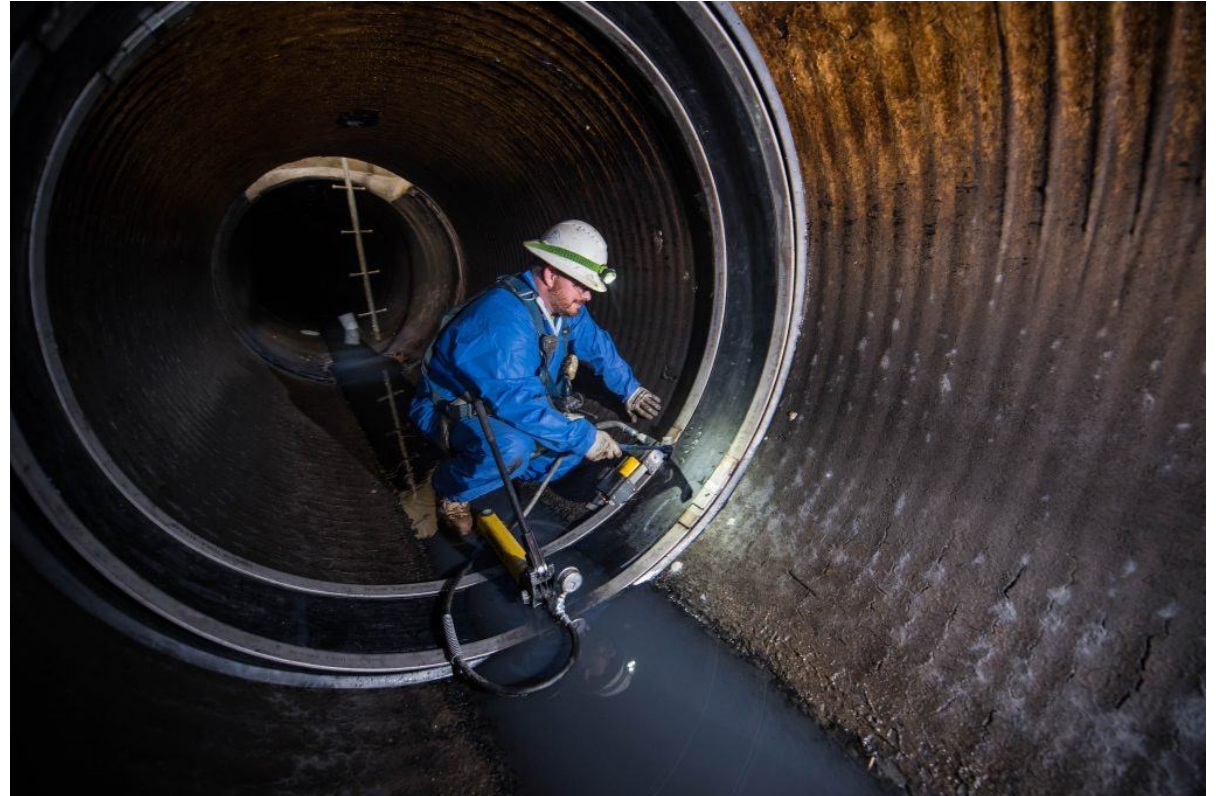
- 36” RCP at Siphon #2 initially recommended for short liner installation for cracking near elbow
 - Because of bend in pipe, equipment could not navigate and install a short liner at this location
- After considering various products and solutions, project team selected to install a Weko Seal
 - This is a rubber gasket secured in place via steel rings
 - Installed via manned entry

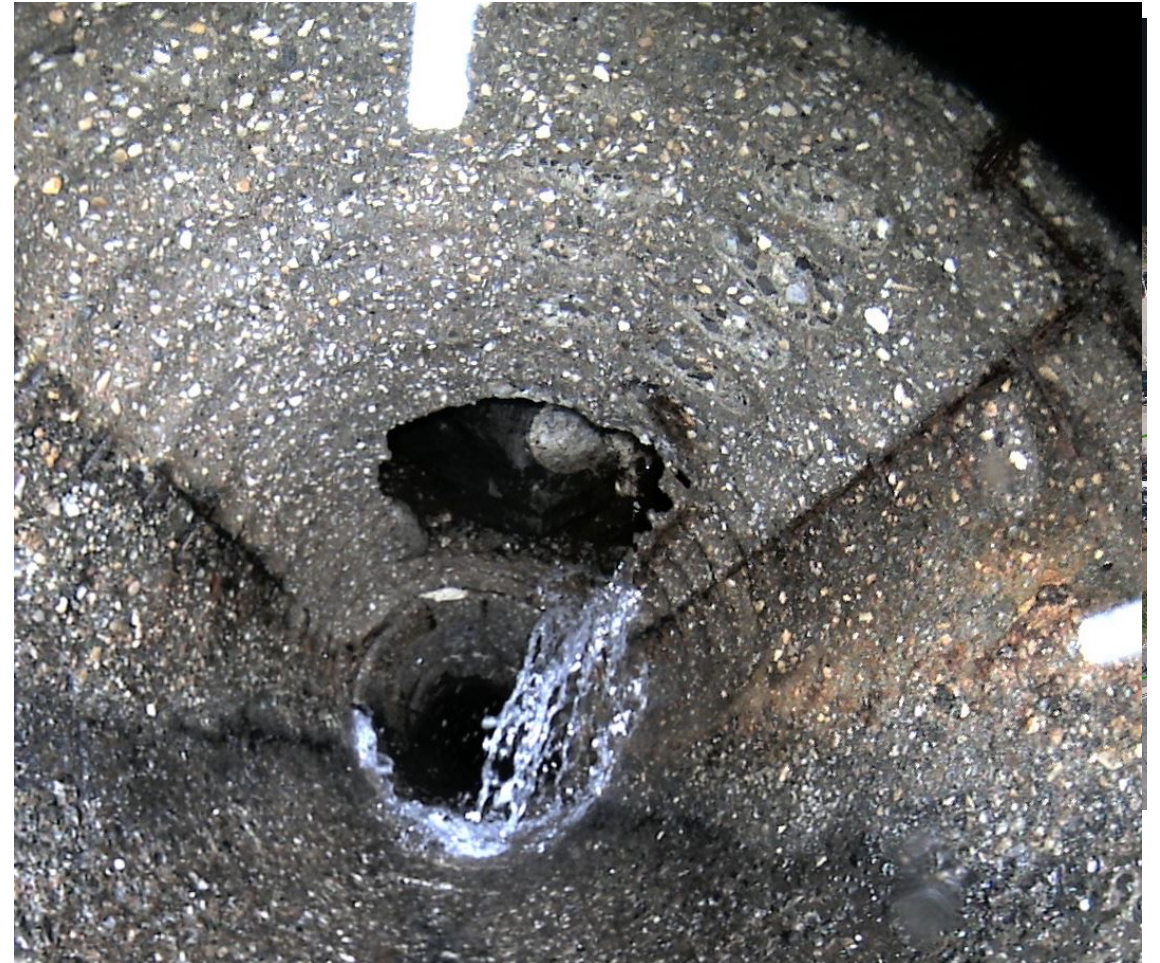
- During inspection Siphon #3 was found to have a large hole in the 21" barrel allowing constant infiltration
- Hole was determined to be near the river's waterline, contributing to inflow
- Design team initially proposed installation of a pre-liner, followed by a full-length CIP liner
 - After installation of the CIP liner, the crew was to drill a hole and grout the void that had been lined over
- Field conditions did not allow this
 - Higher water level → more infiltration → could not install liners or grout

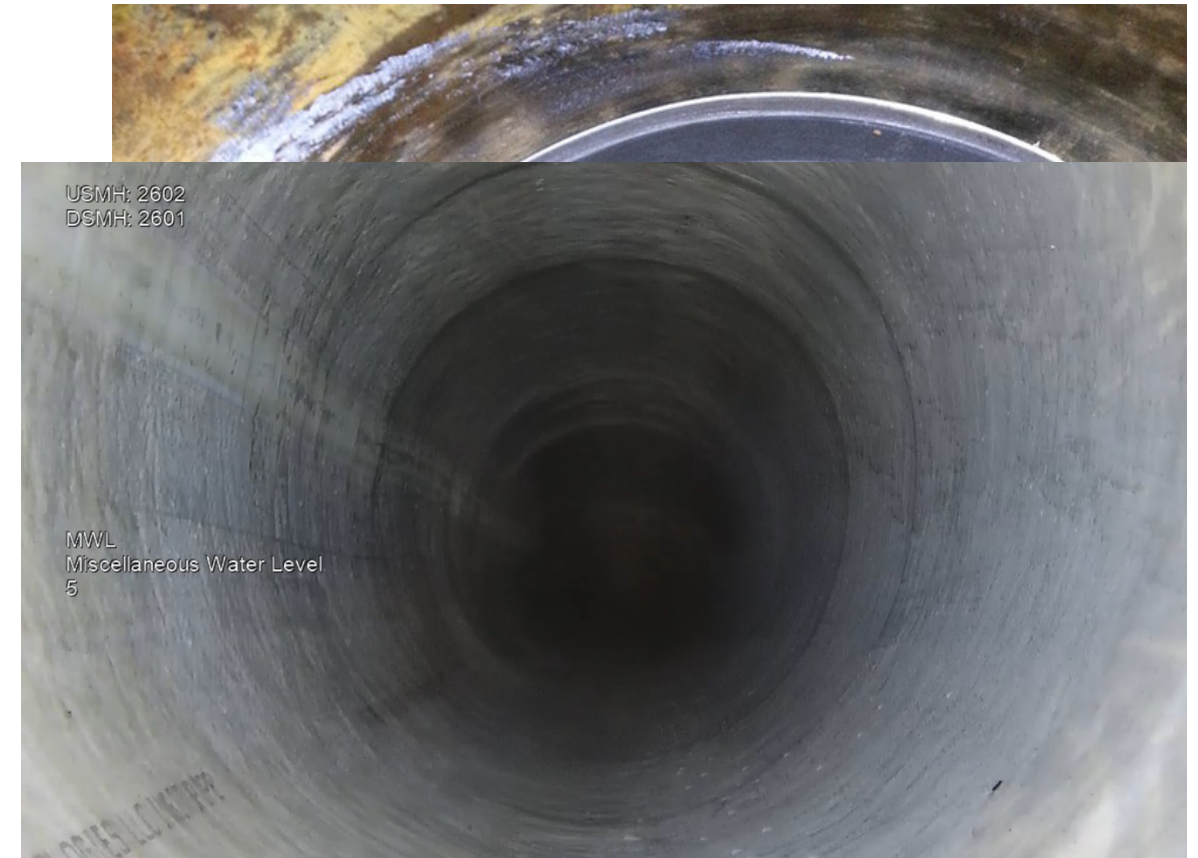
- Solution – install CUES LOCK sleeves to occlude the hole in the crown, install CIP Liner, grout the void via injection through upstream siphon structure wall
 - CUES LOCK are steel sleeves that expand to a set diameter and lock into place, providing a structural repair
- Specialty equipment was flown in from CUES and a representative was on site for installation
- Four, 2-foot sleeves were installed to repair the defect
- Grout was installed via drills holes in the upstream structure's wall to seal the void externally
