Big Sewer Break = Big Problem

Fred McNeill, P.E., City of Manchester

Ben Horner, Hazen and Sawyer

CMOM PHASE II
SEWER REHABILITATION AND REPLACEMENT PROJECT
CONTRACT NO. 2

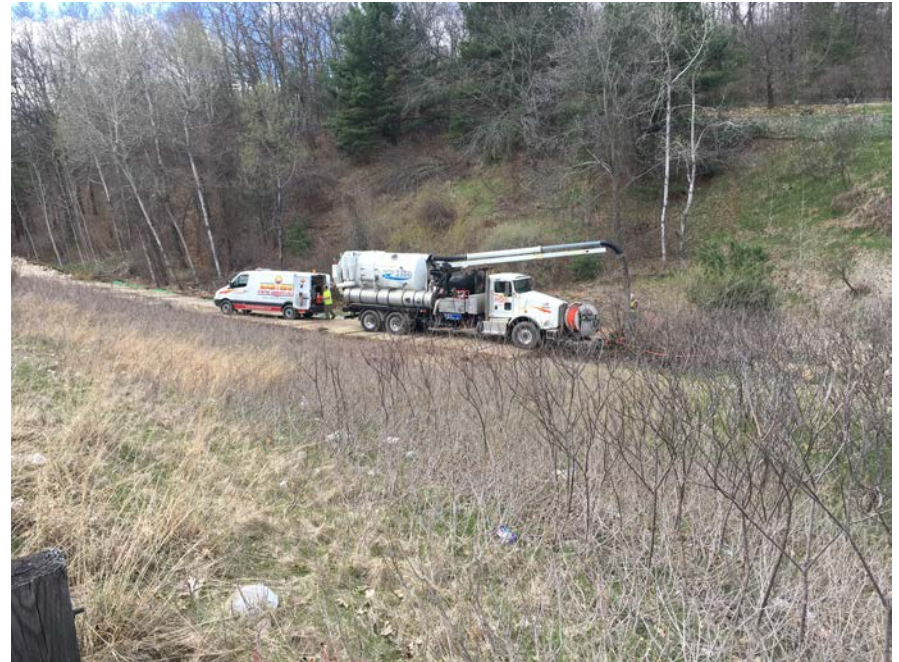
- Exploratory Excavations
 - Excavations at Each End.
 - Found Existing 16" HPDE Collapsed Within the 24" Casing.
- Parallel Tract
 - Review of Adjacent Sewers
 - Save Existing Infrastructure
 - Prepare For Design / Construction of New Infrastructure

Collapsed Sewer – 16” HDPE in 24” RCP Sleeve

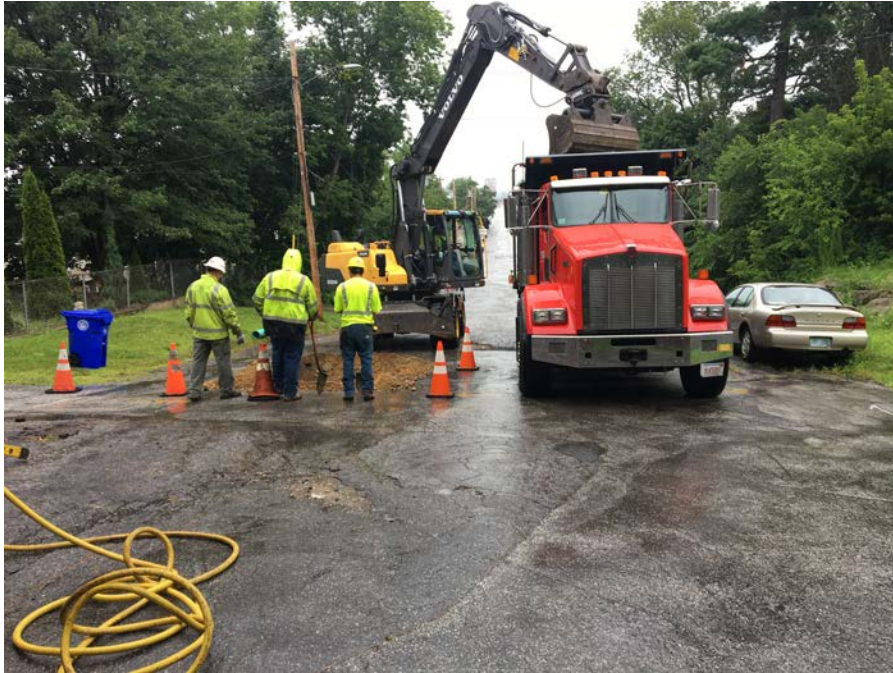
Open Cut

Estimated Cost – \$1.3 Million

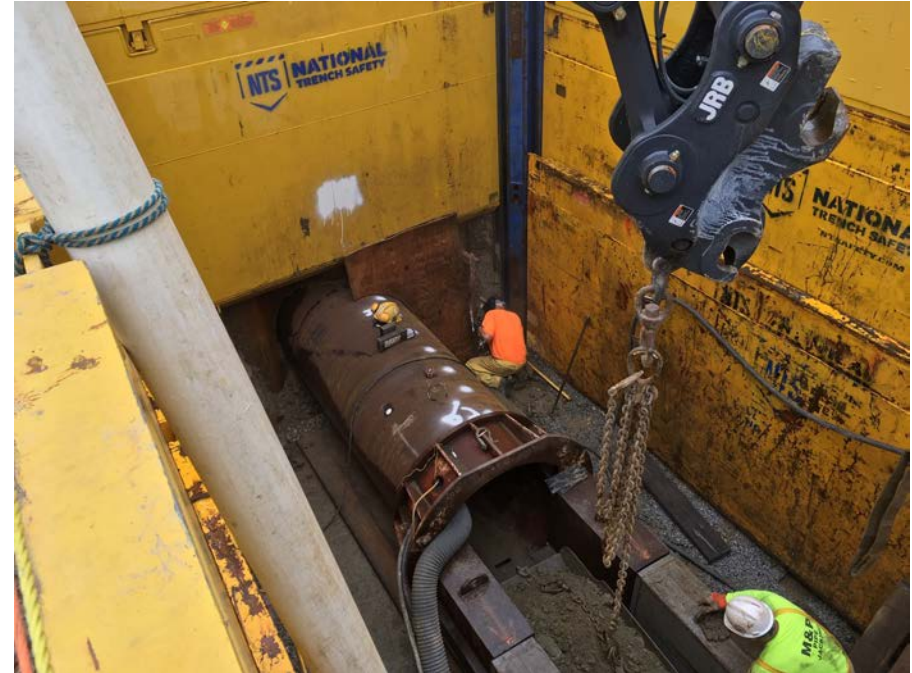
Pipe Jacking with Shield

Estimated Cost - \$1.5 Million

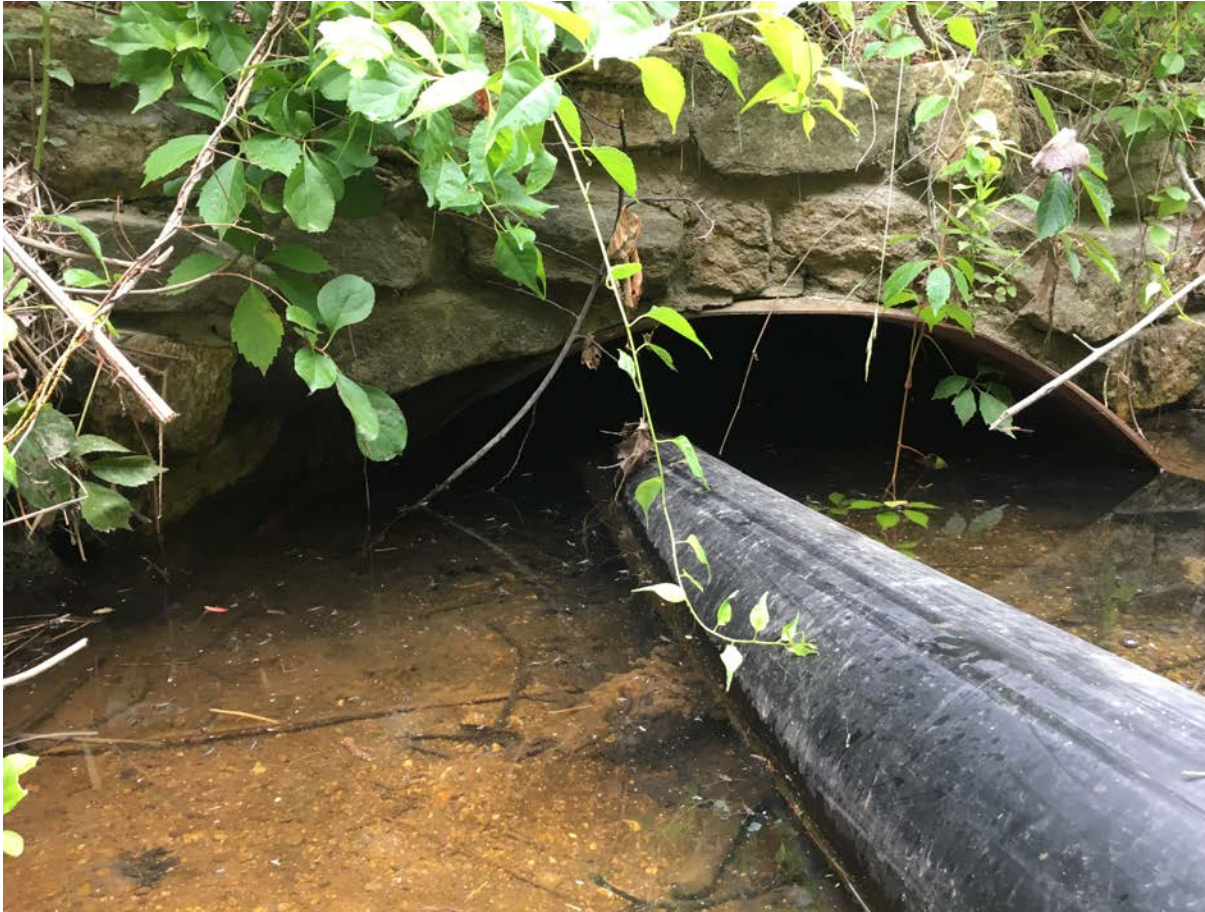
- Downstream end of the 220 LF 60" CMP Humphrey Brook Culvert
- Used for 8" HDPE Bypass
- Filled with Sediment
- Required Cleaning and Inspection

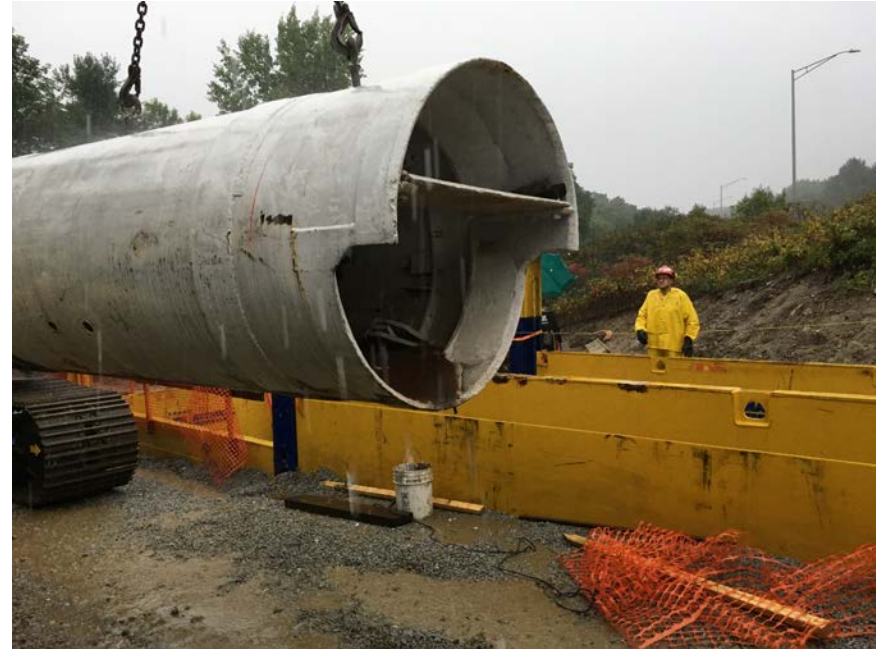
Jacking Pit

- Manned Entry
- Hand Excavation
- Internal Rail System for Spoils Removal
- Averaged Approx. 8 LF per day

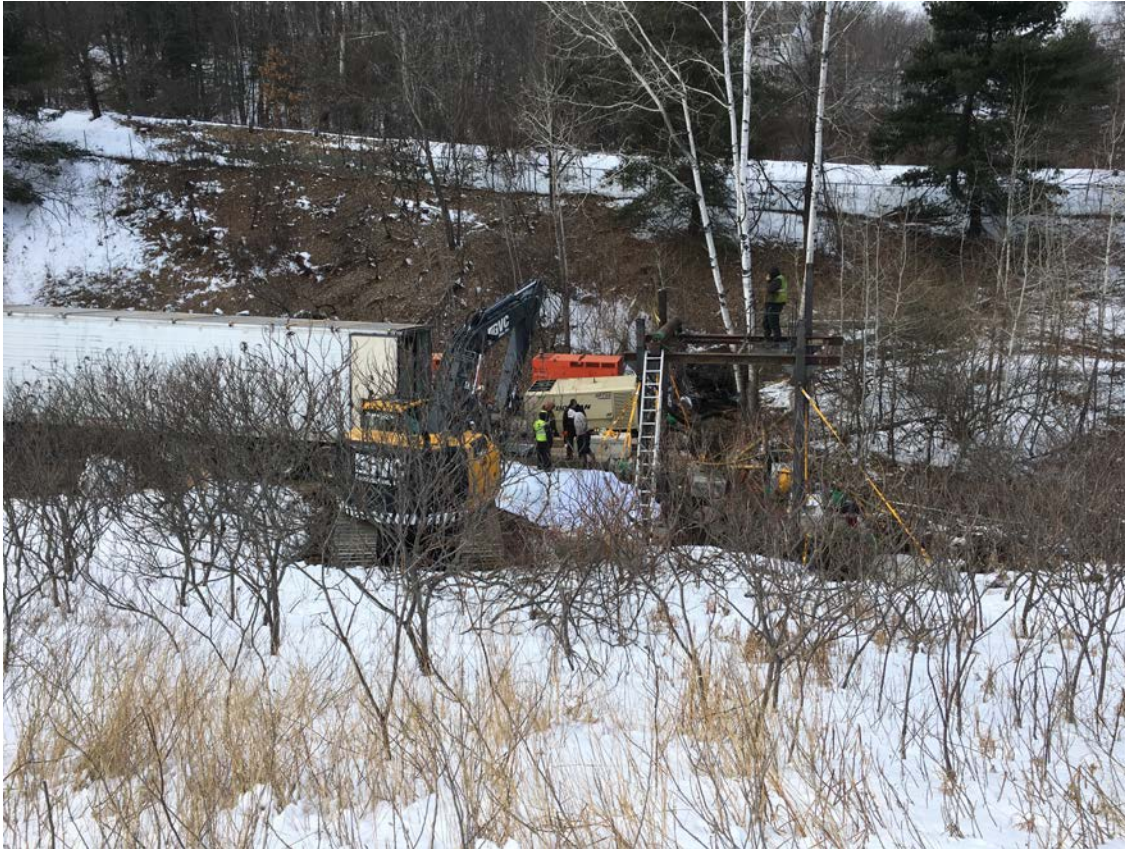
- 2 Week of Cleaning and Sediment Removal Under NHDES Permit
- Lining Completed in Winter to Take Advantage of Low Flows.
- Staging for the Rehabilitation of the 60” CMP Humphrey Brook Culvert.

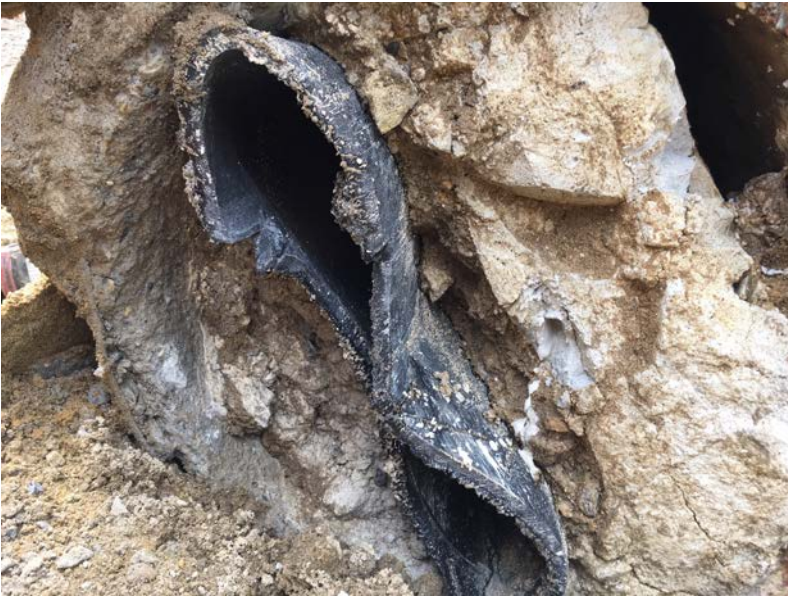
- Improper Grouting Methods
- No Post Installation CCTV

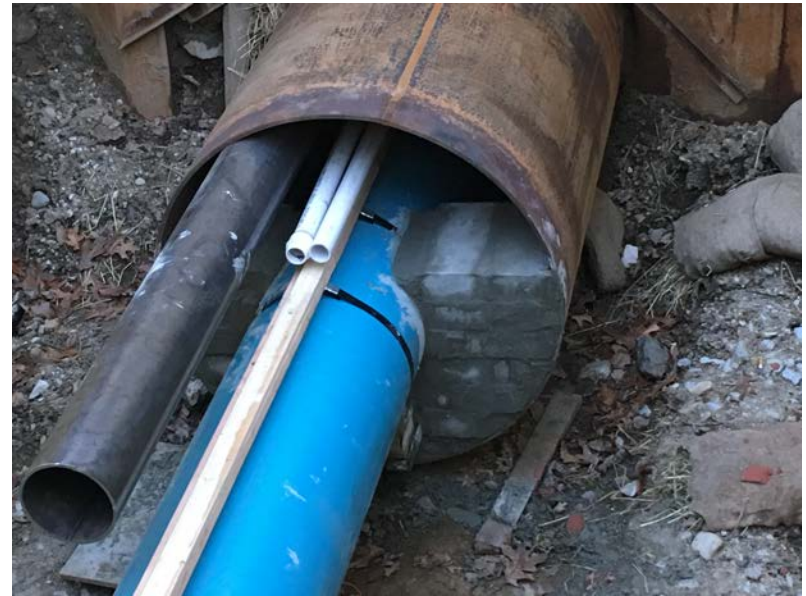
- Proper Grouting Methods
- Post CCTV
