The Whole Story in Woods Hole

Or How Sometimes You Need to Dig a Little Deeper Than a Traditional I/I Project to Really Fix a Collection System

NEWEA Wastewater Collection Systems
Specialty Conference & Workshop Series
September 9, 2014

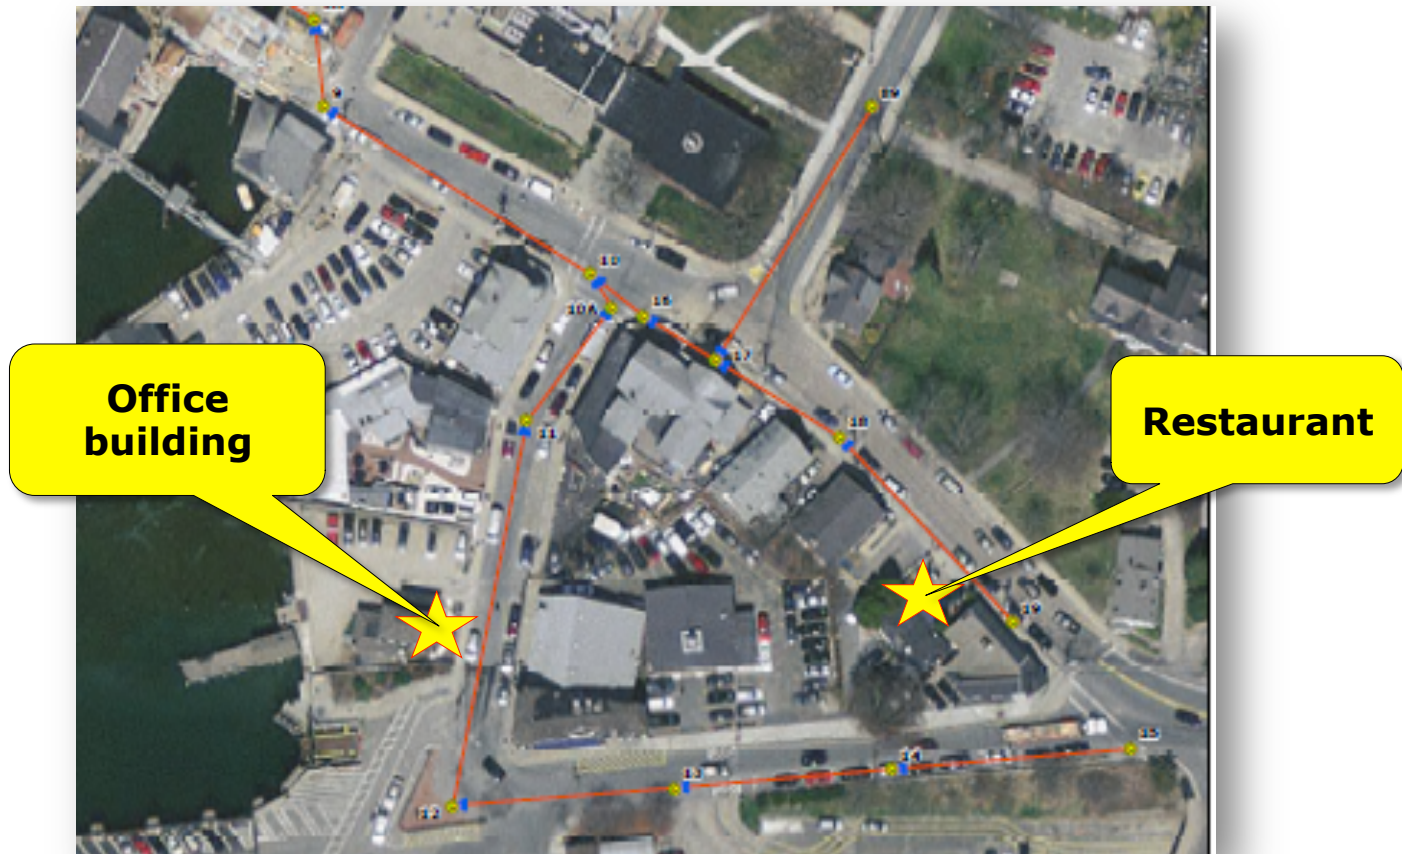
Capacity Concerns

- **Sewer rehab' will meet the needs of the Modified Groundwater Discharge Permit**
- **BUT it does not address**
 - Sags
 - Grease
 - Surcharging

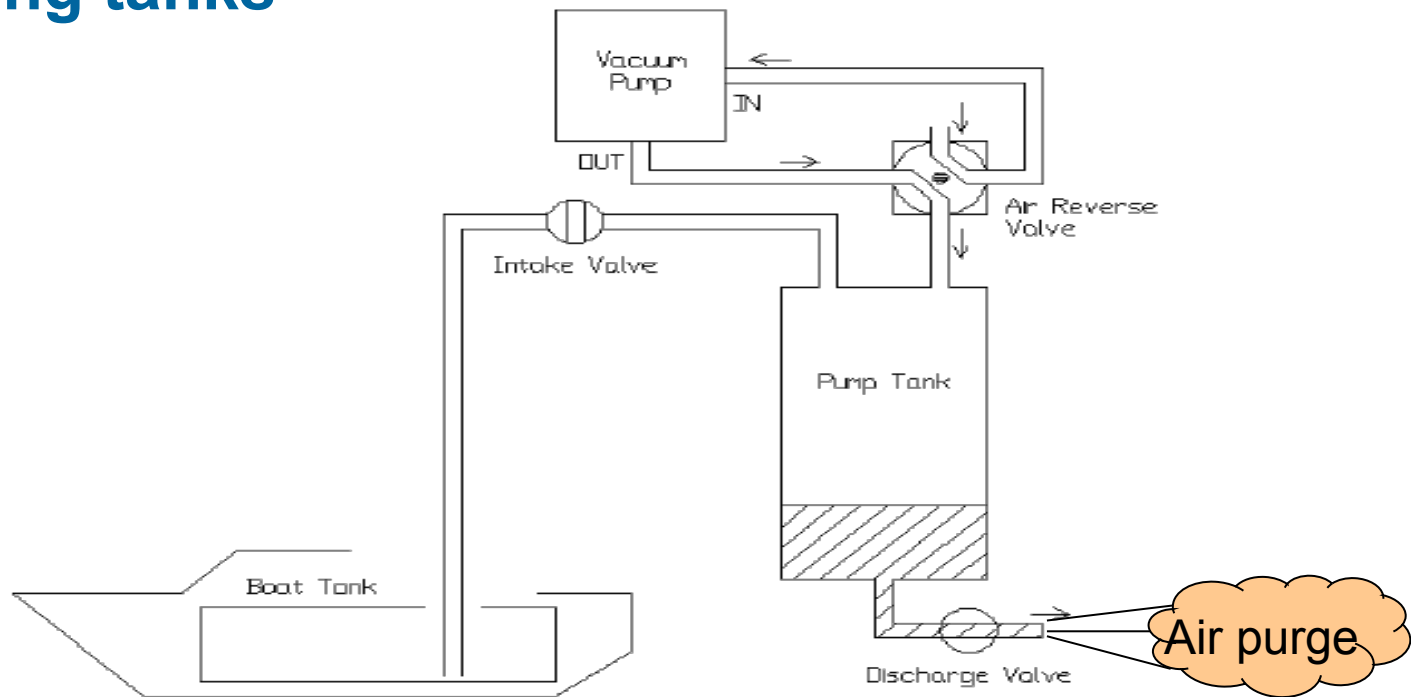
Discharge Phase

- **SSA uses pneumatic system to evacuate ferry holding tanks**
- **Flow is based upon air pressure/ vacuum but it's not linear**
- **Air purge was added feature due to concern of freezing**
 - Air was originally discharged to the sewer, caused splashing
 - Air purge re-directed to carbon canister

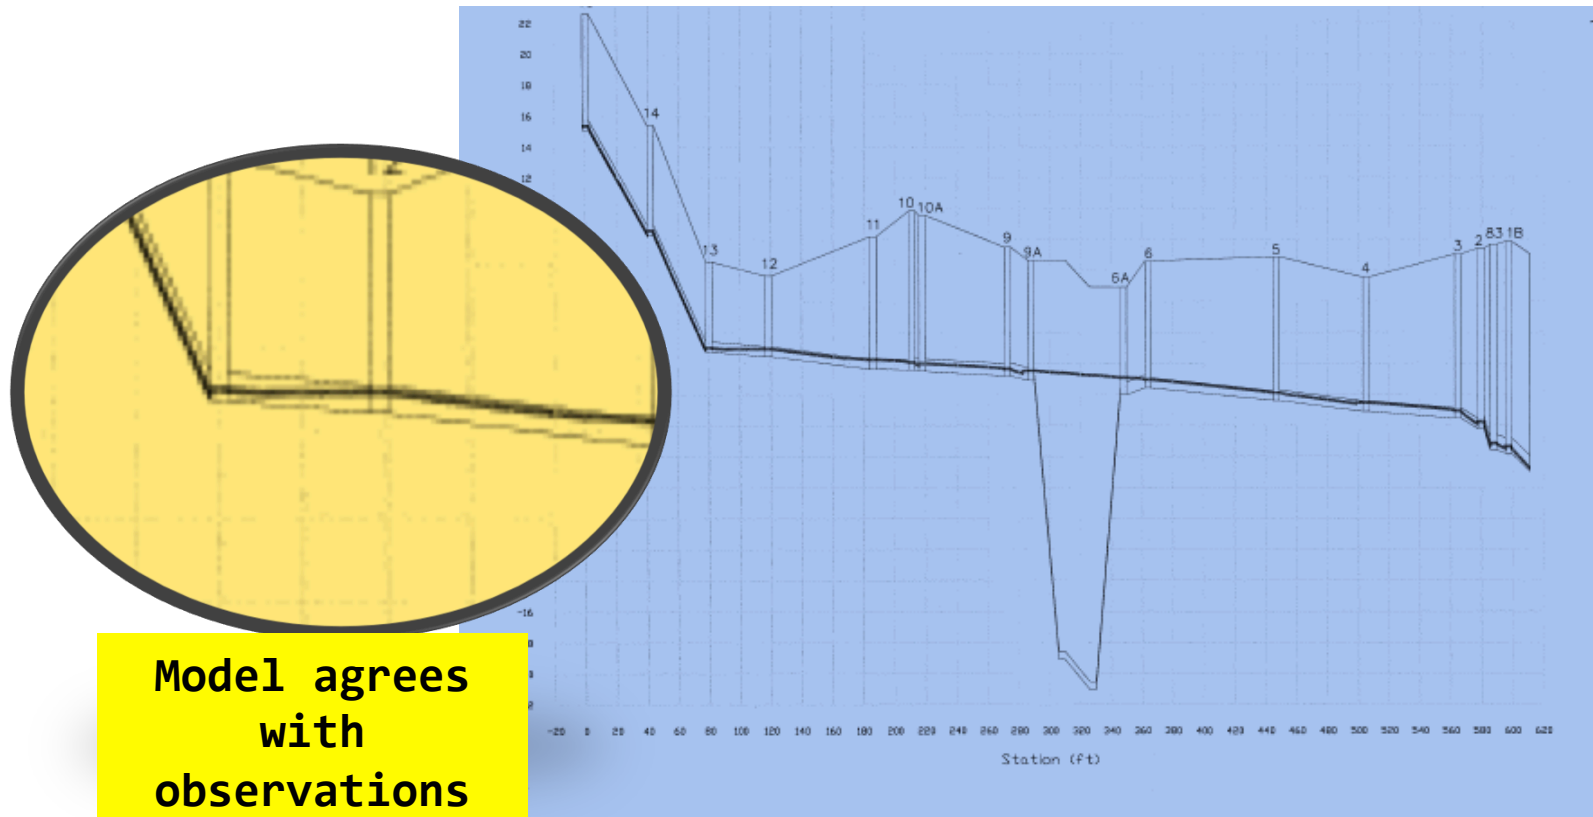
■ Hydraulic model results

■ Siphon is limiting factor

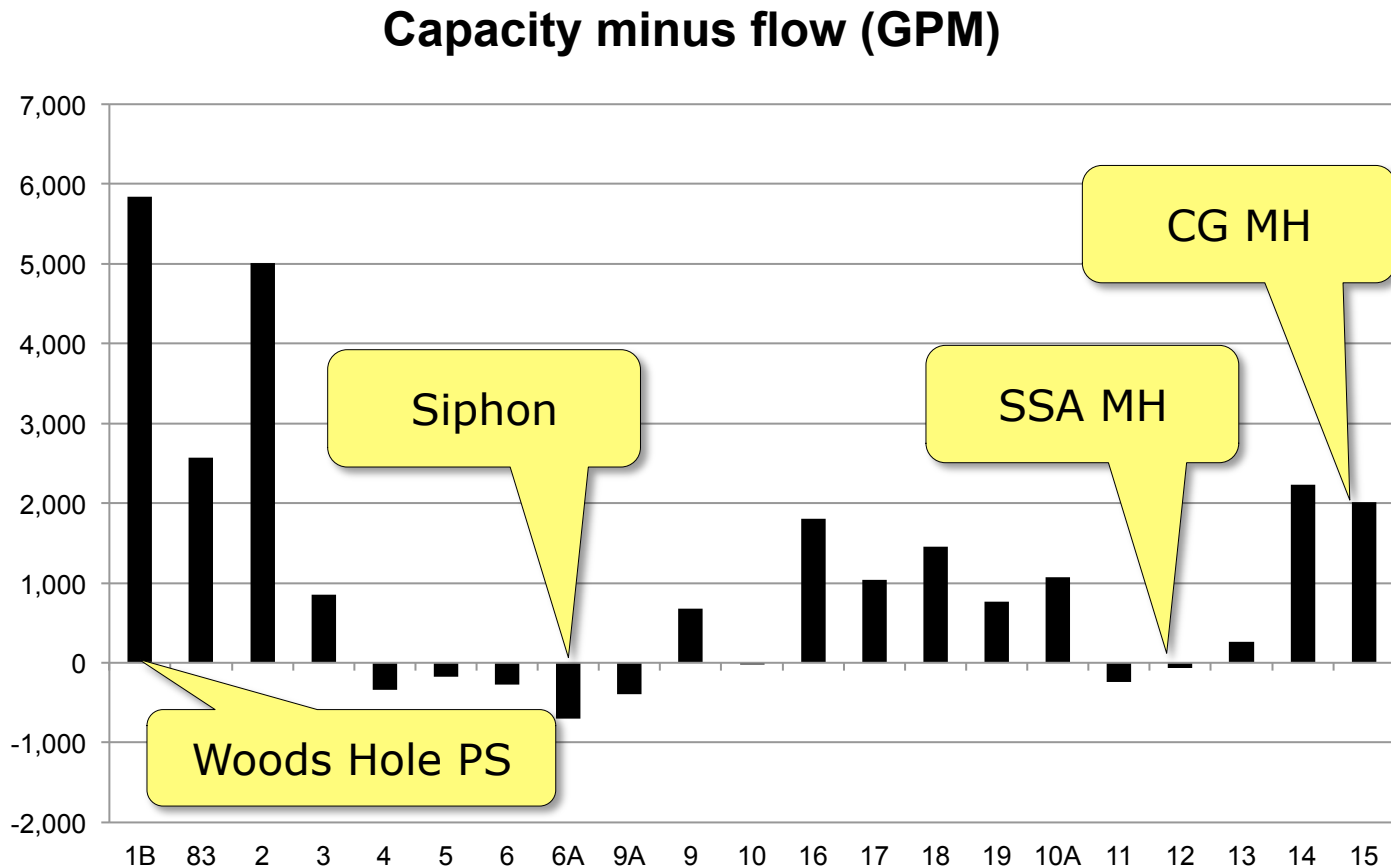
What can the system accommodate?

- Need to reduce SSA discharge
