# Model Forensics: Validating the Performance of a Hydraulic Model against a Design Storm that Actually Occurred

David Bedoya, MWH

# Background: Cambridge's Area 13

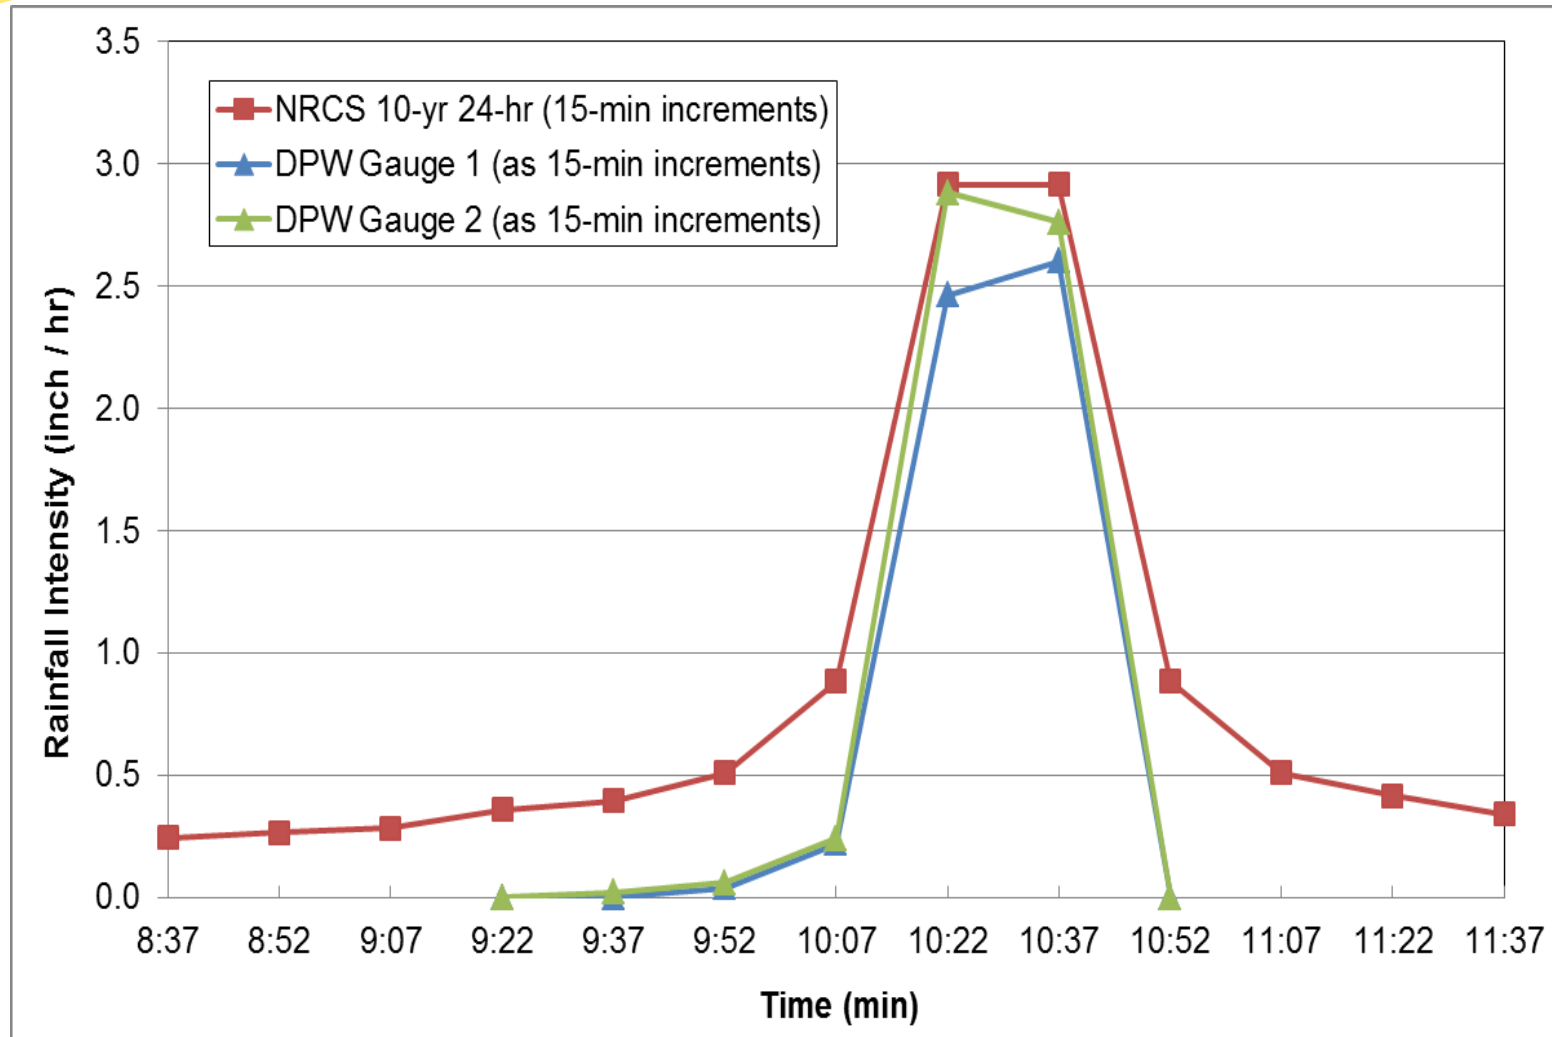
# Analysis of the Storm's Rainfall Distribution

STORM DURATION					
		1h	2h	3h	6h	12h	24h
	Jul 28th Max. Rainfall Accumulation (in)-CWD Gauge 2.	1.49	1.49	1.49	1.49	1.49	1.49
RETURN PERIOD	1yr	0.75	1.04	1.27	1.61	2.05	2.62
	2yr	0.94	1.26	1.59	2	2.51	3.15
	5yr	1.18	1.58	2.02	2.54	3.18	3.98
	10yr	1.4	1.87	2.42	3.05	3.81	4.75
	25yr	1.74	2.35	3.06	3.86	4.84	6
	50yr	2.07	2.79	3.68	4.65	5.8	7.17
	100yr	2.46	3.31	4.4	5.57	6.94	8.57
	200yr	2.92	3.93	5.28	6.68	8.33	10.25
	500yr	3.68	4.93	6.71	8.5	10.58	13

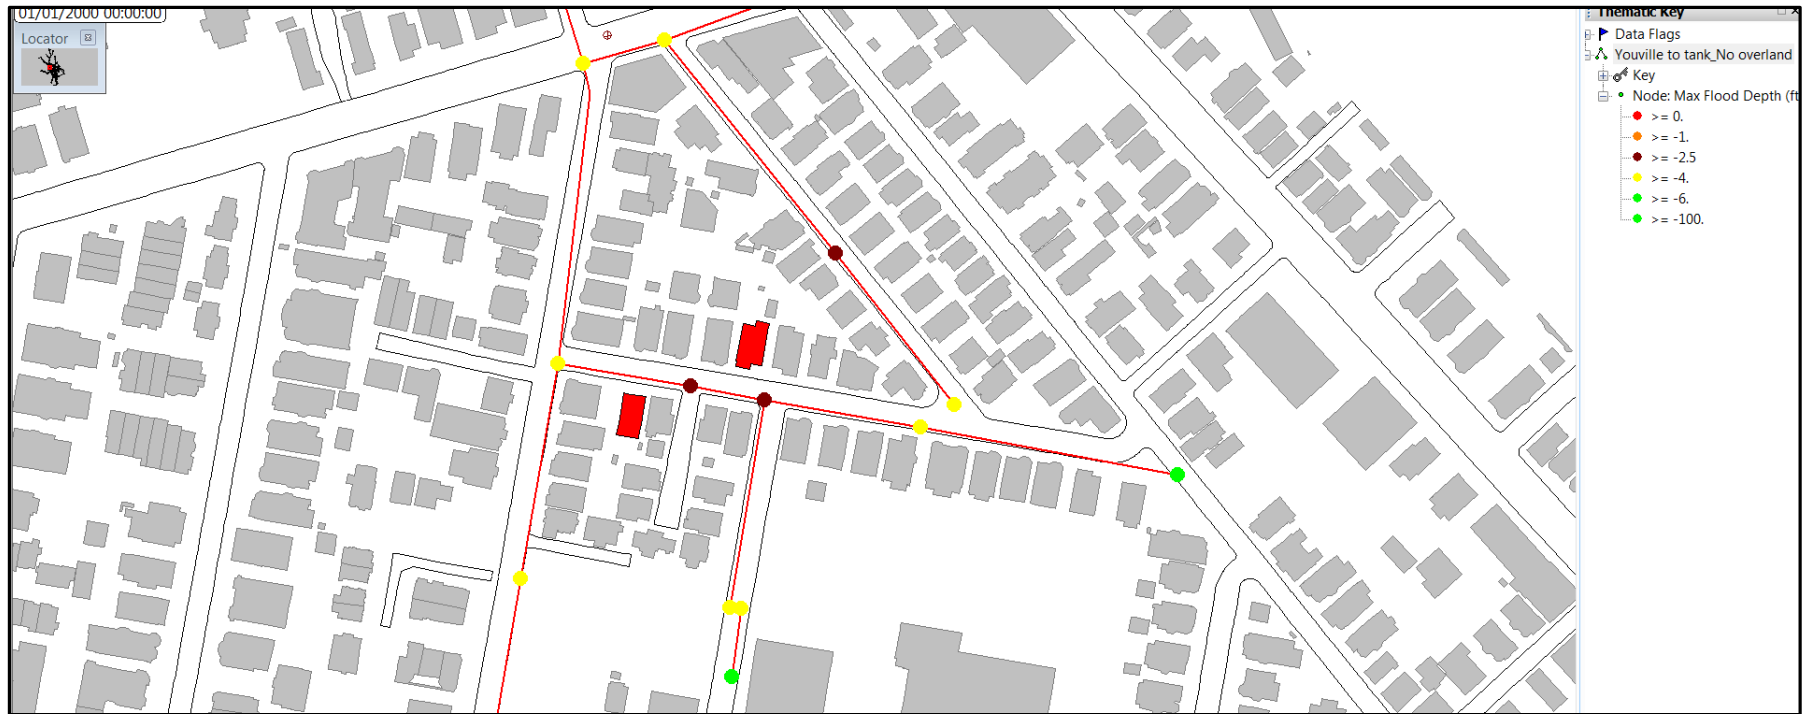
# Sanitary System Modeling

Sanitary sewer backups were reported at #9 and #20-22 Magnolia Avenue
