Recovering from H₂S Attack: Greenwich, CT – Shore Road Area Sewer Rehabilitation Project

January 26, 2016

Shore Road Area Sewer Rehabilitation Project

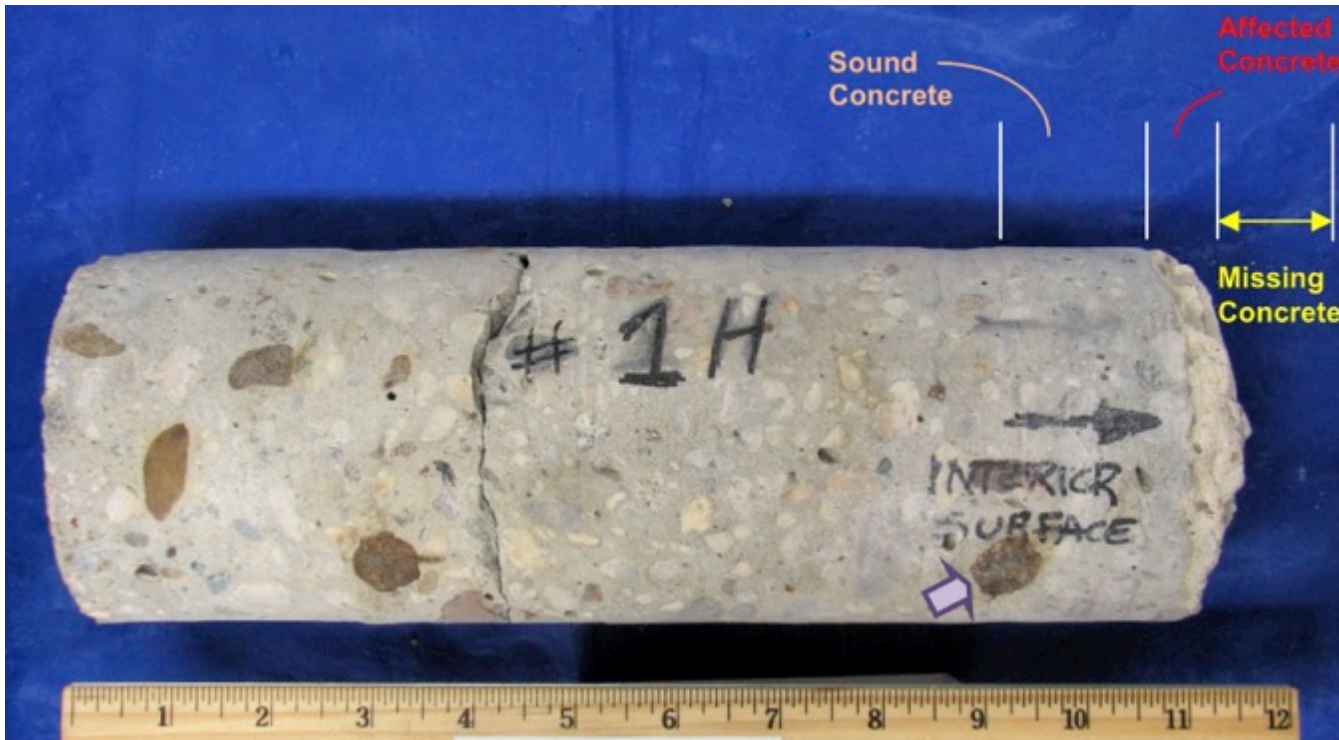
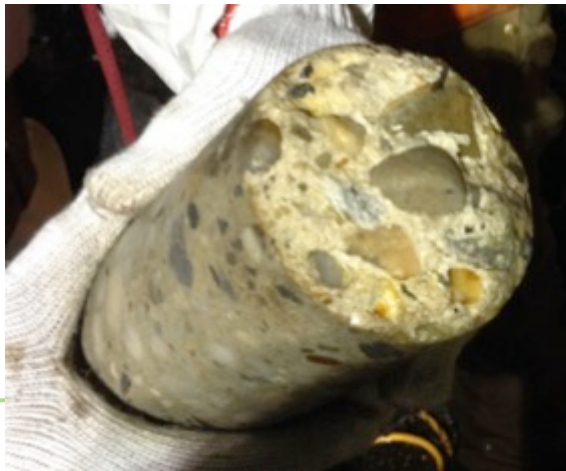
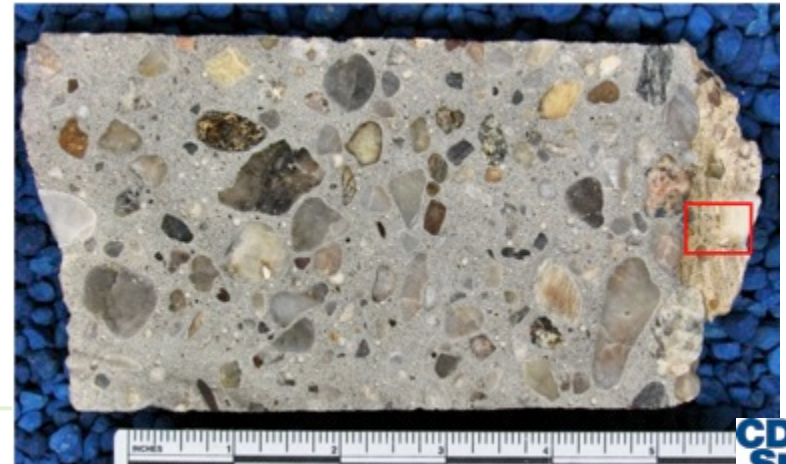
Junction Chamber and Transition Chamber

- Petrographic Analysis
- Sulfate Content & pH:
 - Roof Slab: 0-1", 1-2" & 6"
 - Walls: 0-1" & 1-2"
- Results:
 - Petrographic confirmed chemical attack
 - Reinforcing steel in relatively good condition
 - 0.4 to 0.8 inches of remaining concrete surface integrity compromised
 - High amount of sulfate content in all samples to a maximum depth of 2 inches
 - pH of concrete samples ranged between 8.5 – 11.5
