A Proactive Approach to Assessing and Managing The Wastewater Collection System, and a UV Cured CIPP Rehabilitation

Stamford, CT WPCA

Presented by:
Joe Hausmann, PE – Wright-Pierce

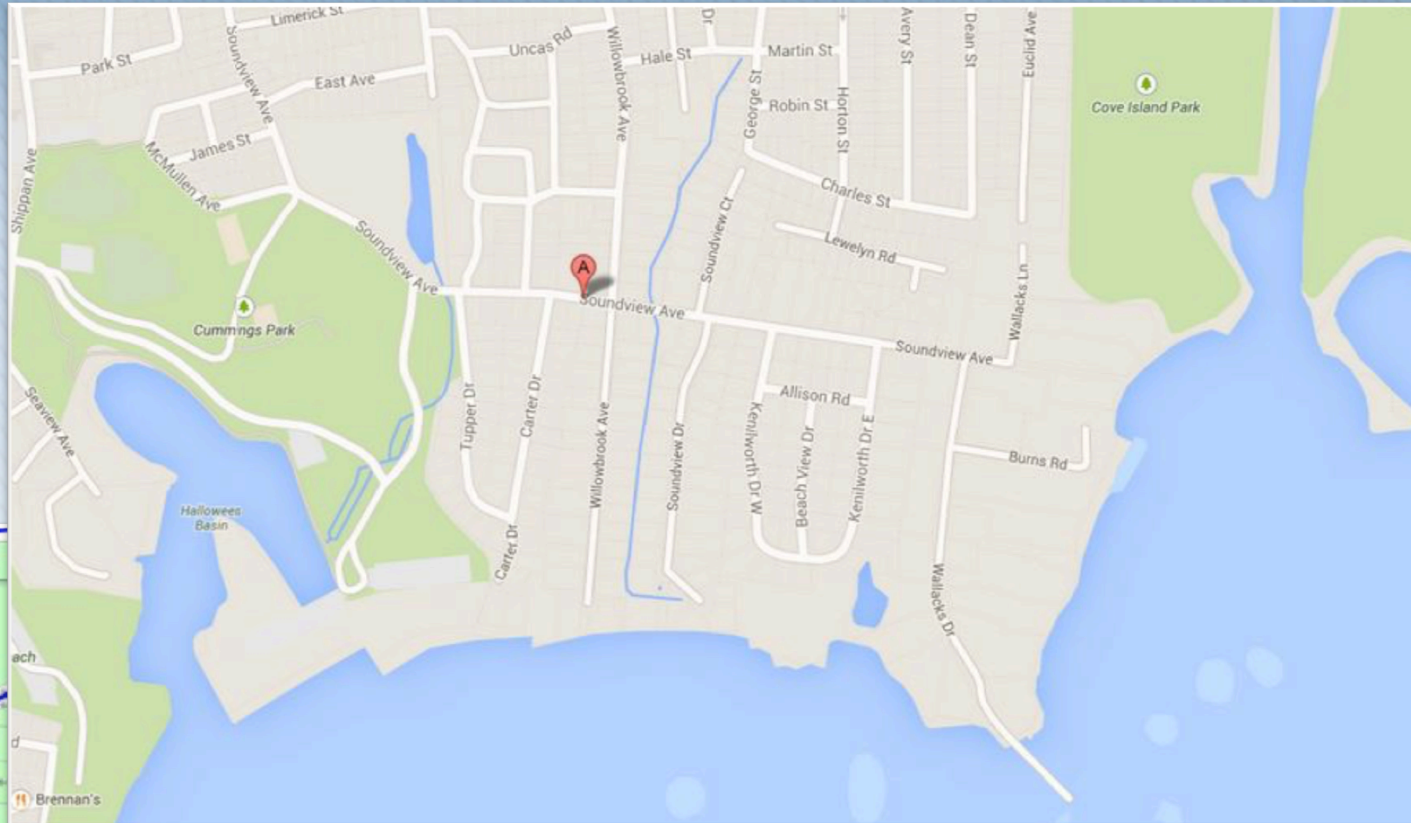
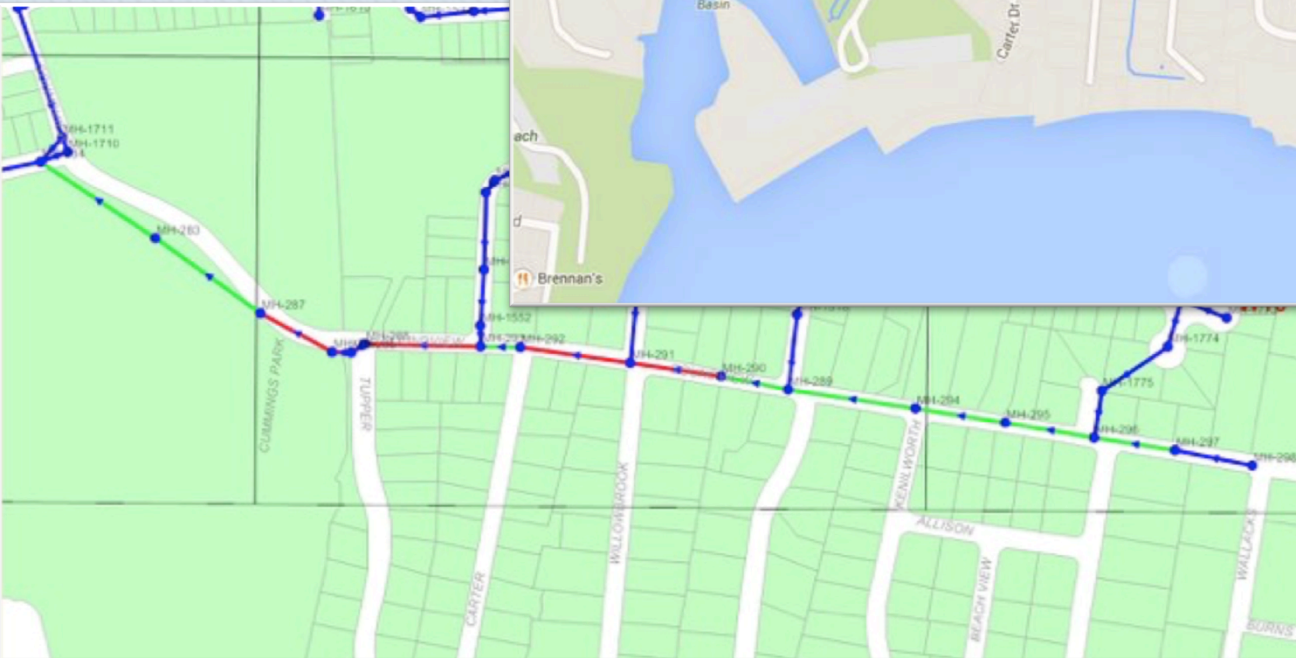
- 36" and 42" RCP Interceptor
- Rebar visible during inspection
- ~3,000LF of sewer in danger of collapse

- WPCA and W-P initiated design immediately
- Lining was preferred method:
 - Too deep for open cut (Road Closures)
 - Laterals reduced sliplining's viability
 - Linestop on upstream forcemains for bypass
- Precision Industrial Maintenance
 - Selected as contractor - very competitive bid
 - UV cured CIPP liner
