# NASHUA REDUCES CSOs WITH GREEN INFRASTRUCTURE AND TRENCHLESS TECHNOLOGY

Nicholas Ellis, P.E.  
Hazen and Sawyer  
Joe Mendola, P.E.  
City of Nashua

June 6, 2017

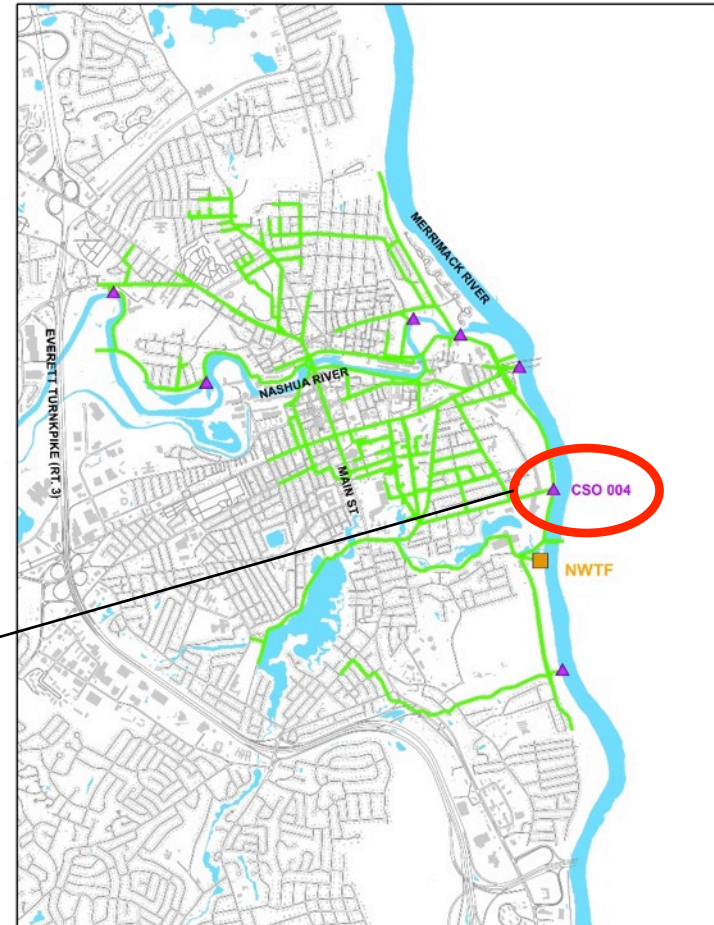
CSO 004

- CSO-004 is located directly downstream of the Burke Street interceptor
- CSO-004 was modified to include a new storage tank to prevent CSO events

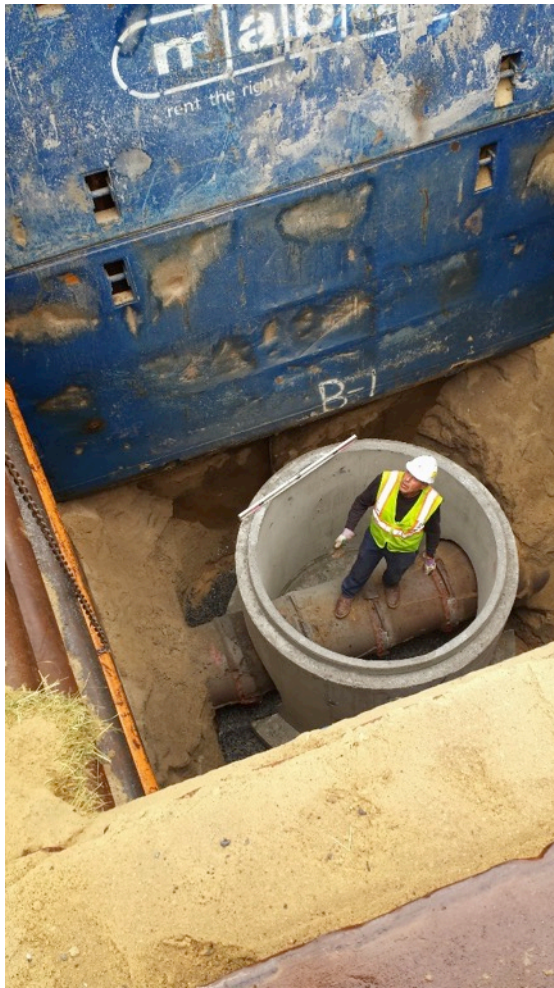
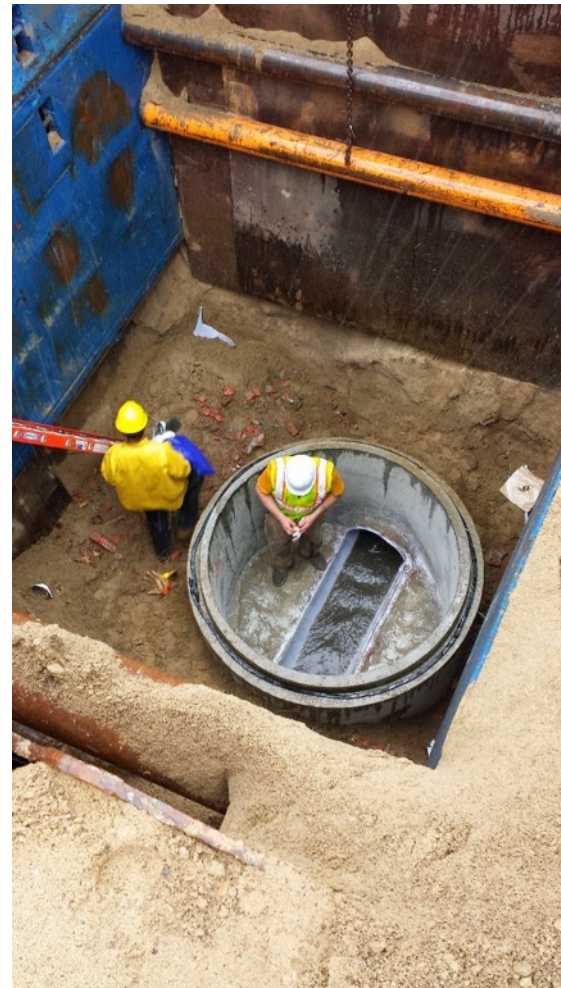
- New doghouse manhole installation
