Marc R. Moccio, PE

# Not Just Another Leak in the Pipe City of Haverhill, Massachusetts

Presented at the 2018  
NEWEA Annual Conference

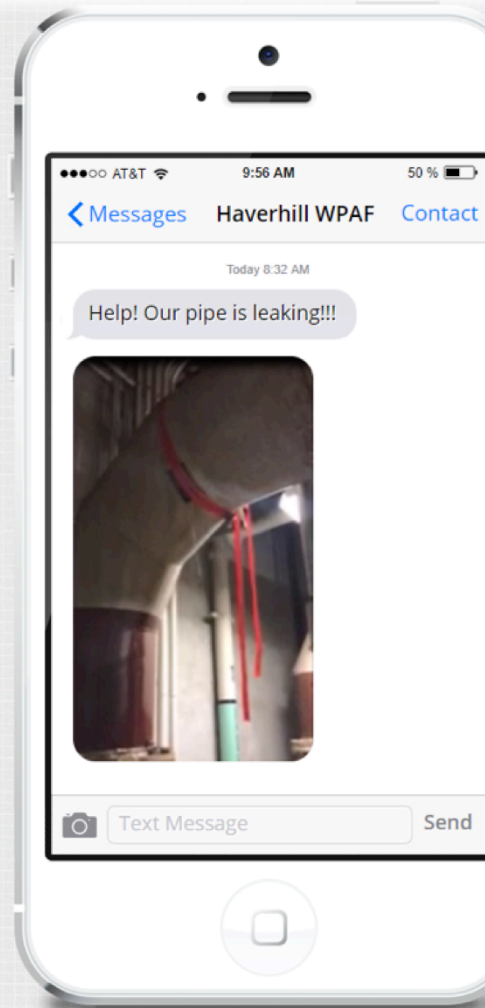
- Leak located on a mitered elbow joint
- No way to isolate
- Fix needed to be done quickly
  - Weld a patch?
  - Epoxy, rubber patch, ratchet strap?
- How extensive was the corrosion?

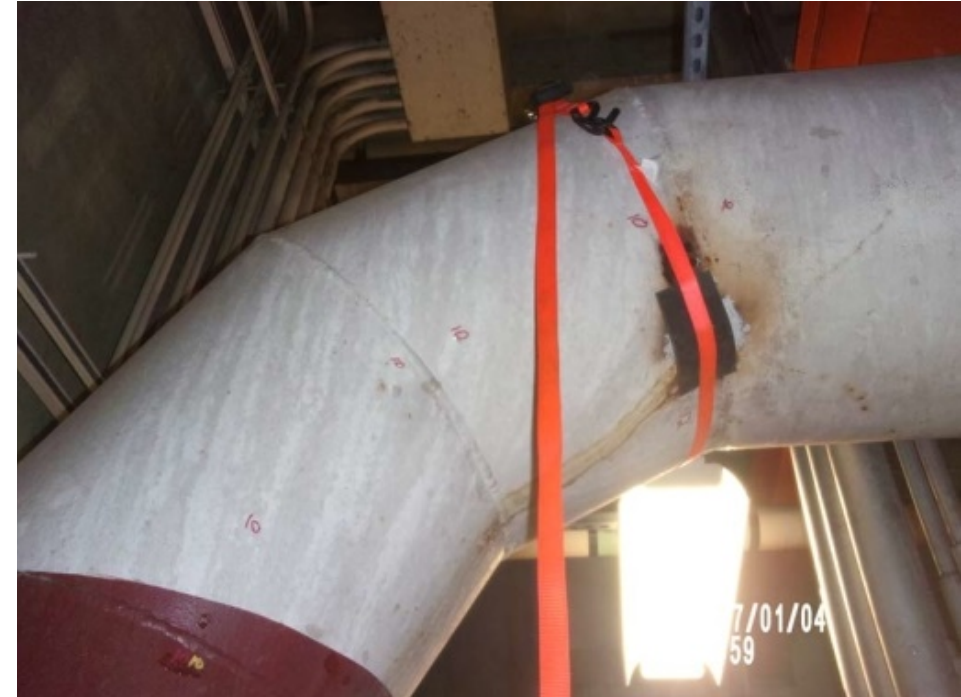
- Determine the extent of corrosion
- Ultrasonic Thickness Testing
  - Non Destructive
  - Steel & Cement Lining Thickness
  - Full Inspection of 24" and 36" force mains
  - Two Technicians/Two Days

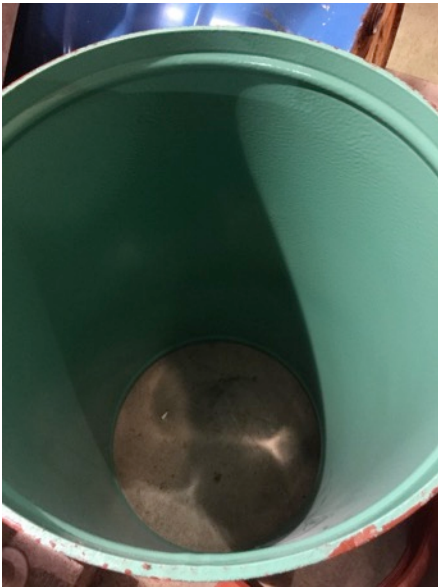
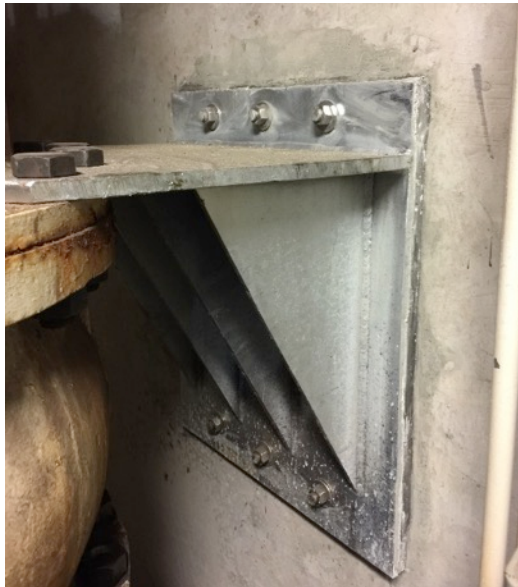
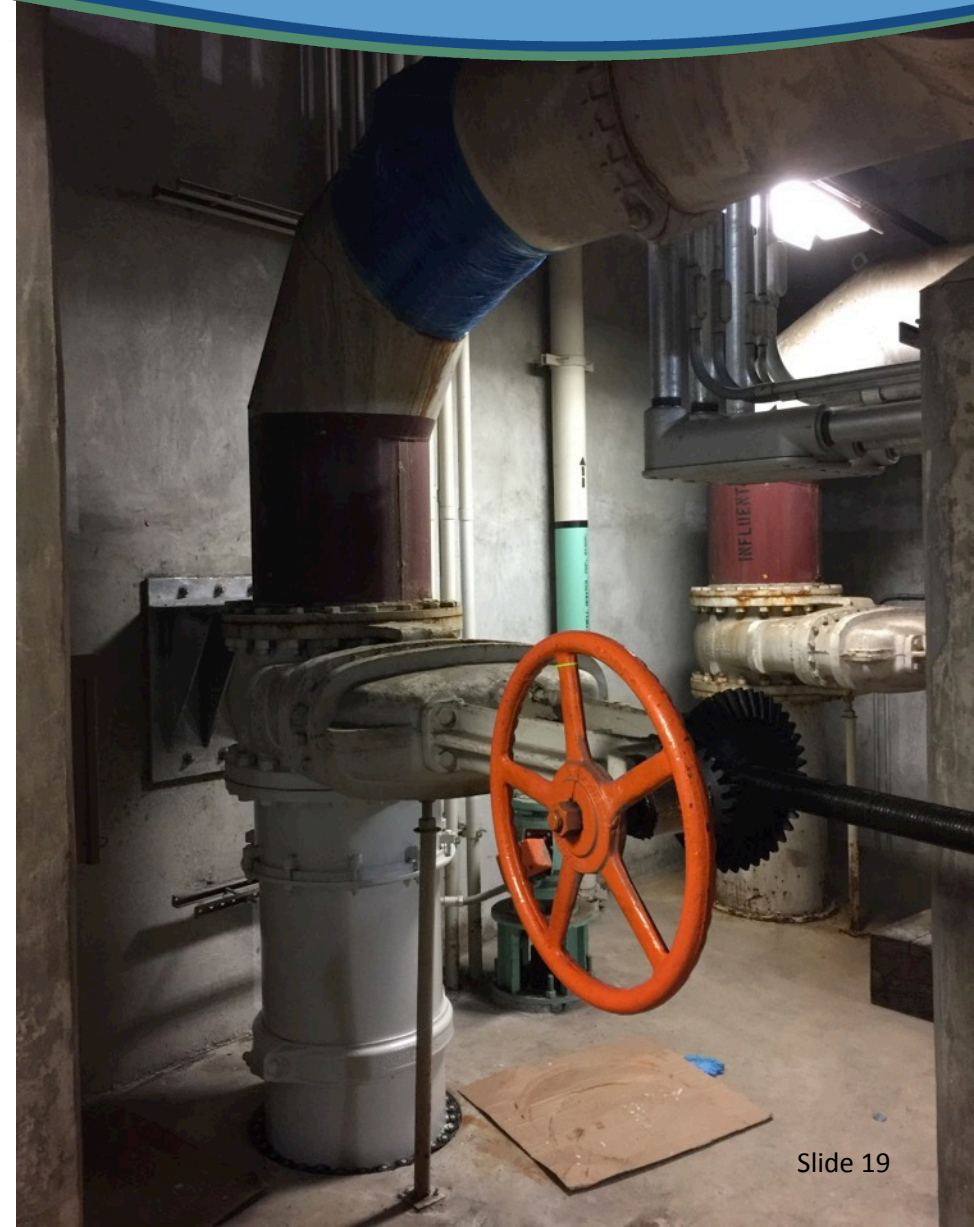
## Existing Pipe

- Discovery: 24" Pipe is actually Schedule 10 NOT Schedule 20
- 0.25" vs. 0.375"
