# Identification and Removal of Tidal Intrusion Sources in Manchester-by-the-Sea's Wastewater Collection System

**2019 NEWEA Annual Conference**  
Allison Shivers, PE

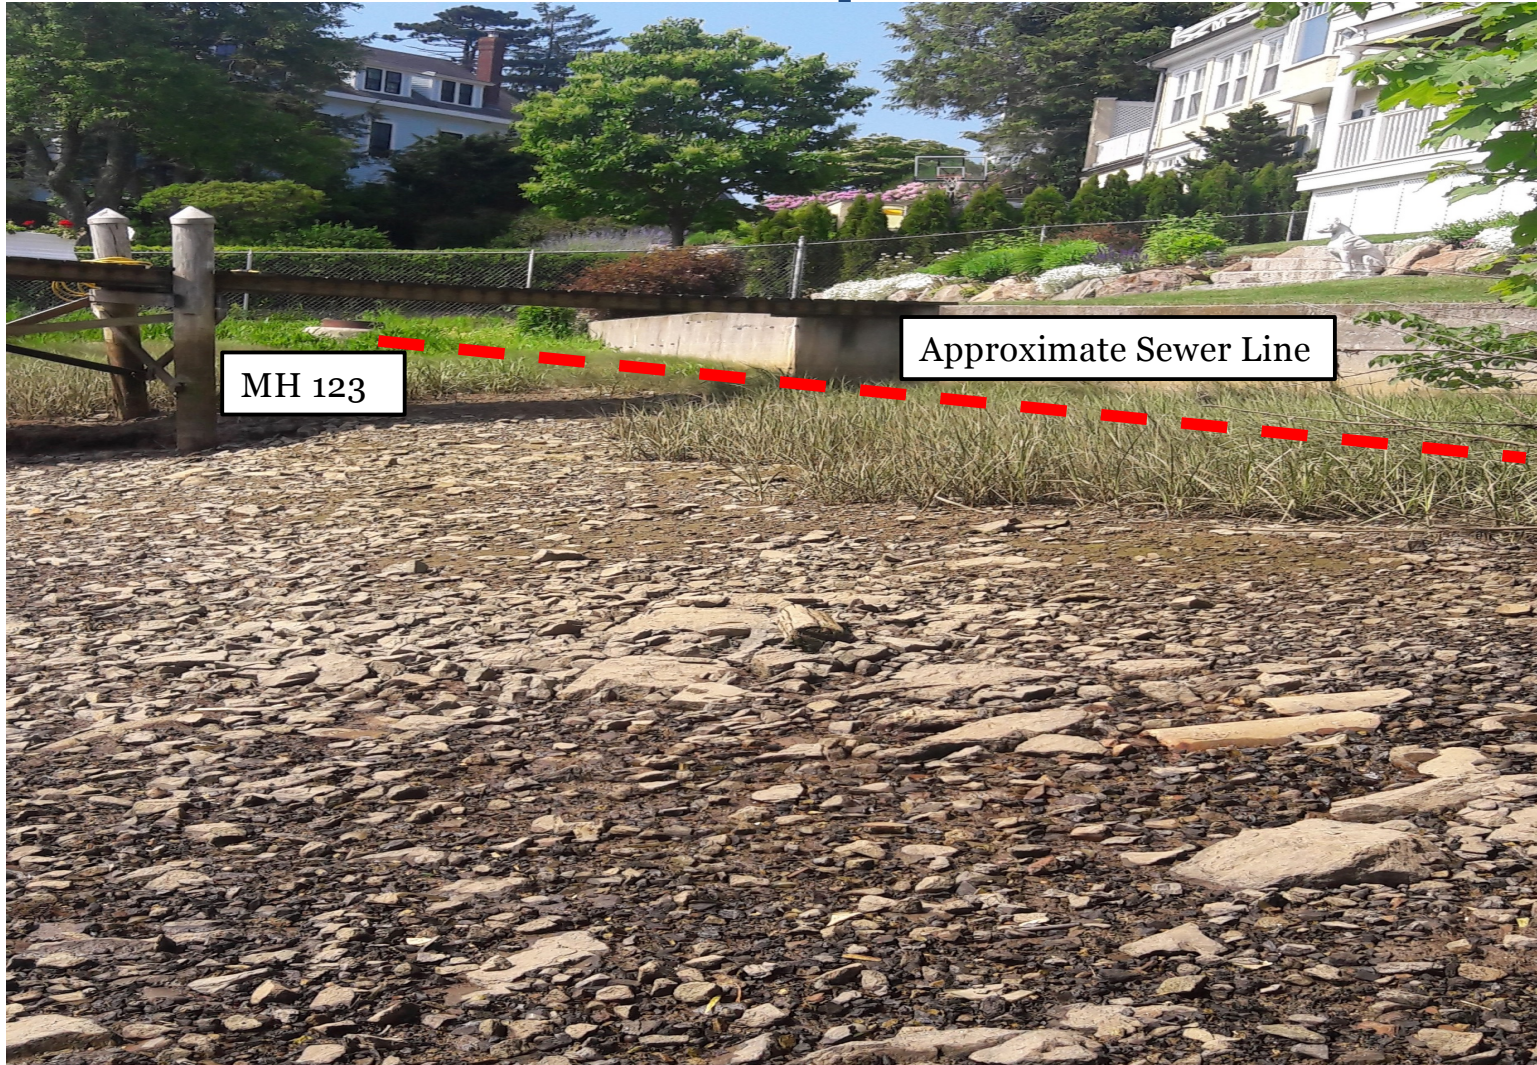
# Harbor Loop Sewer

- Results
  - Depth of flow observed to increase during high tide MH's 119-120
  - No significant change in depth of flow upstream of MH 125.
- Recommended CCTV – Low Tide

- Sewer Lining of entire sewer from MH126A to MH 119
  - Light cleaning
  - Water Inversion with Hot Water Cure
- Full service lateral lining
- Manhole Rehabilitation
  - Watertight frames and covers
  - Raise MH 123 above tide level

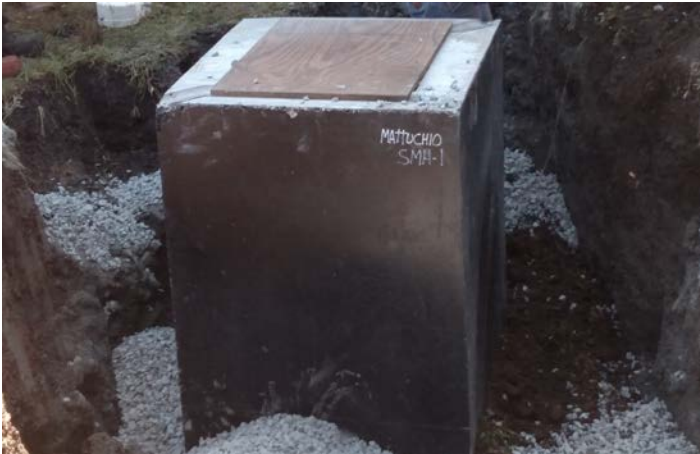
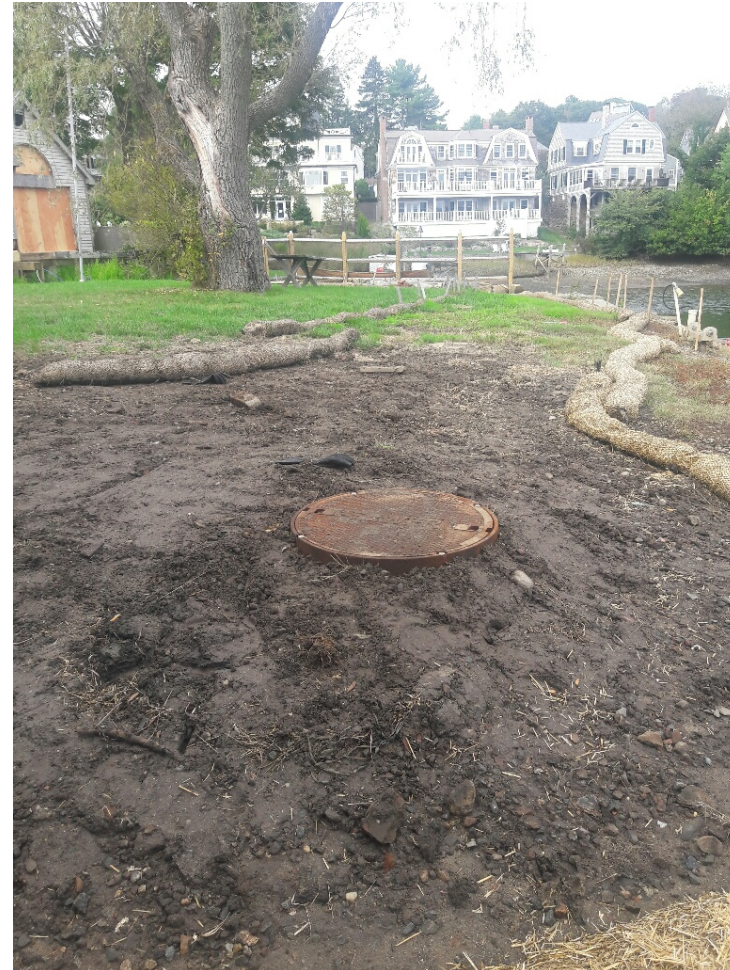
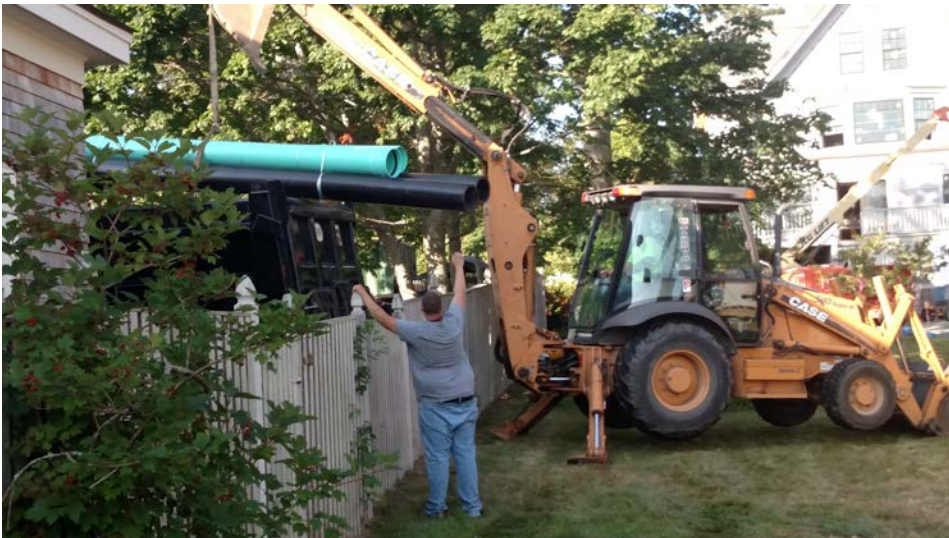
# New Manhole Installation

- CCTV work unable to be completed
  - Heavy build-up in sewer between MH 121 and 122.
  - No access to MH 125 to guide CCTV through MH
- New Custom Manhole Installation

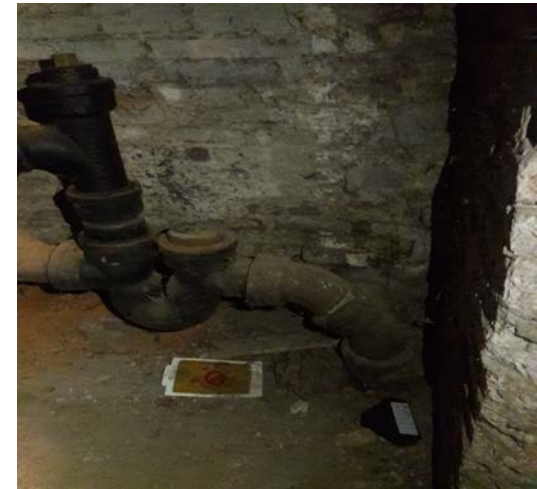
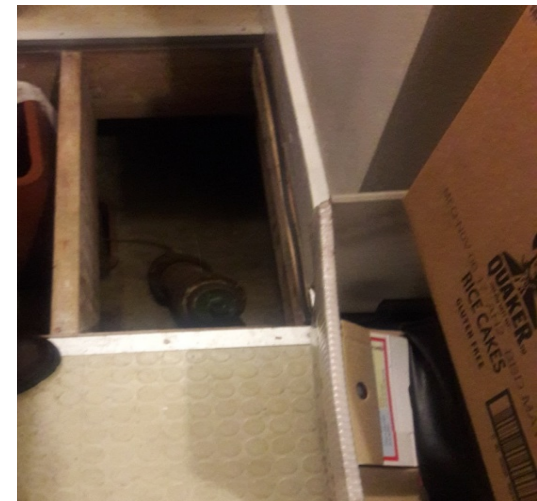
# Homeowner meeting and Home inspections

- Homeowner Meetings
  - Not in favor of grinder pumps
  - Concerns with impacts to property
  - Generally preferred sewer lining option
- Homeowner Inspections
  - Inspected service location and depth
  - Surroundings/obstacles in back yard's
  - Grinder Pump piping locations
- Notable Observations
  - Difficulty of installing grinder pump pressure sewer
