North Metropolitan Sewer Sections 4, 5, 6, and 186 Study

LiDAR Scanning and Strategies to Guide Rehabilitation Planning

January 28, 2019

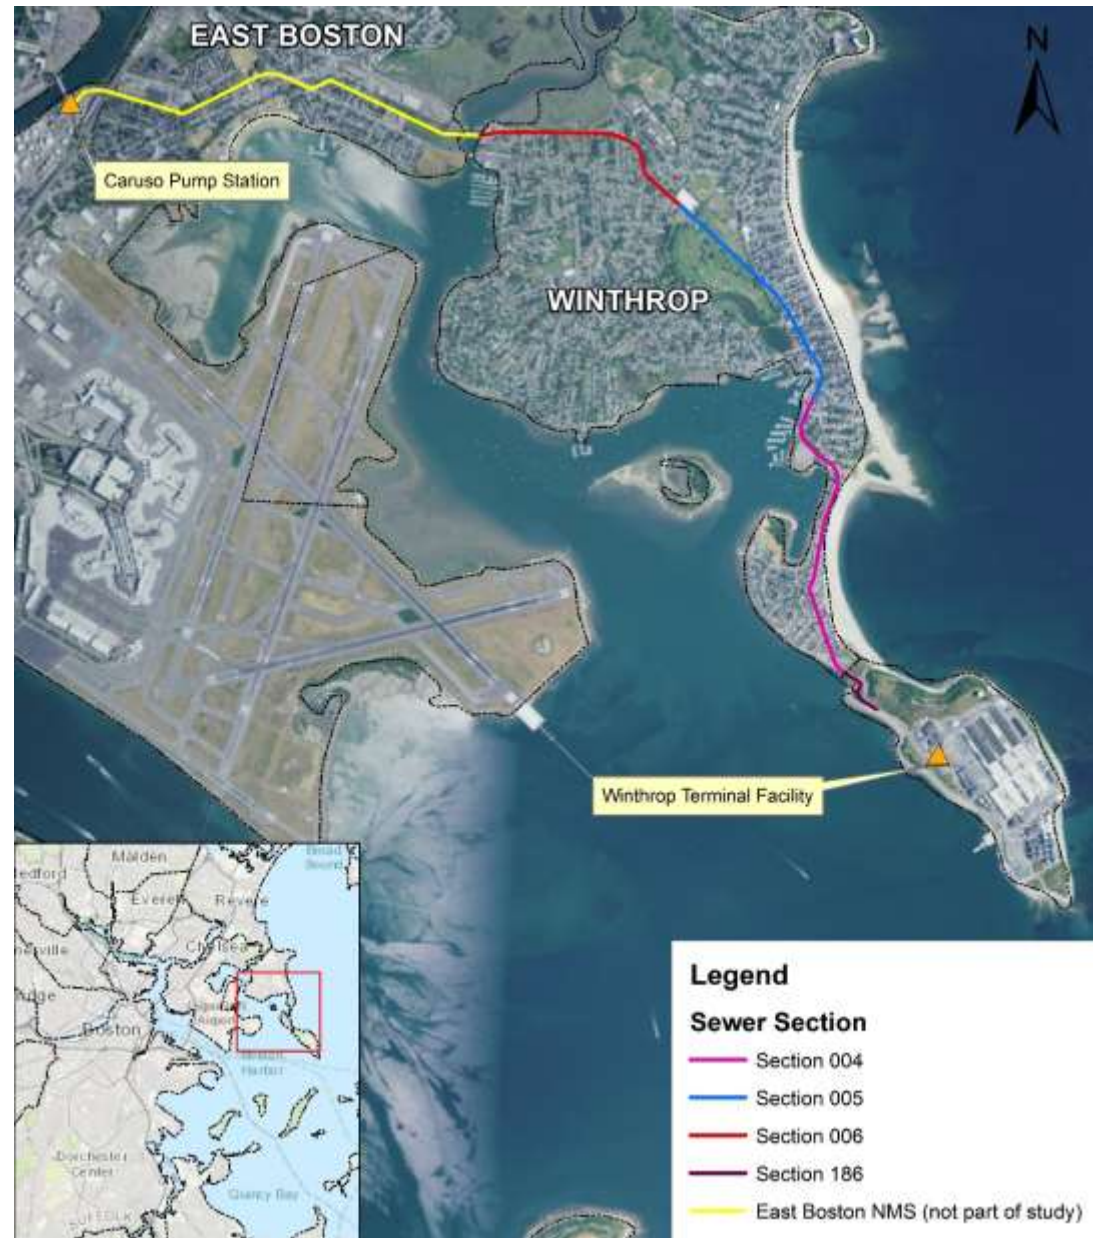
And then this happened...

- Large piece of plastic discovered on inlet screen to Winthrop Terminal
- MWRA video inspection unit locates source
- Contractor hired to remove additional loose liner

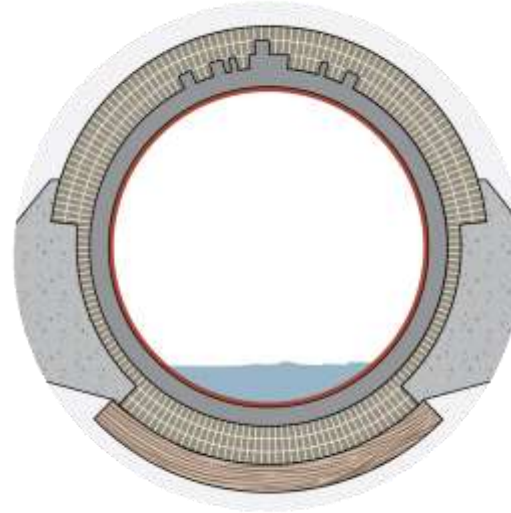
1992 – Phase 1 Rehabilitation

- 3,200 LF
- 5-6" shotcrete
- Wire mesh for structural support
- **60 mil epoxy coating**

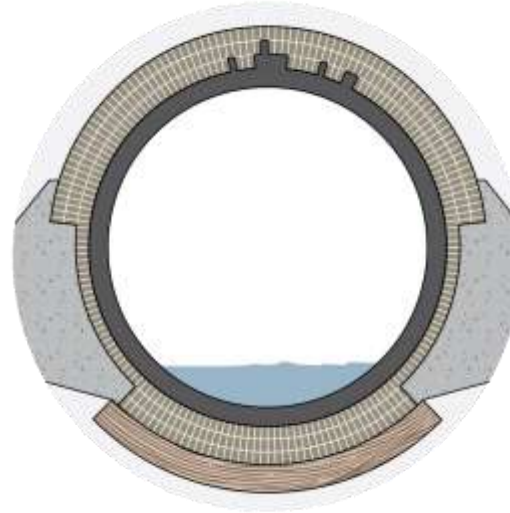
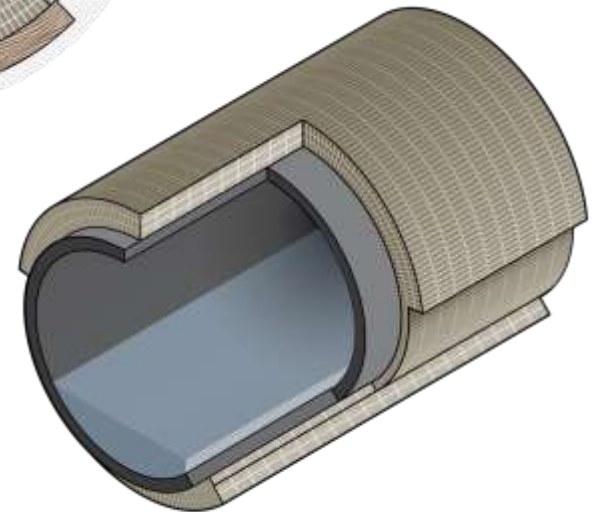
1995 – Phase 2 Rehabilitation

- 10,500 LF
- 3-4" shotcrete
- 8% microsilica (MS)
- No epoxy coating
