Non-Destructive Investigation and Proactive Hydrogen Sulfide Corrosion Rehabilitation of Collection System Infrastructure – Uxbridge, MA Case Study

James Legg | Town of Uxbridge, MA
Anastasia Rudenko PE, BCEE, ENV SP | GHD
Sara Greenberg | GHD
Benn Sherman | Town of Uxbridge, MA

NEWEA 2020

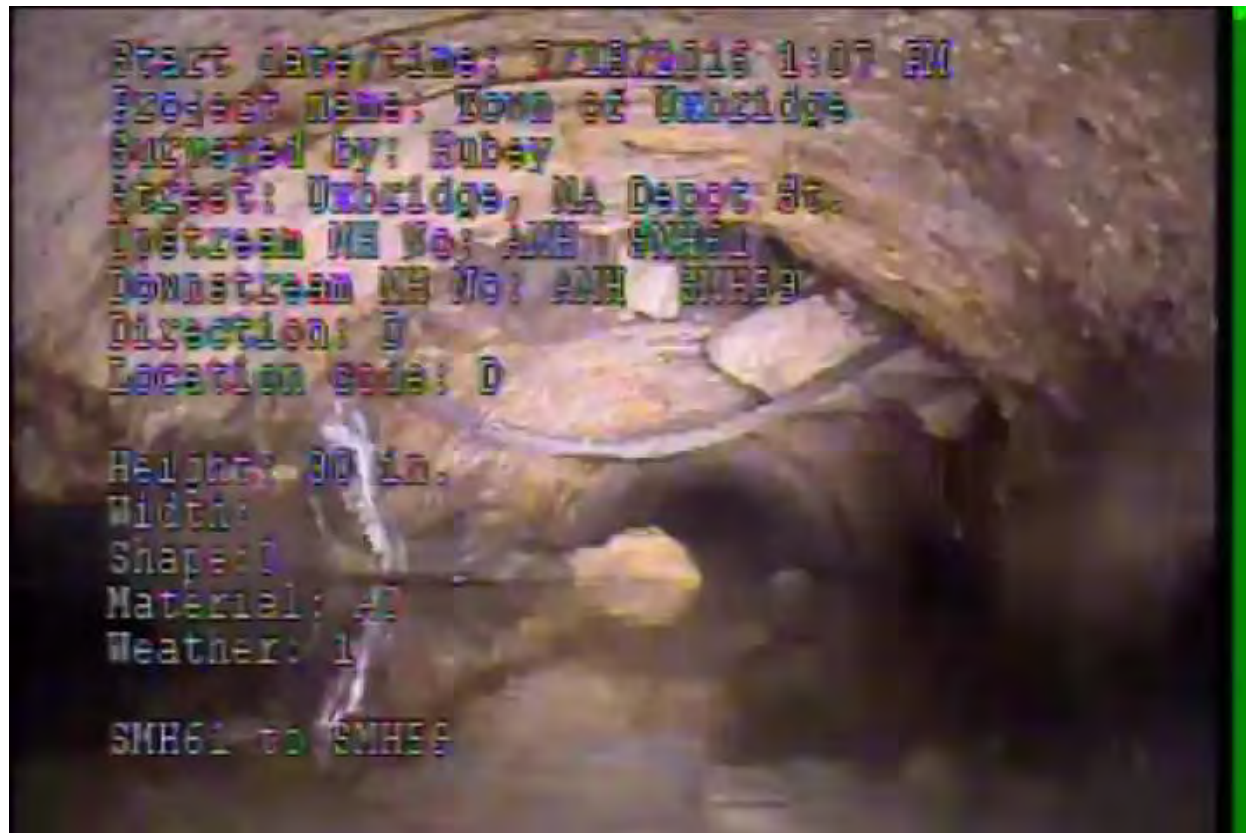
CCTV inspection video

- Inspected
 - 1 upstream pipe segment
 - 2 downstream pipe segments
- CCTV indicated minor defects upstream of the interceptor manhole
- CCTV of downstream gravity interceptor found:
 - Aggregate visible
 - Intruding Sealing Ring
 - Infiltration gusher at broken joint

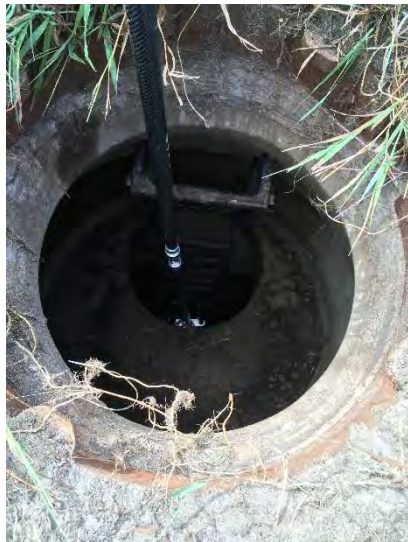
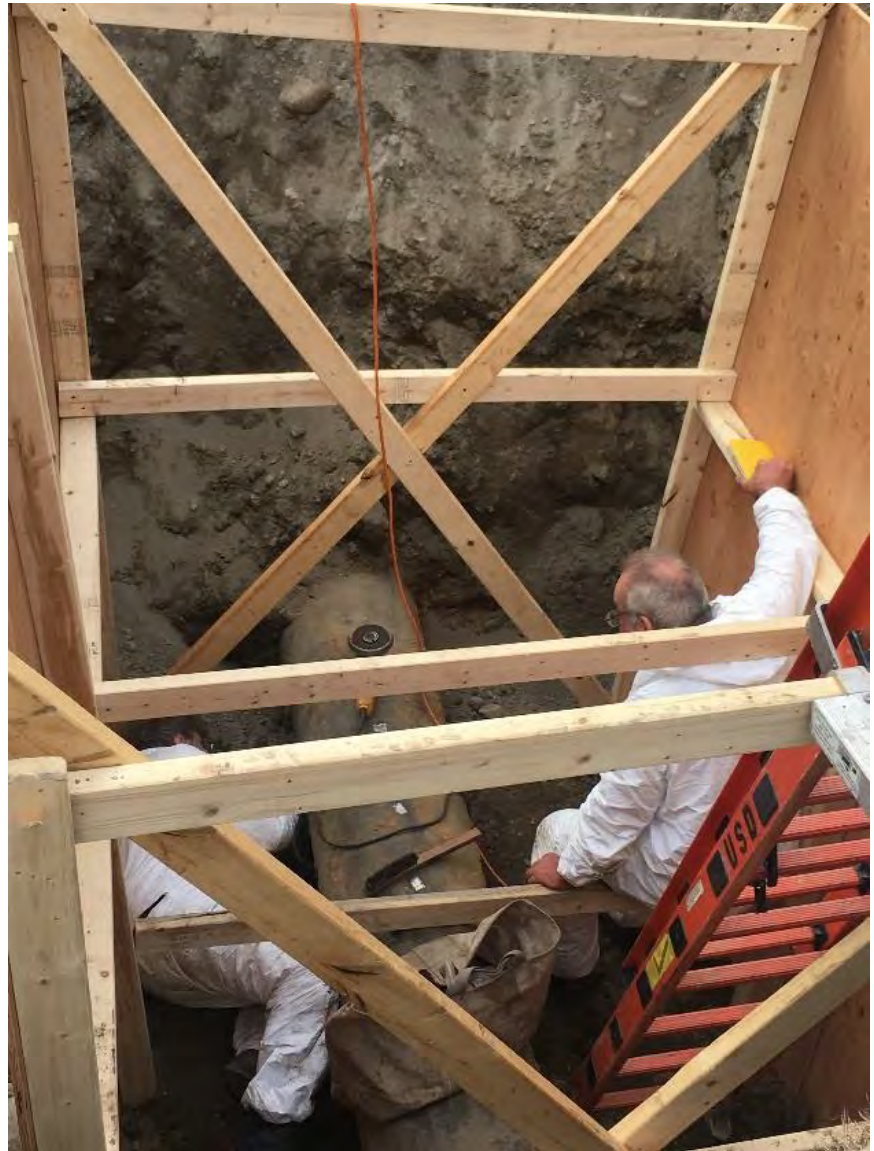
Ultrasonic testing

6 locations tested by LPI, Inc.

- 4 localized high points
- 2 easily accessible locations (manholes)

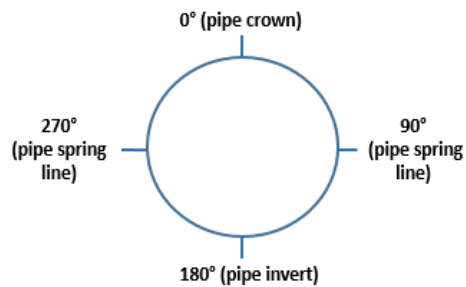
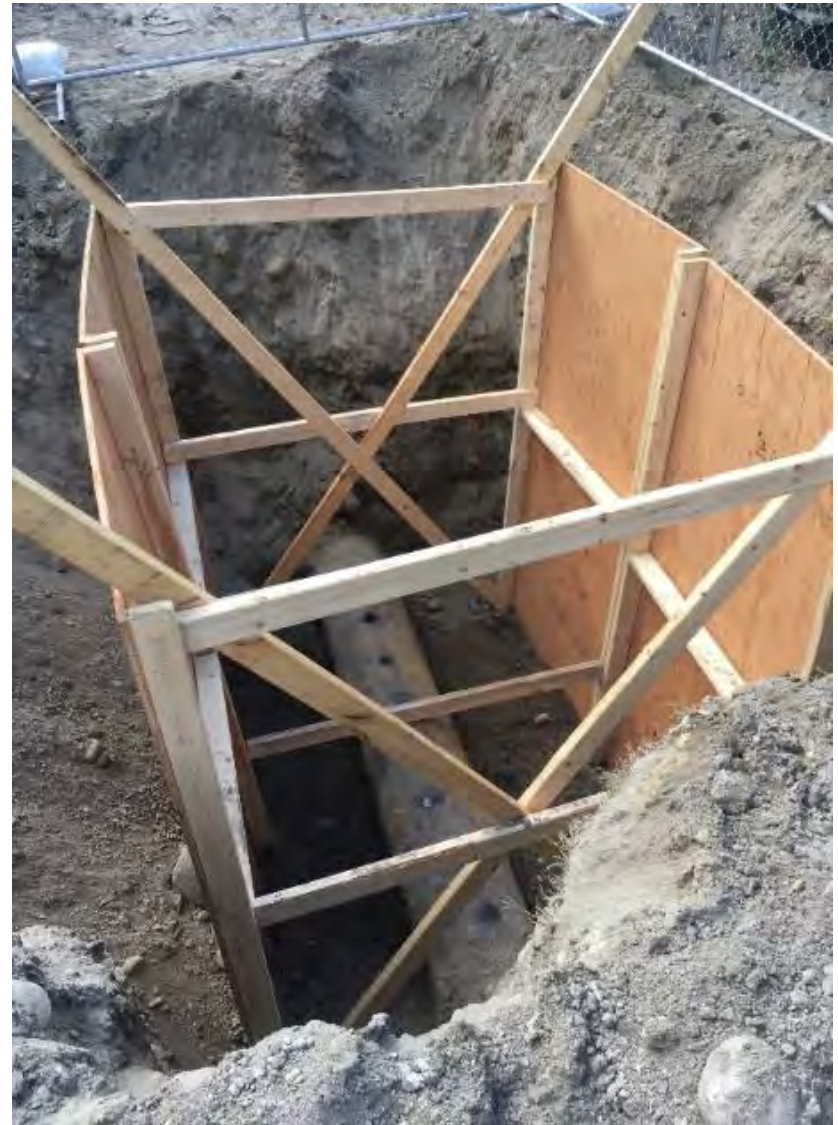
Ultrasonic testing

- Grinder used to remove small portion of exterior pipe coating at equally-spaced measurement locations
- Thickness measurements taken at multiple points along each length of exposed pipe

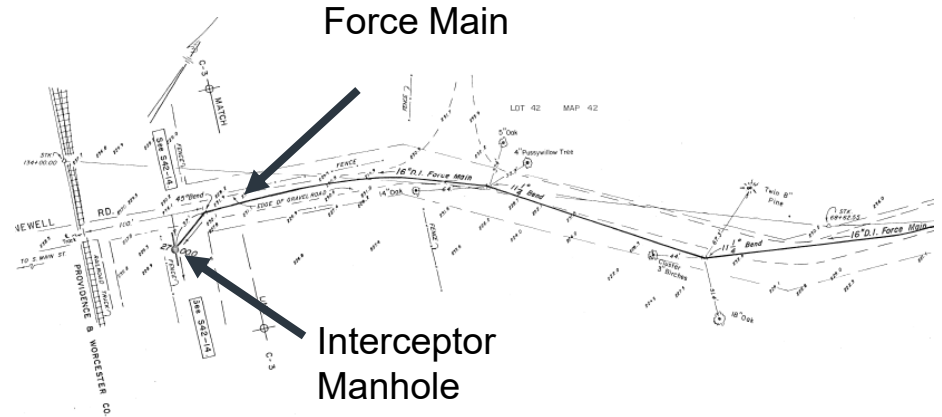
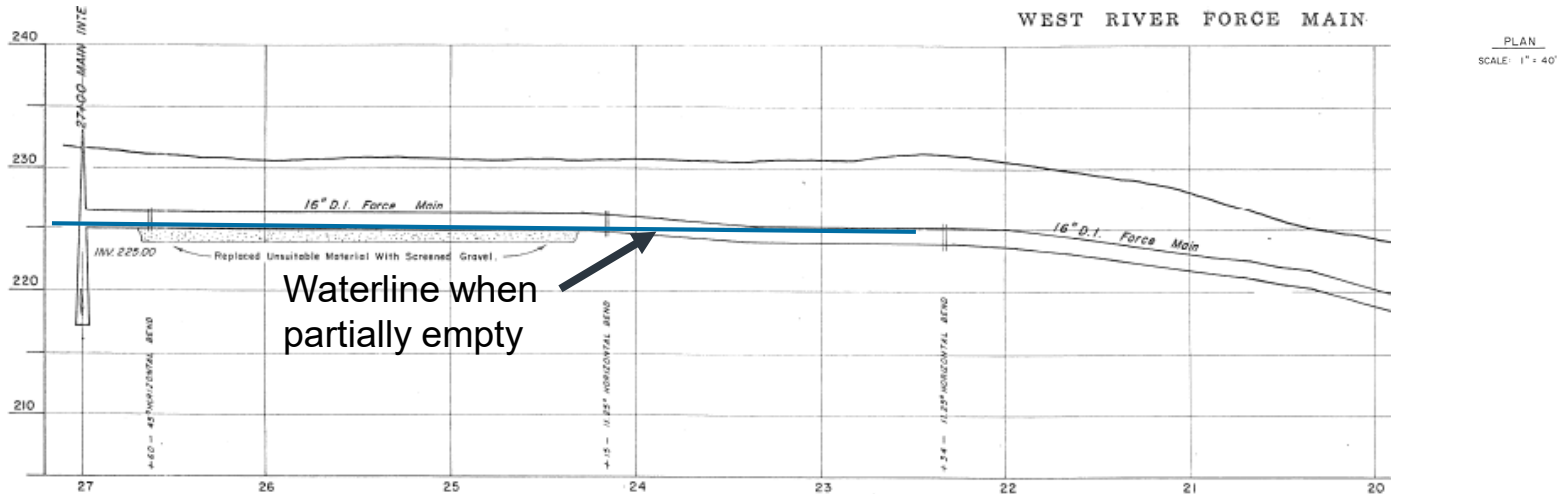
Rehabilitation recommendations

CONSTRUCTED UNDER CONTRACT #3, DURING AUG. & SEPT., 1977.
 CONTRACTOR - MOHAWK EXCAVATING, INC.
 MAIN PIPE ----- 16" DUCTILE IRON, CLASS 52.

Rehabilitate portion of force main suspected of periodically sitting partially empty
