HAVE YOU EVER BEEN RAILROADED?

Lessons from a Force Main Repair in a Railroad Right-of-Way

Jeff Kalmes Water Resource Recovery Superintendent Town of Billerica, MA

Olivia Lafond, P.E. Project Manager Woodard and Curran

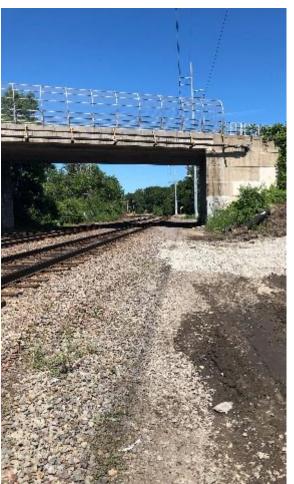
JUNE 2020: BREAK #1

- Located east of Pond Street crossing within RR ROW
- Reported the SSO to DEP, Con Com
- Contacted Railroad
- Repaired in 4 days
 - 2 days for pipe repair
 - 2 days for reconstruction of hillside and seeding
- Total Cost approx. \$60K

- Agency coordination
- Importance of updated SOPs
 - Steps to follow during emergency
 - Contact information

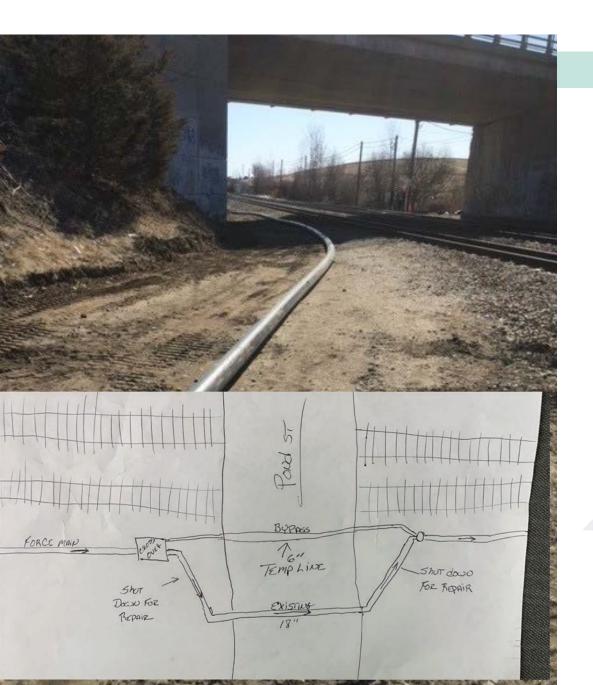
MARCH 2021: BREAK #2

- Assessment of break
- Bypass of Force Main will be required for repair
 - Above ground bypass in railroad ROW
 - Closest discharge point (downstream manhole) 3000 LF away
 - Maintain and monitor pump station and continuously vactor the wet well until bypass in place
- Obtained required permits, licenses, insurance and railroad safety training (RWP)

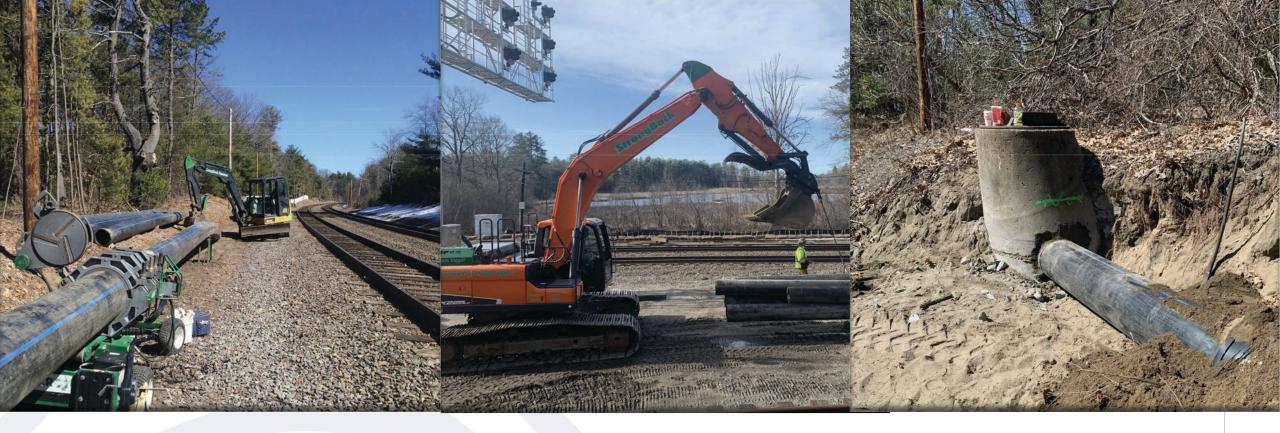
FORCE MAIN BYPASS

- Purchase and weld 3000 feet of 16-inch HDPE pipe plus 350 feet of 6-inch.
 18" Ductile to 6" HDPE to 12" HDPE to 16" HDPE
- Install Line Stop special order, overnighted from Tennessee. Extra Cost!
- Core into existing manhole to connect bypass

All work within the Railroad ROW and less than 15-feet from live track

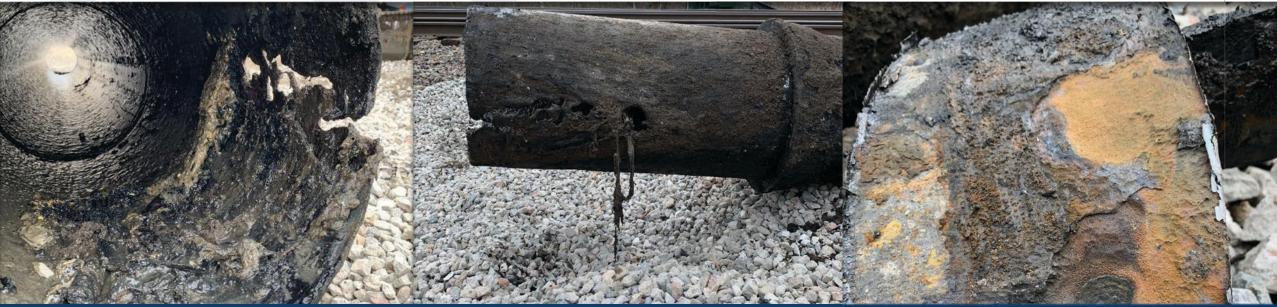
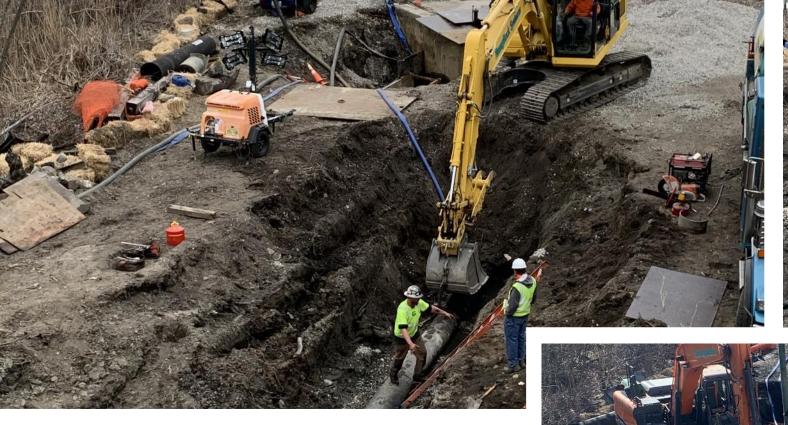
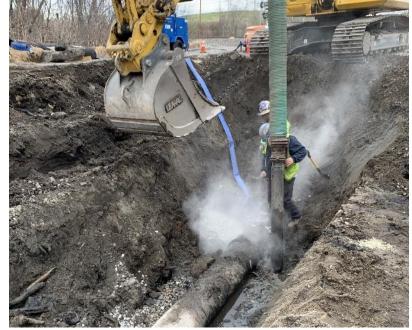
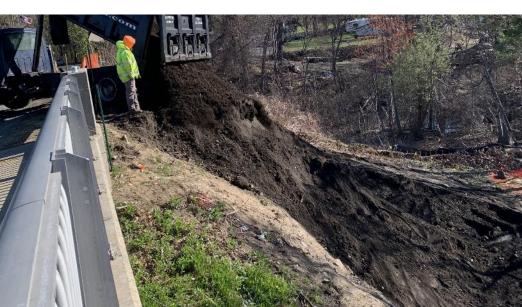
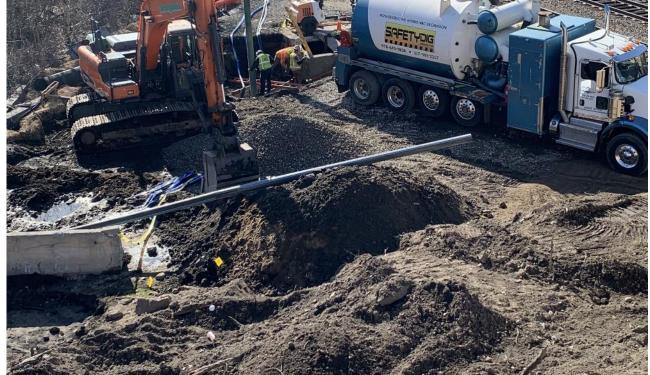
BREAK #2 SUMMARY

- Discovered on 3/11/21 Normal flow through repaired pipe on 4/22/21 (42 days!)
- Another 8 days to rebuild the hillside and protect the crossover pipe box. We also flushed out the bypass piping and capped it. (50 day total job)
- Failed ductile iron pipe was analyzed cause of the failure was corrosion due to groundwater and soil conditions, it rotted from the outside to the inside.
- Replaced 60 linear feet of force main with 16-inch HDPE pipe
- Total Job Cost = \$940,000
