## Extreme Makeover Outfall Edition

Chelsea Waite, PE Erik Osborn, PE January 26, 2022

Inspection of the Town of Hull's Water Pollution Control Facility Effluent Outfall

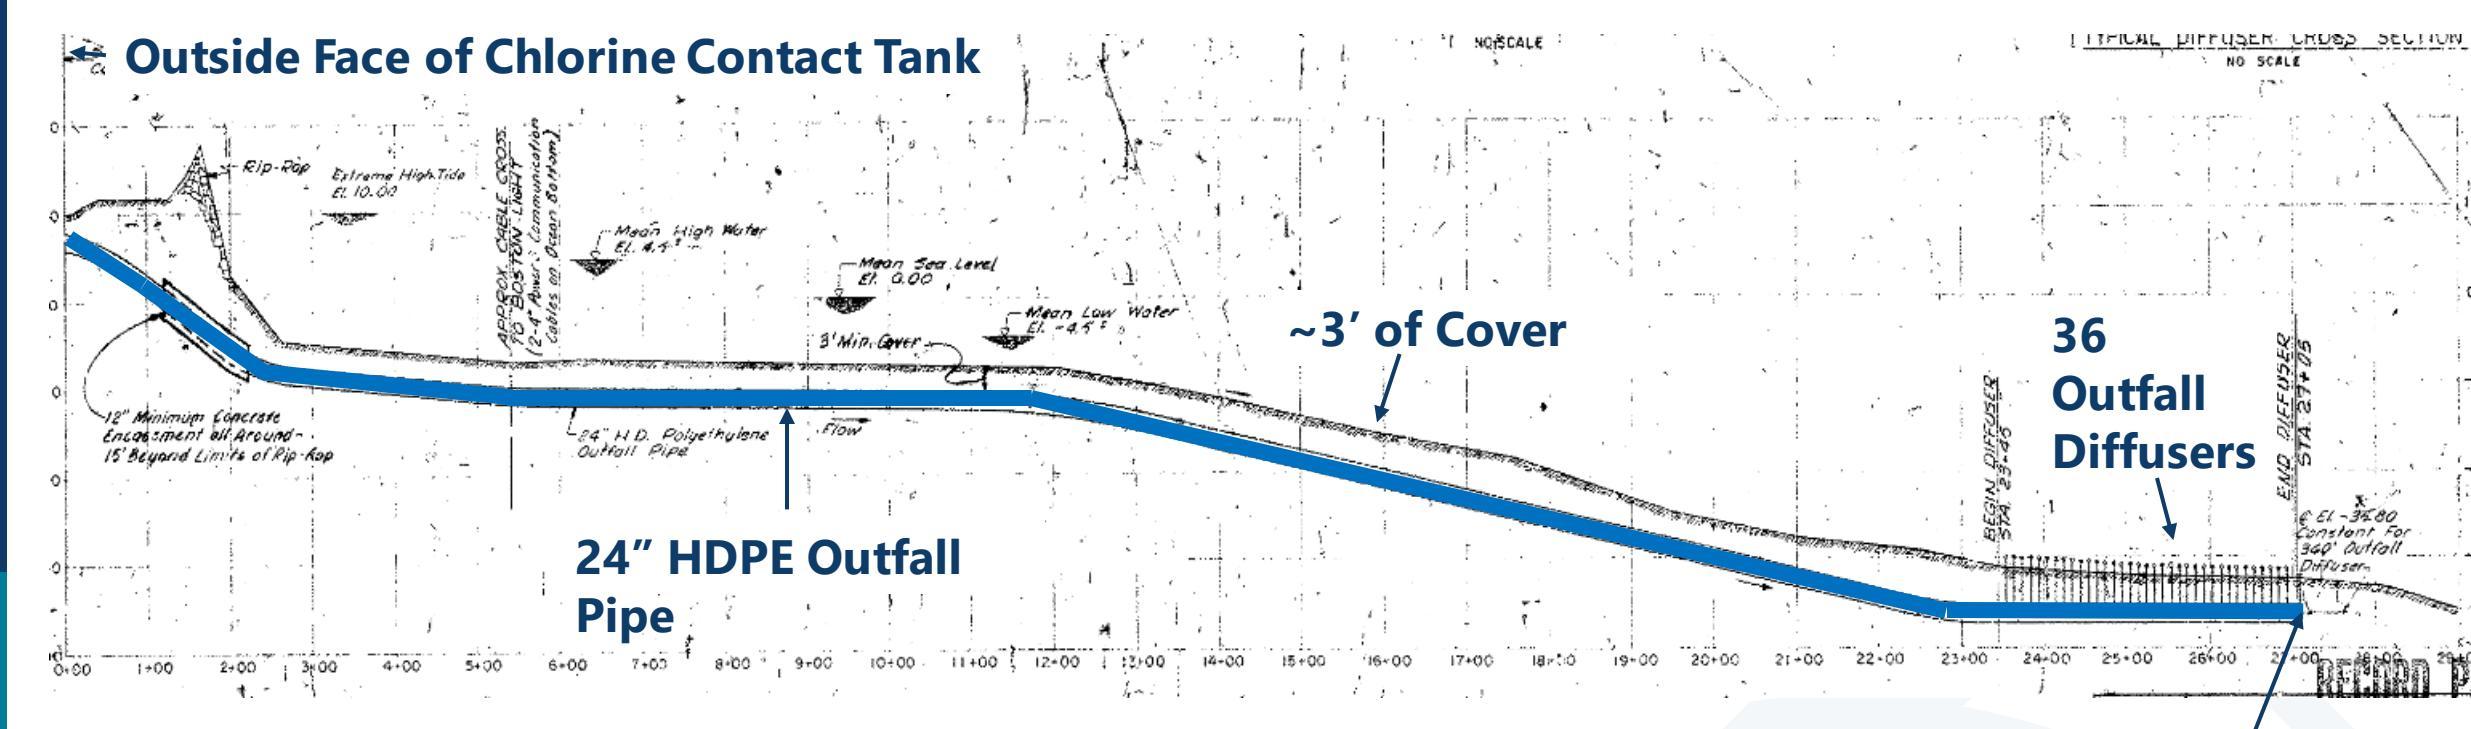
#### **Outfall Profile**

End Diffuser/ Outfall Terminus

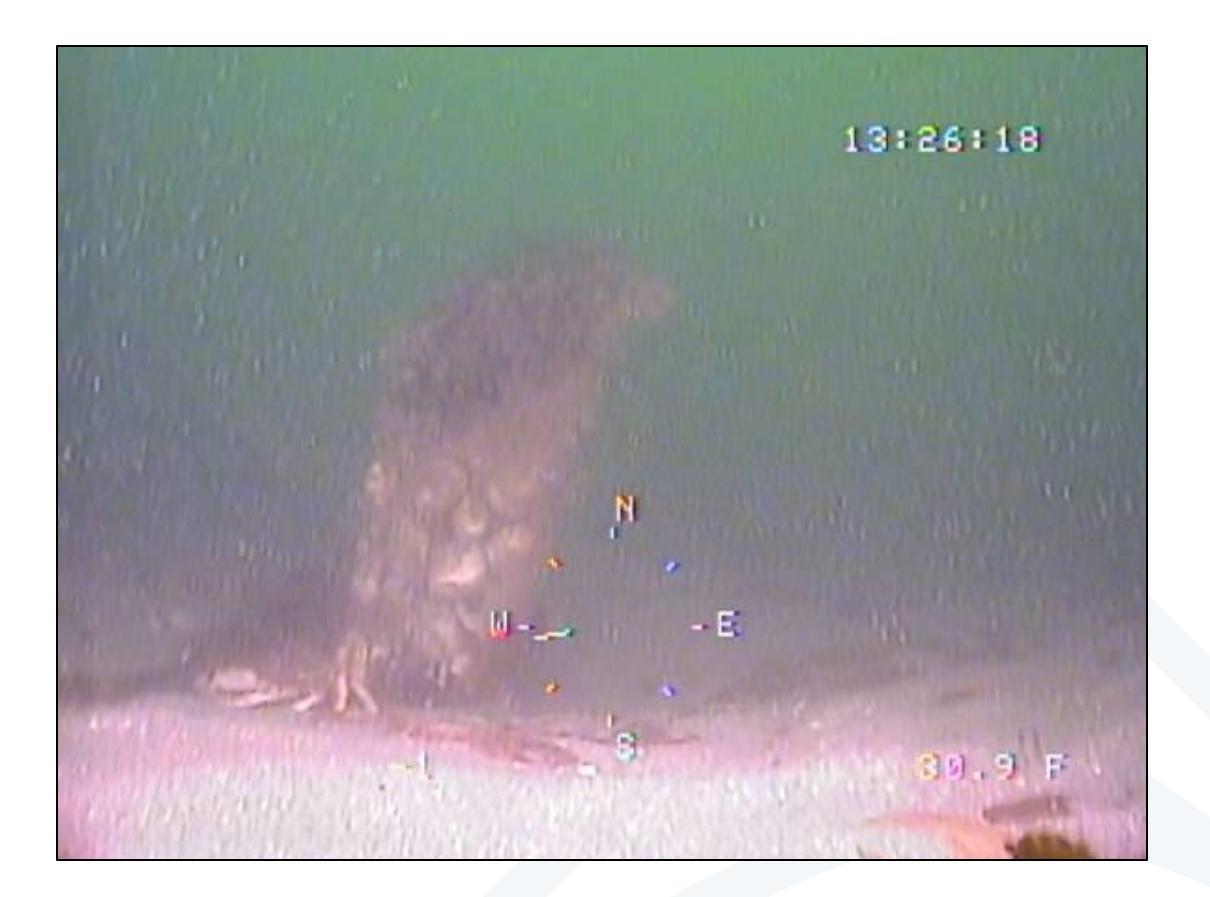
# If I was a diffuser where would I be...

### **External Inspection Conclusions**

- 18 diffuser ports were located
- Diffusers were 3 to 8-inches from seafloor
- 17 of 18 diffusers had flow
- Inside of diffusers had little to no marine growth
- Three most inland diffusers were in two- to four-foot diameter crater-like depressions
- Diffuser spacing was every 10 feet except for two locations where it was about 20 feet.
- The diffusers were not damaged
- Diffuser openings were cut flush on a diagonal alternating east and west

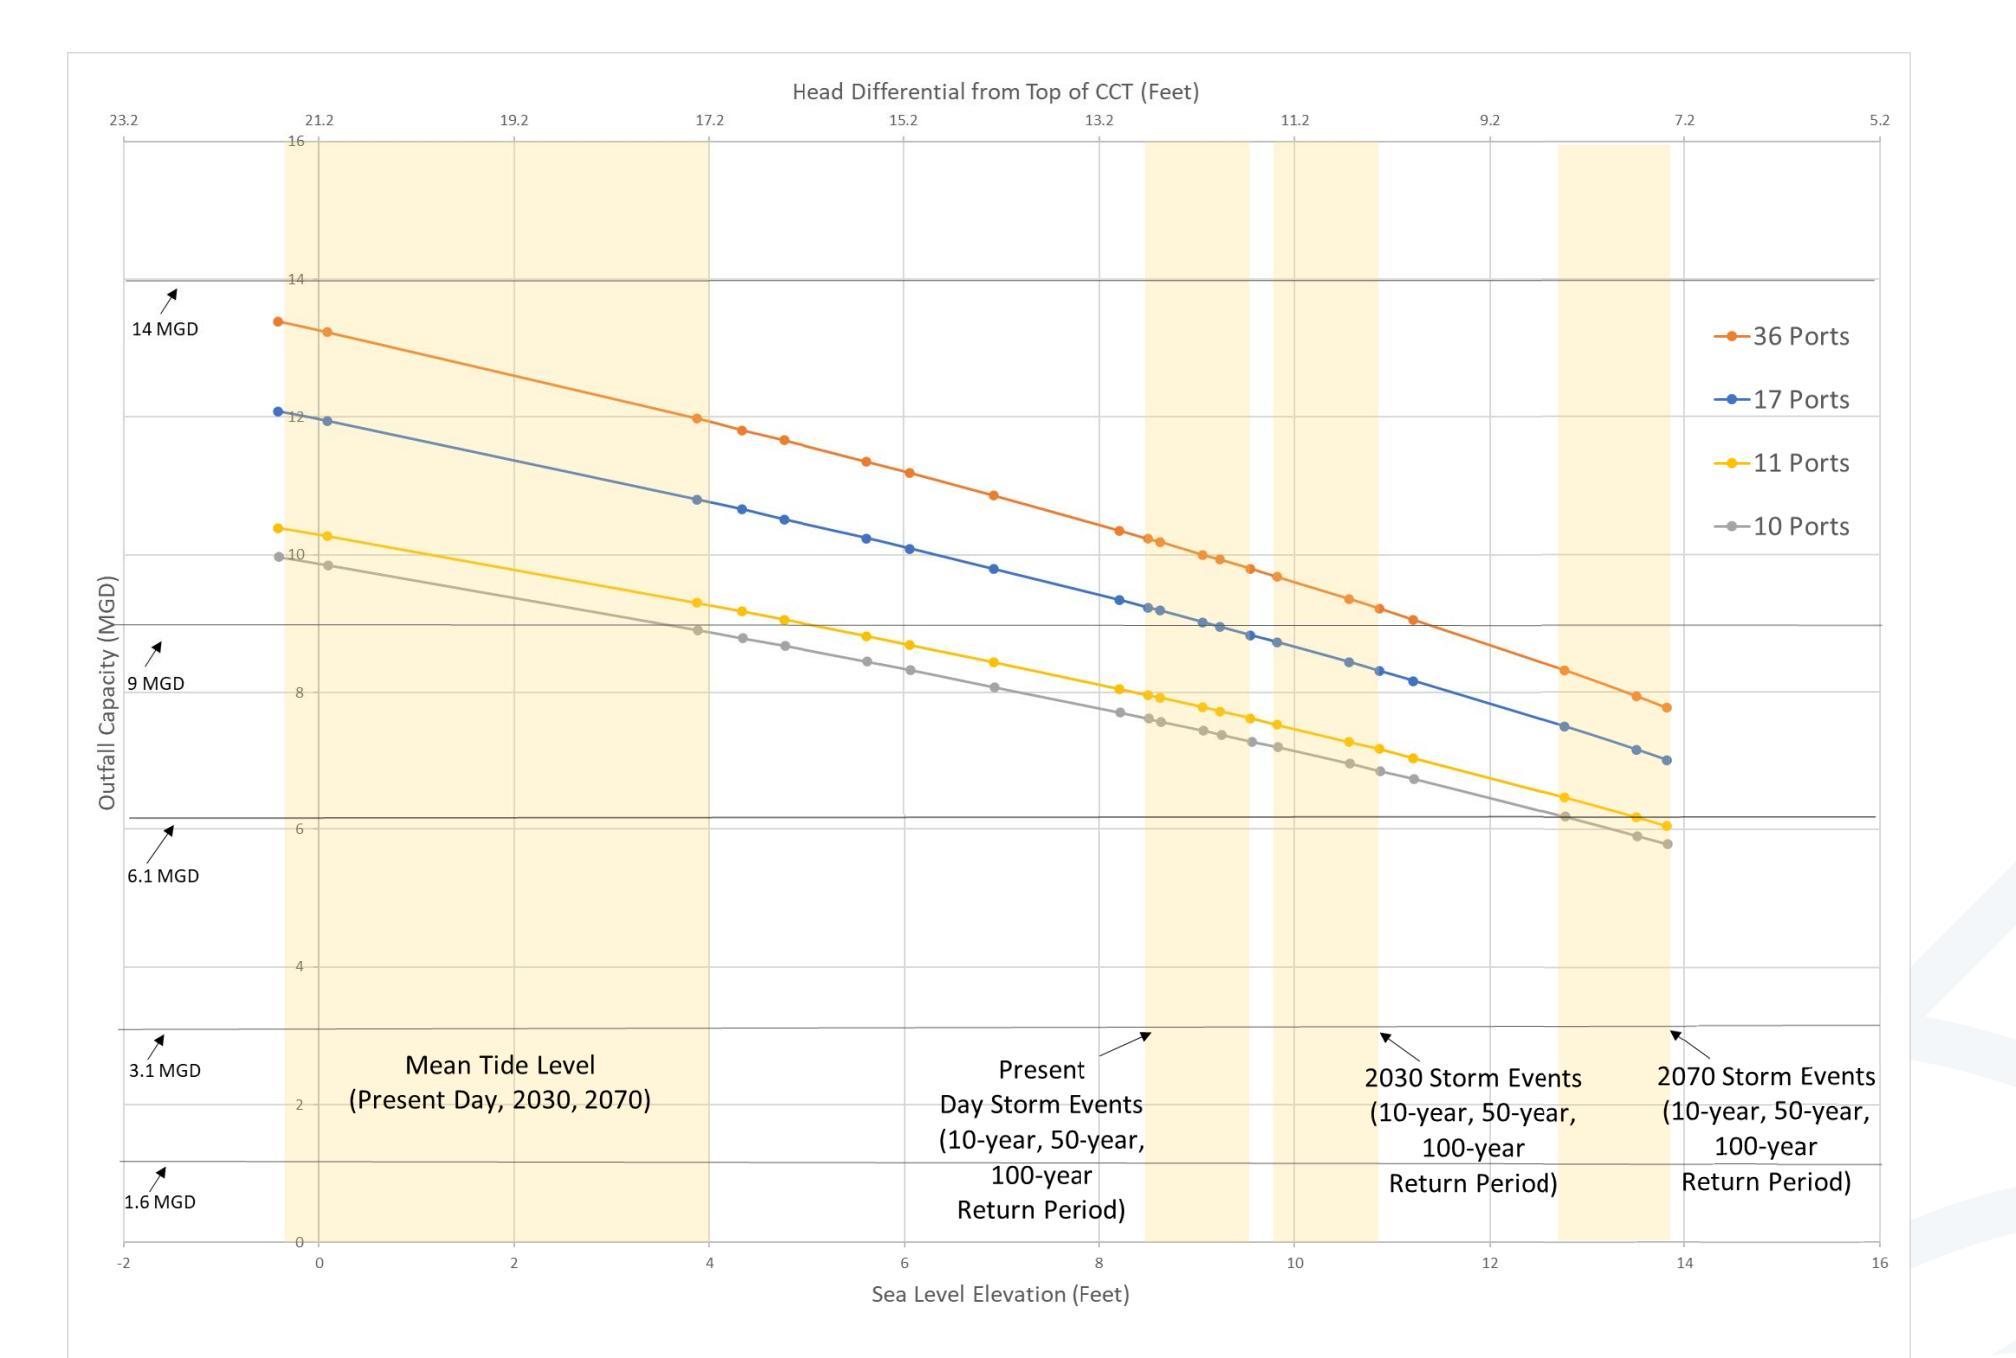
Number of Diffusers Required to Achieve Capacity for Given Sea State									
Water Level Scenario, Sea Level Elevation	Average Annual 1.6 MGD	Maximum 30-Day Average 3.1 MGD	Maximum 7-Day Average 6.1 MGD	Maximum Day 9 MGD	Peak Hour 14 MGD				
100-year Return Period (2070), 13.82'	2	5	12	Not enough capacity	Not enough				
10-year Return Period (2070), 12.77'	2	4	10	Not enough capacity	hot enough capacity				
100-year Return Period (2030), 10.87'	2	4	9	29	Not enough capacity				
10-year Return Period (2030), 9.82'	2	4	8	20	Not enough capacity				
100-year Return Period (Present Day), 9.55'	2	4	8	19	Not enough capacity				
Mean High High Water (2070), 9.06'	2	4	2	17	Not enough capacity				
10-year Return Period (Present Day), 8.5'	2	3	7	16	Not enough capacity				
Mean High High Water (2030), 6.06'	2	3	7	12	Not enough capacity				
Mean High High Water (Present Day), 4.77'	2	3	6	11	Not enough capacity

Mean Tide Level (2070), 3.87'	2	3	6	11	Not enough capacity				
Mean Tide Level (2030), 0.87'	2	3	5	9	Not enough capacity				
Mean Tide Level (Present Day), -0.42'	2	3	5	9	Not enough capacity

Note: Analysis assumes clean pipe and diffusers and no freeboard at the CCT or built into ocean levels.
