I/I Study Finds H₂S Corrosion to be the Critical Priority: Utilizing Institutional Knowledge to Guide Sewer Investigations and Rehabilitation in Darien, CT

NEWEA Annual Conference

January 25, 2023

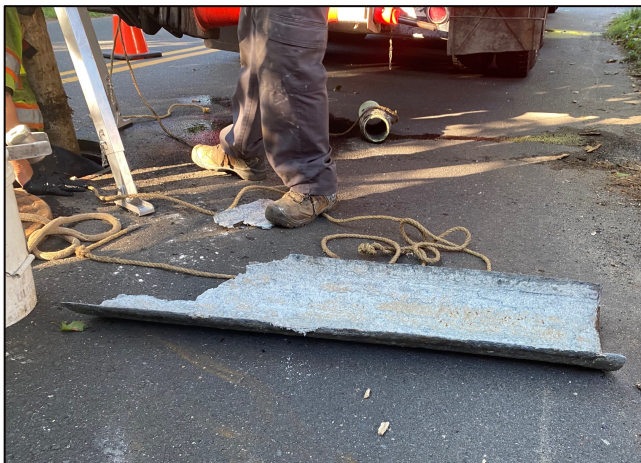
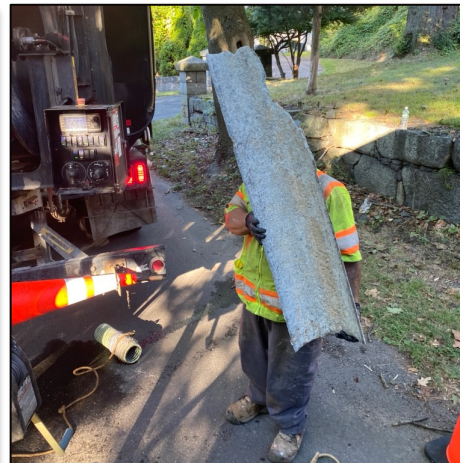
- Cured-in-place pipe lining – *NO DIGGING!* 😊
- Manhole frames and covers replacement
- Manhole benches and inverts rebuilding
- Manhole cementitious lining

- Lateral lining – adjusted approach
- Manhole epoxy lining
