# HOW LONG WILL THAT FORCE MAIN LAST?

A Planning Approach for Evaluating, Assessing, and  
Rehabilitating Ductile Iron Force Mains

# RECENT FORCE MAIN FAILURE CASE STUDY

Town of Whitman, Massachusetts

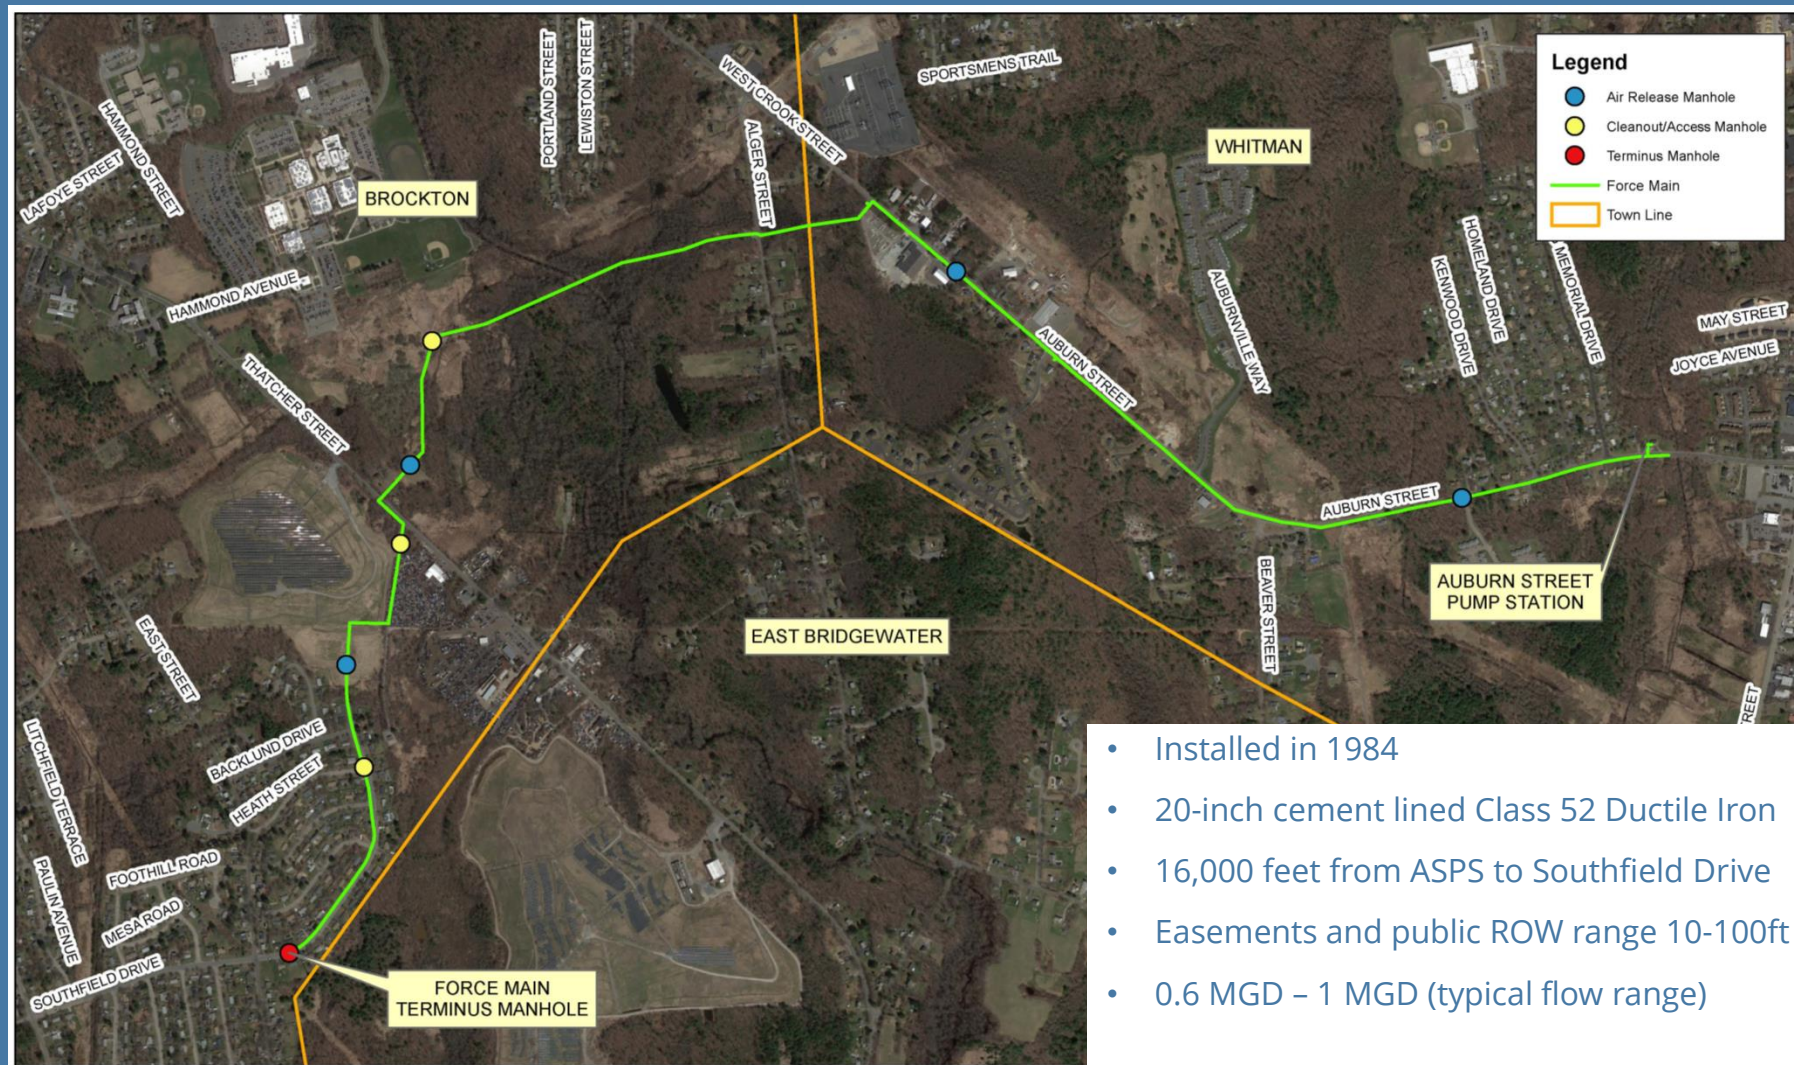
# 20-INCH SEWER FORCE MAIN BACKGROUND

- Location: Alger Street
- Dates: 9/16 and 10/17
- Emergency Response
  - Tanker truck brigade from Auburn Street Pump Station to Brockton AWRF
- Approximate Cost of Emergency Response: \$500,000 Each Occurrence

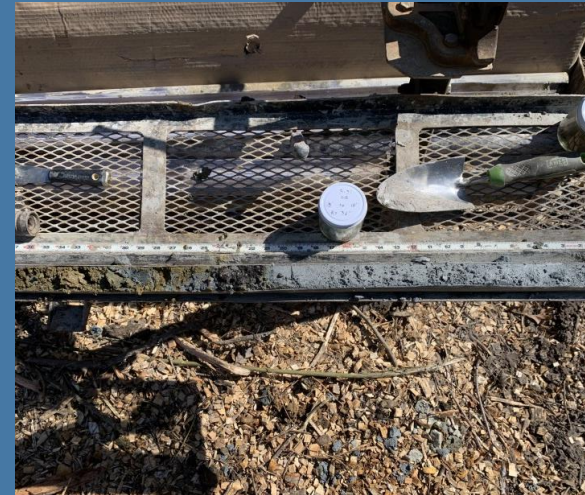
## Ultrasonic Scan

- No observed lower UT measurements at crown of pipe
- Force main is constantly flowing full
  - H<sub>2</sub>S attack is unlikely
- Probable cause of failure - External corrosion via highly acidic localized soils off Alger Street

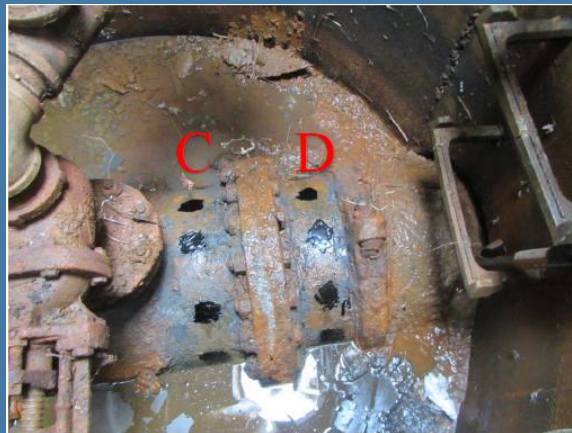
## Hydraulic Analysis

- Force main is constantly flowing full under pressurized conditions
  - Open channel flow is not present
- Under typical conditions, velocity in the pipeline is acceptable: 3.0 feet per second
- Force main and ASPS pumps are appropriately sized to handle current pump station flows

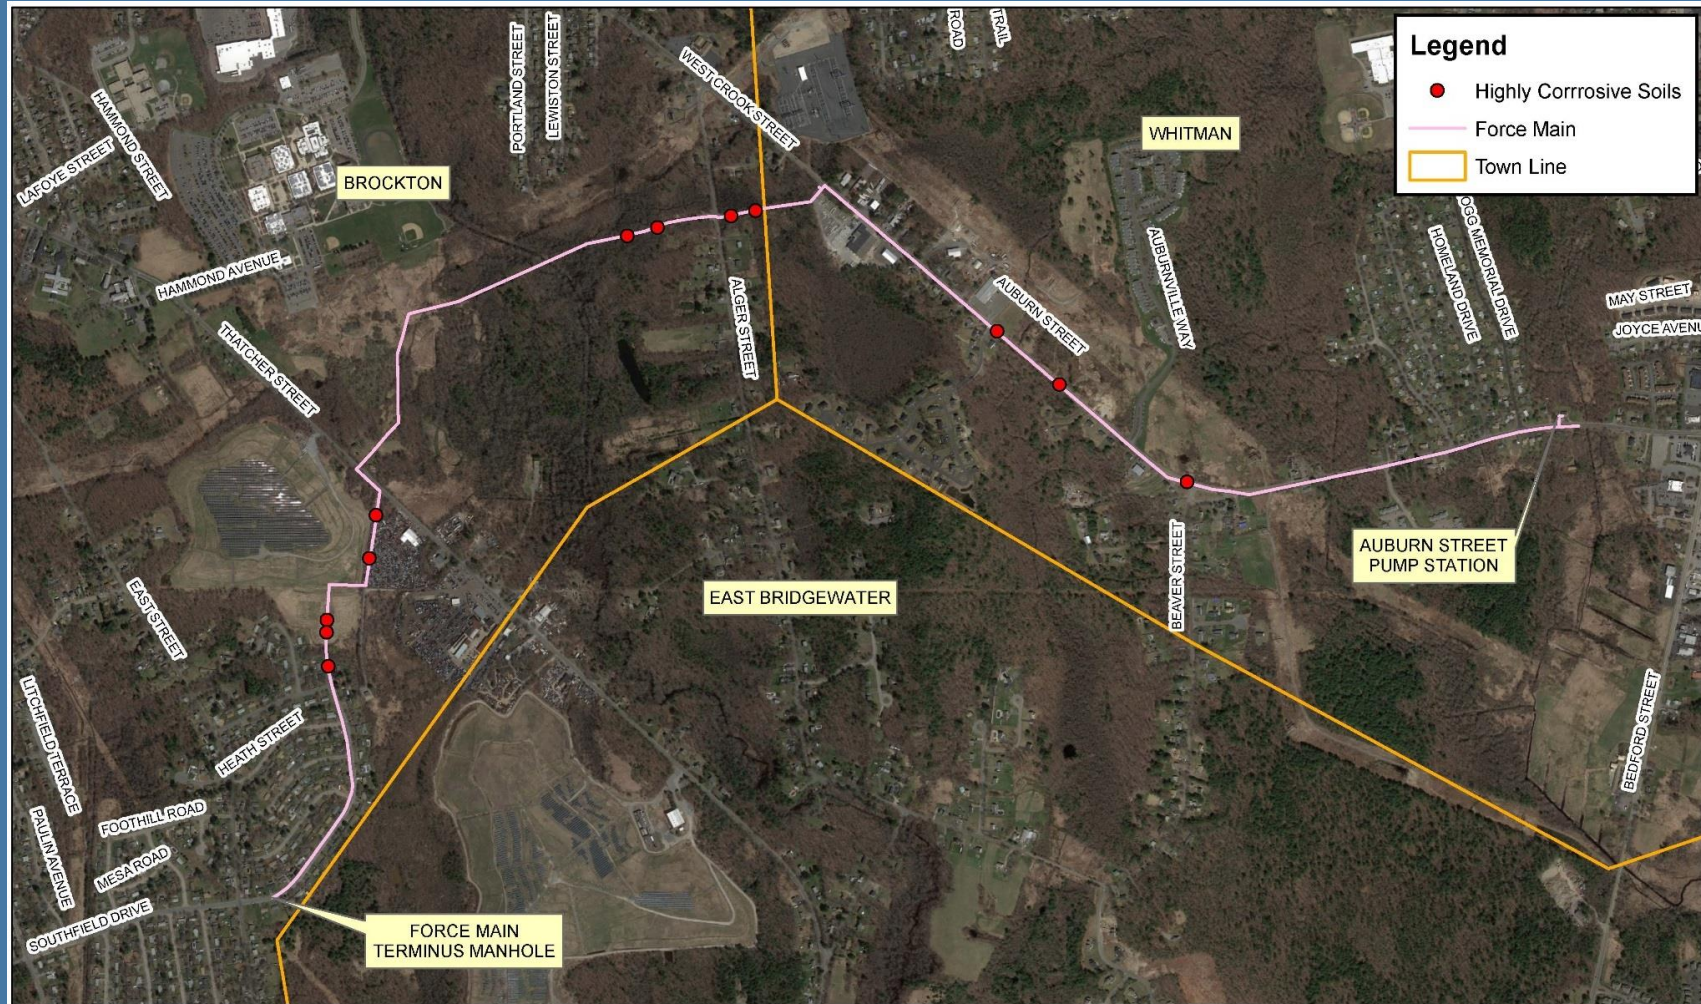
# HIGHLY CORROSIVE SOILS

- 12/70 tested soil samples: highly corrosive to ductile iron pipe (AWWA "10-point system")

- Existing 20-inch Sewer Force Main is:
  - At risk of failure due to highly corrosive soils along its alignment
  - Nearing end of useful life based on acceptable industry/design standards
- Repair/Replacement Alternatives:
