The Hydrogen Sulfide Beast From Below: A Reactive, Responsive, and Proactive need for handling H₂S before it handles us

NEWEA Annual Conference

January 22, 2024

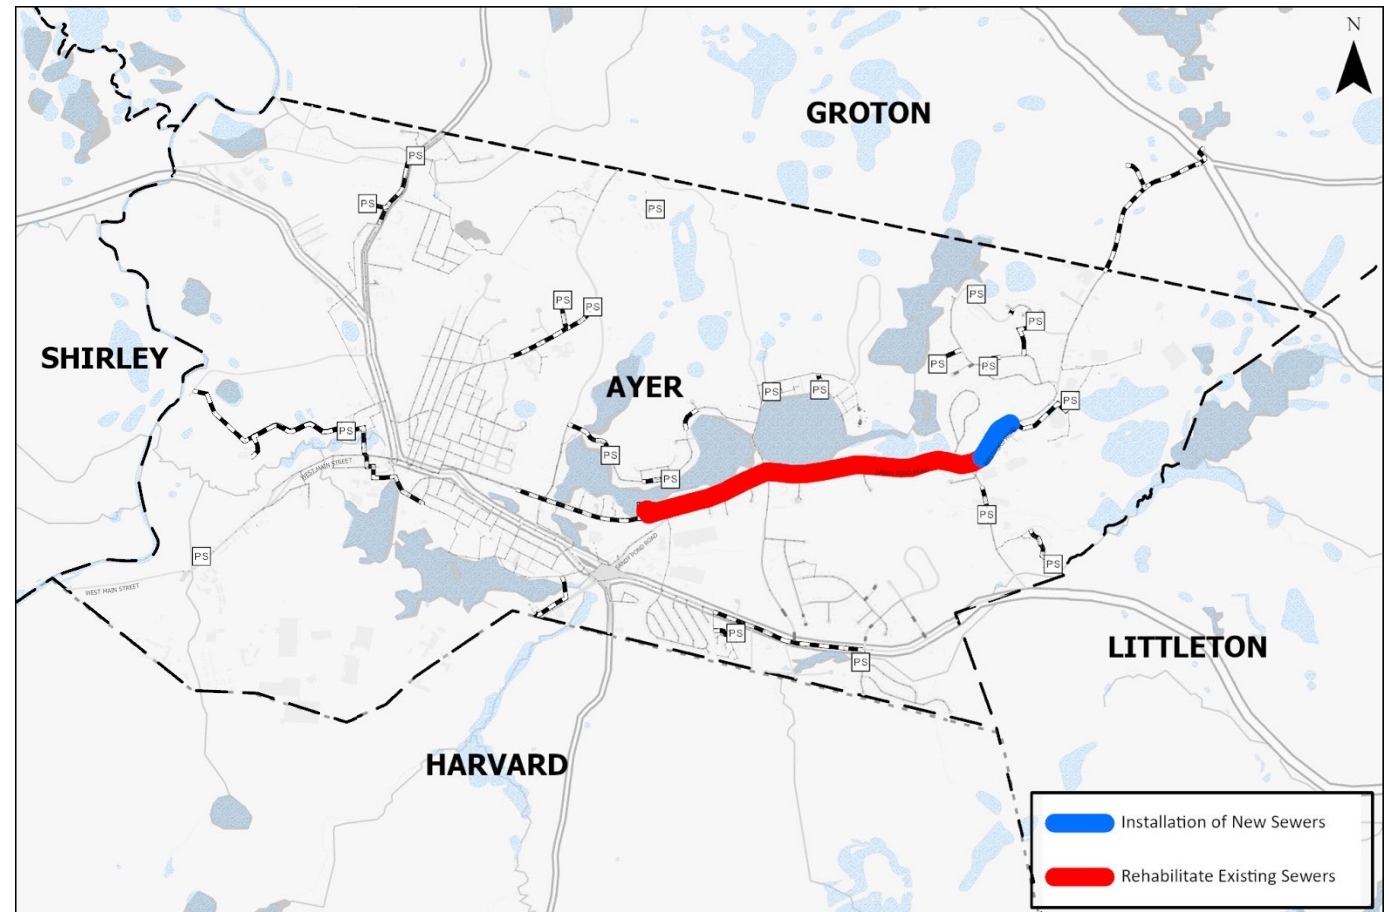
Severely deteriorated pipes on the verge of collapse had to be replaced or abandoned

Pipes retaining structural integrity while still transporting wastewater can be rehabilitated

1. Westford Road Sewer Replacement

- Abandon/Remove failed AC sewer pipes and manholes
- Install new PVC sewer pipes
- Install new precast sewer manholes

2. Sandy Pond Road Rehabilitation

- Rehabilitate sewer pipes with Cured-in-Place Pipe Liners
- Rehabilitate service connections with Cured-in-Place Lateral Connection Liners
- Rehabilitate sewer manholes with chemically resistant epoxy lining
