Protecting Critical Infrastructure: Phases 1 and 2 of the Beardsley Force Main Renewal

“A Walk in the Park”

NEWEA Annual Conference

Beardsley Pump Station and Force Main

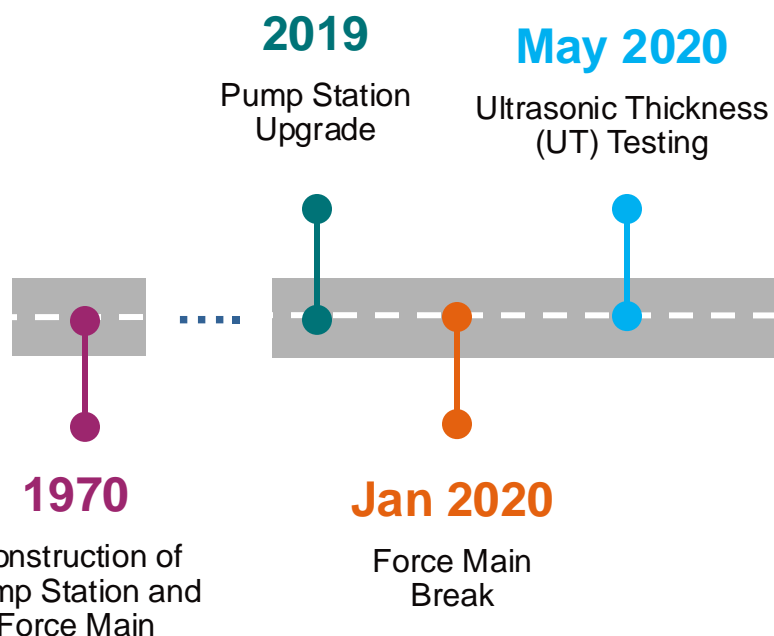
UT Testing

- Failure Analysis of removed pipe
 - Mode of Failure: Microbial Induced Corrosion (MIC)
- (2) Additional locations selected for UT testing

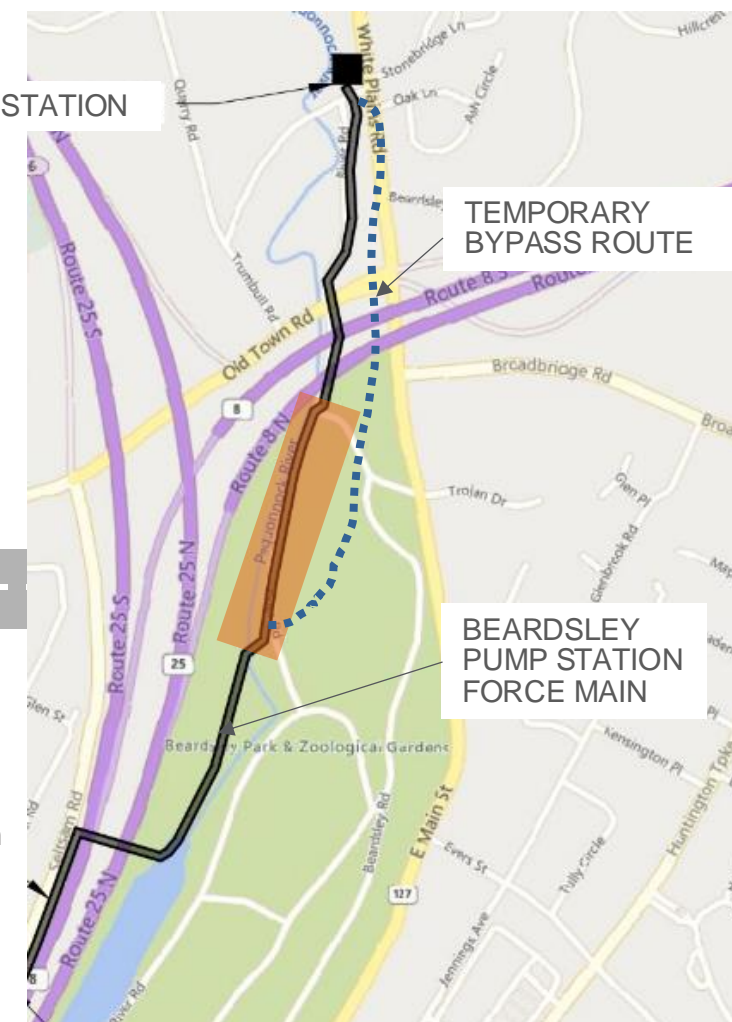
CCTV Inspection

CCTV inspection completed while FM was under bypass during replacement period

Long, continuous groove located at 6 OC

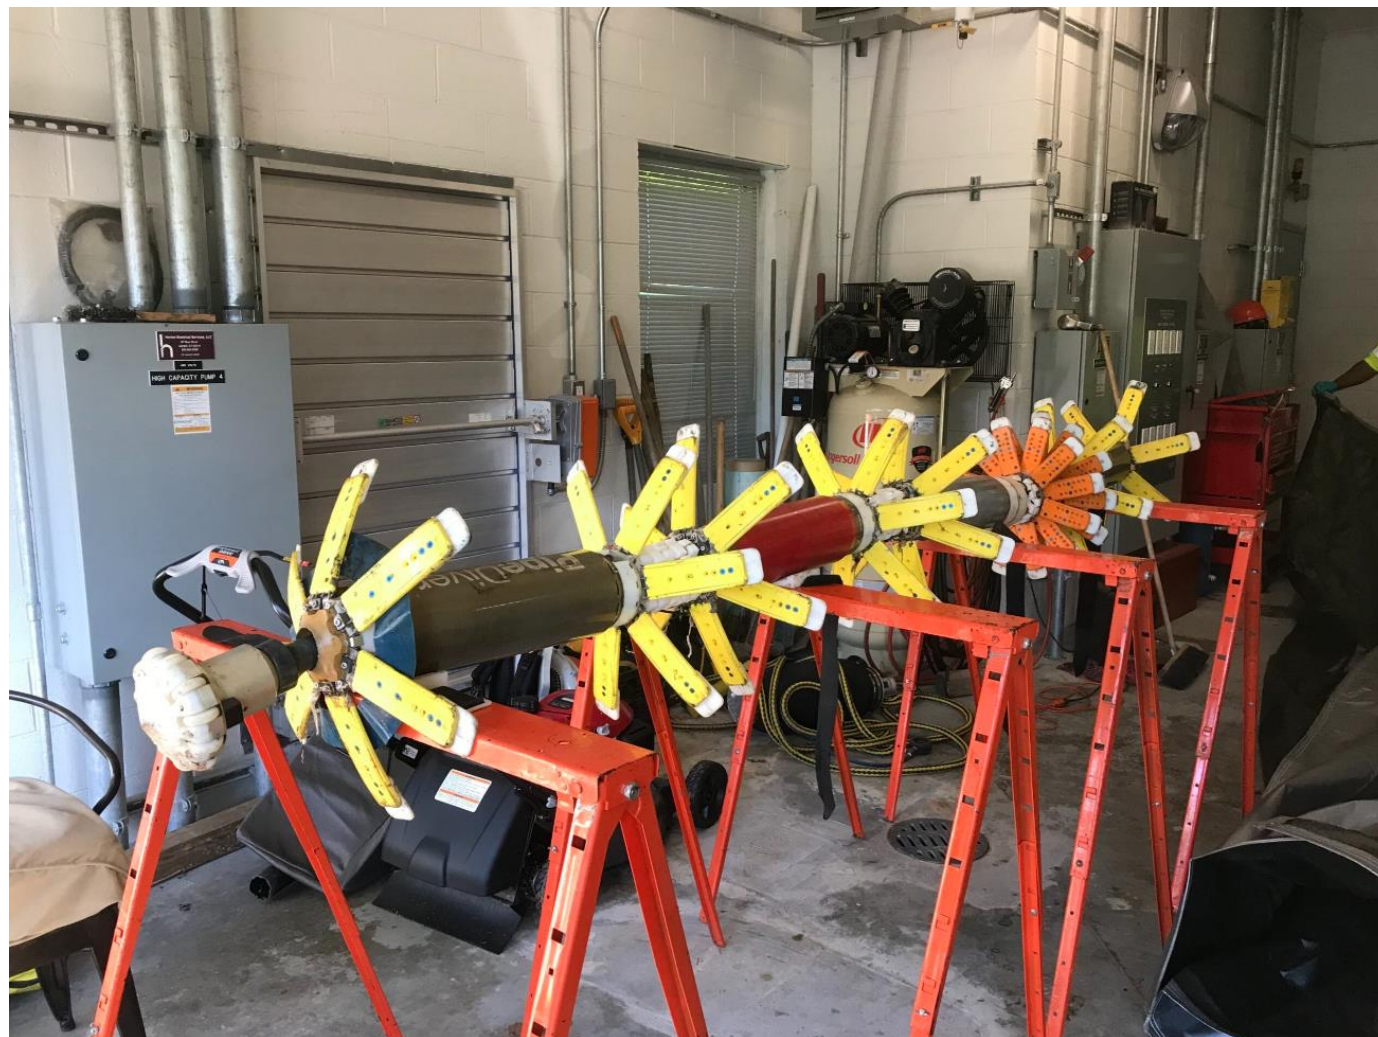
Phase 2 PipeDiver Inspection Results

- Zero (0) electromagnetic anomalies characteristic of wall loss were detected.
- One (1) pipe was identified with an anomaly that was detected circumferentially – bypass connection

- Requested additional analyses of PipeDiver data
- Additional analyses found 52 areas of signal variation at pipe invert were identified across a total of 49 pipes.
 - Possible causes
- Comparison with prior BEM

1. Continue operating pump station under operational parameters that limit extended periods of low flow velocity, which was the cause of the microbial induced corrosion.
2. Additional external inspections at locations of signal variation
3. Re-inspect in 10 years

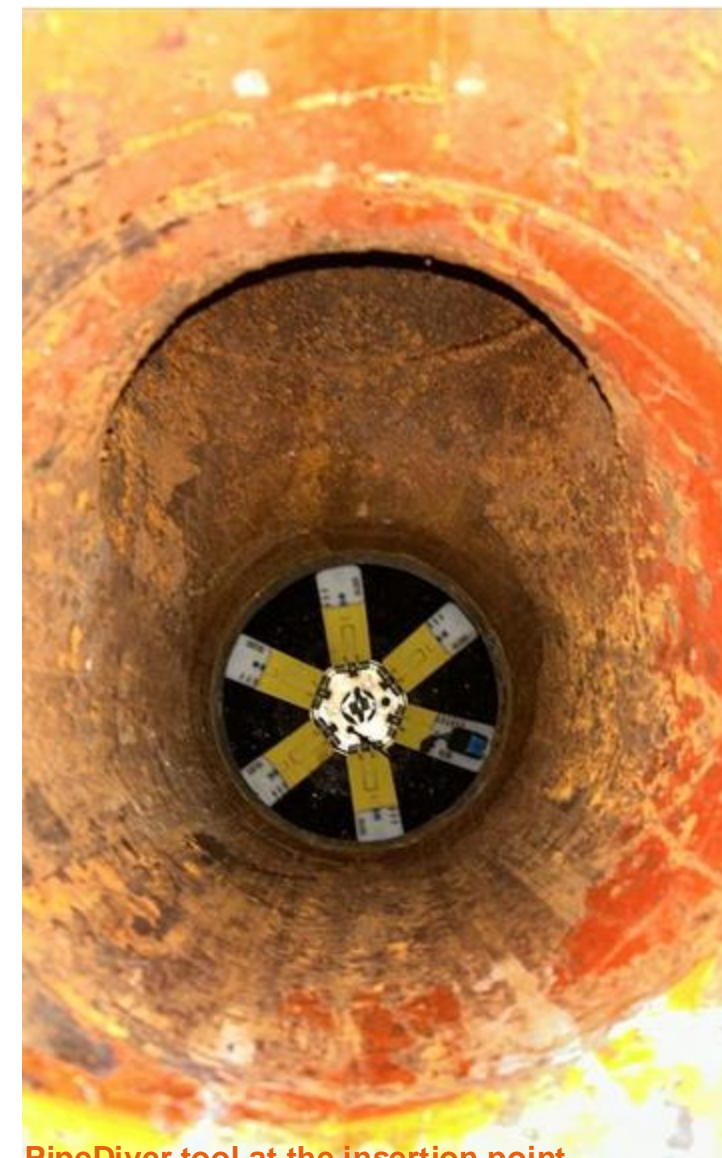
PipeDiver tool at the insertion point.
