# Targeted Inspections Used to Assess Force Main Condition After Failure

# About the Beardsley Pump Station Force Main

# Force Main Failure

# Outcome of Failure Analysis

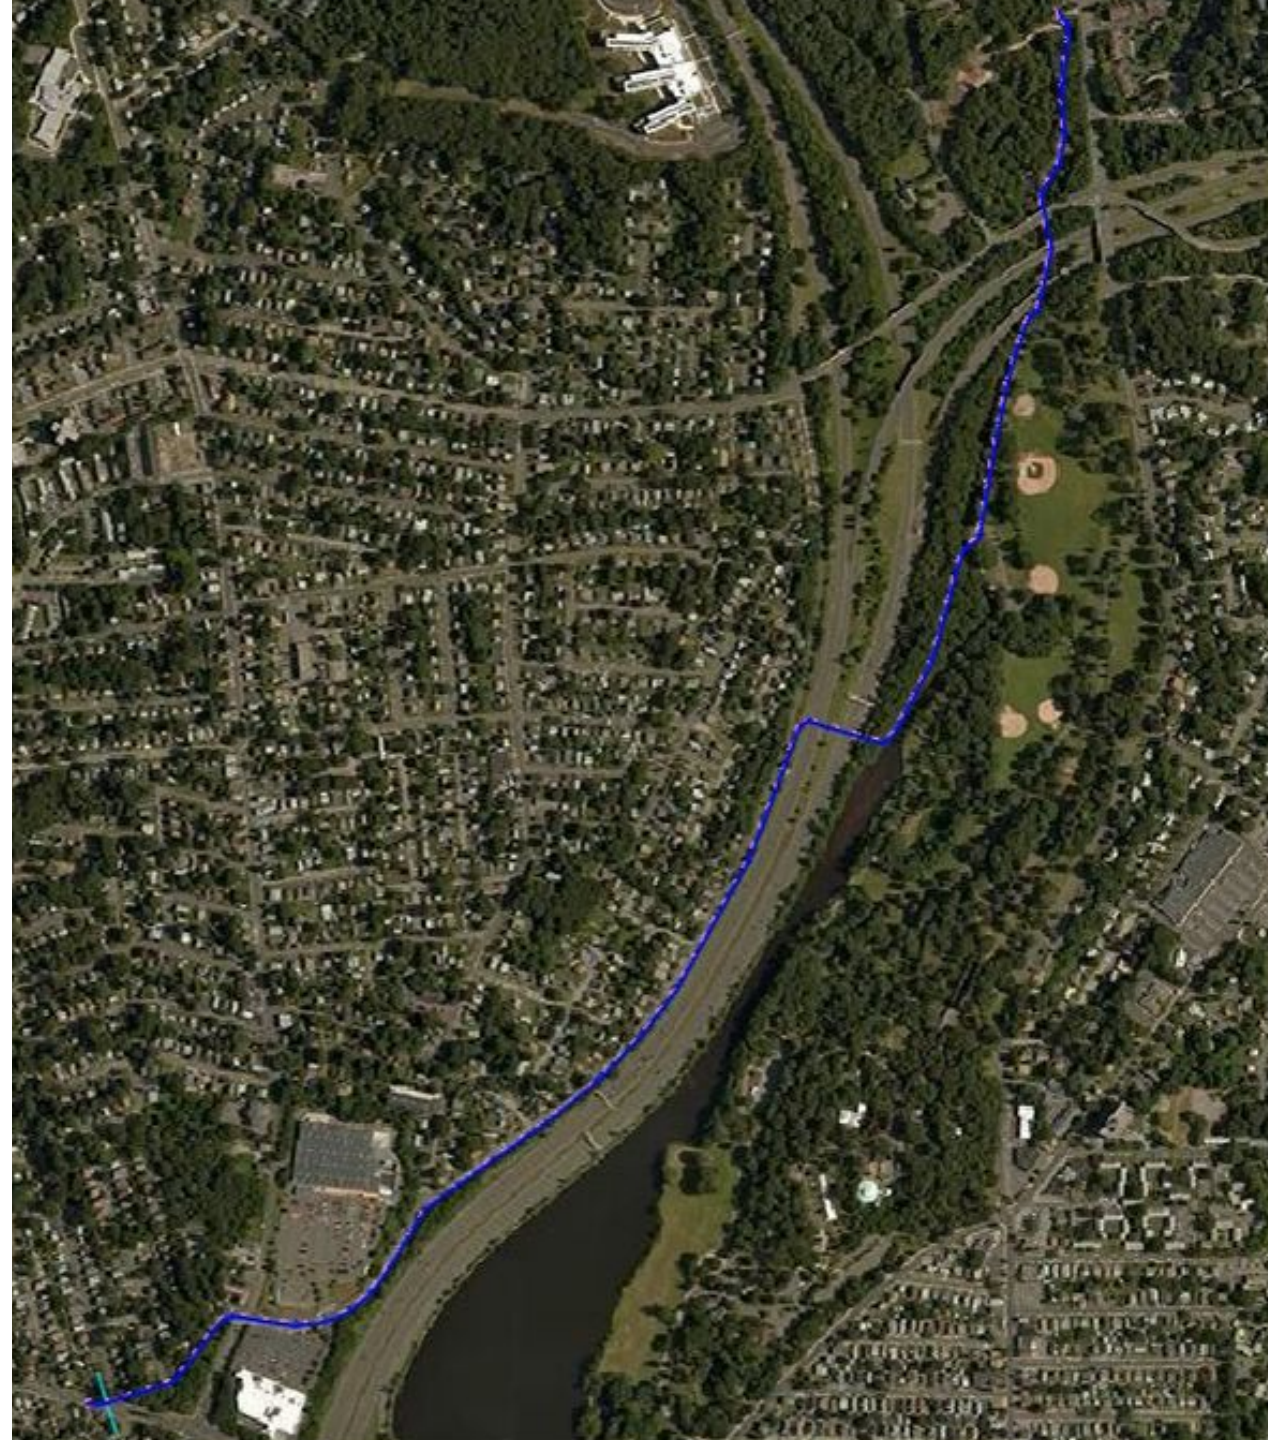
- Installed in 1970s
- Nearly 2 miles long
  - Through a Park
  - Under a River and Highway
- 20-inch Ductile Iron Pipe
- Critical Infrastructure – Conveys 2/3 of Town Total Flow

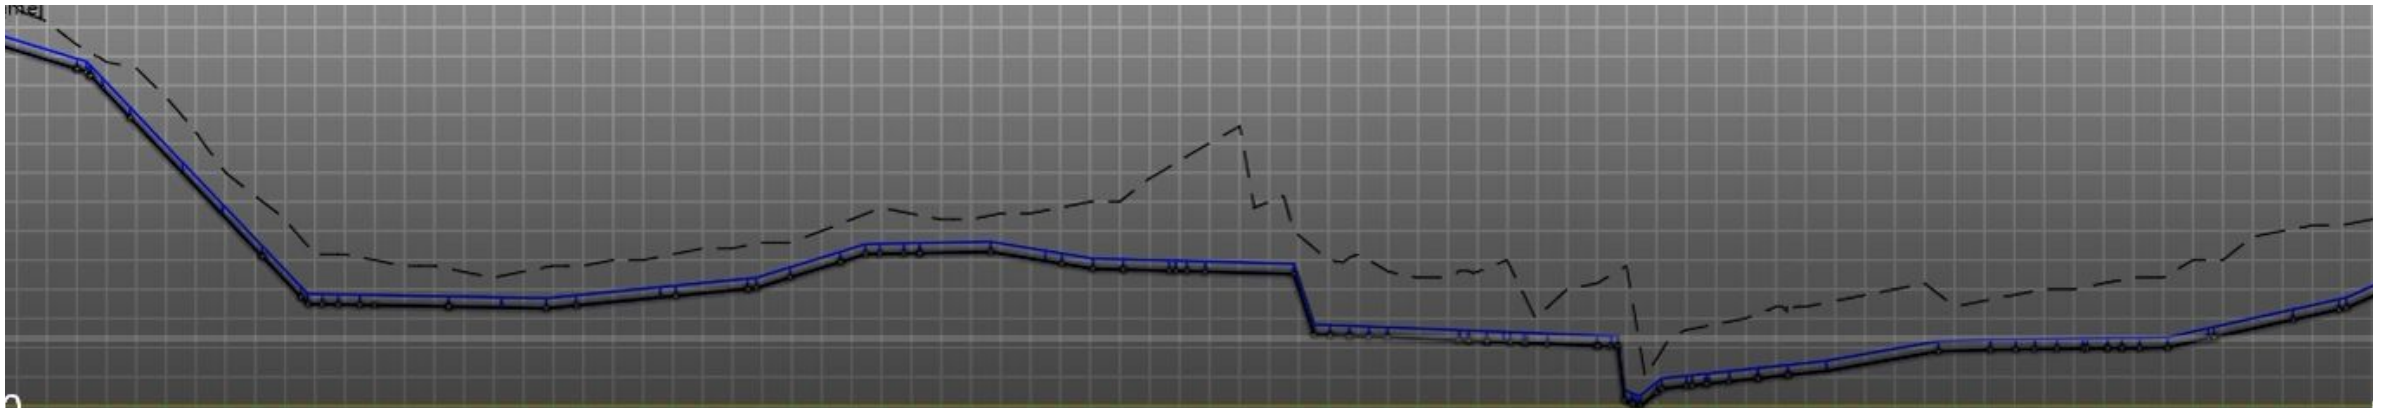
- Holistic review entailed:
  - Desktop Study to Identify Potential Areas of Concern
    - Low Point in Park (Failure Location)
    - 2nd Low Point with Flat Slope (Seltsam Road)
    - High Points
  - Non Destructive Testing
    - High Points (Air Release Valves) – 2 Locations
    - Low Points via Test Pits – 4 Locations
