# Man, Machine or Both! Bringing SSES into the GIS Space for More Efficient Sewer Rehabilitation Design

NEWEA CSO / WWI Conference
Tools for Change

October 30, 2018

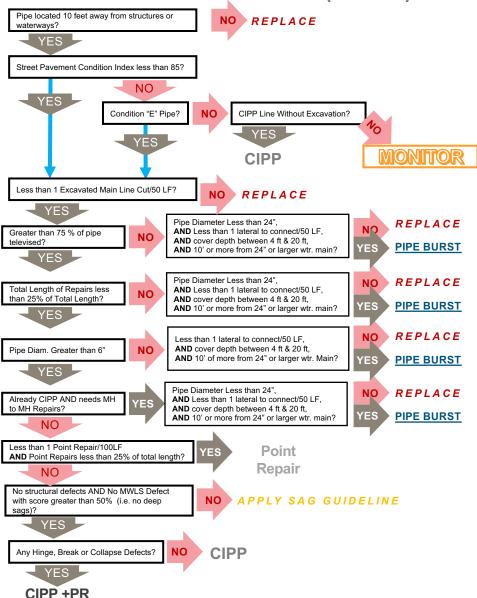
#### Condition Remedial Measures Flowchart Small Diameter (<24")

What is the pavement condition? Is the pipe >6"?

What is the depth of the pipe?

Was the pipe at least 75% televised?

How many point repairs will it require to rehab?

Has the pipe already been rehabilitated?

Is the total length of repairs > 25% of total length?

Is the pipe greater than 24"?

Is the pipe located under any permanent structures?

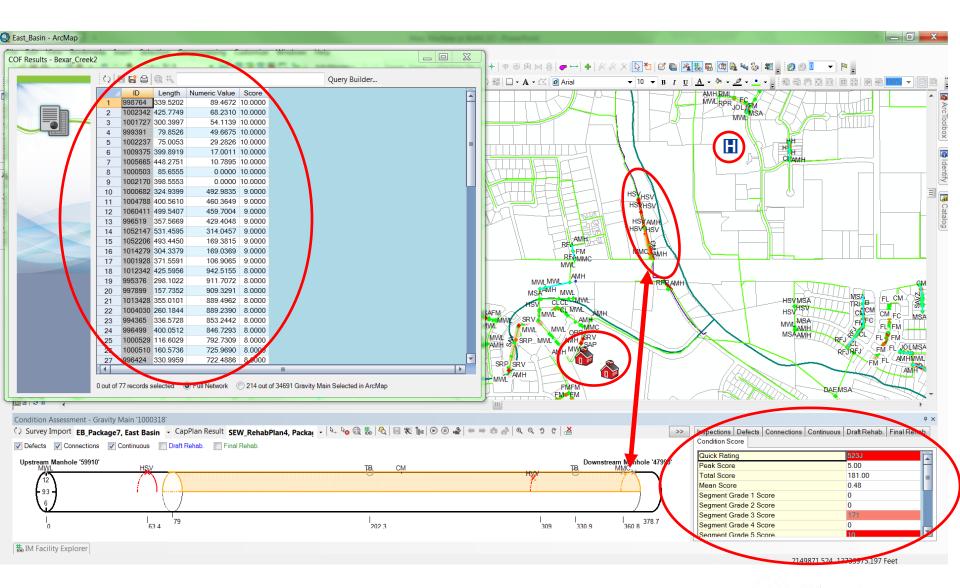
The ability to geographically overlay available PACP data allows users to quickly assess system issues.

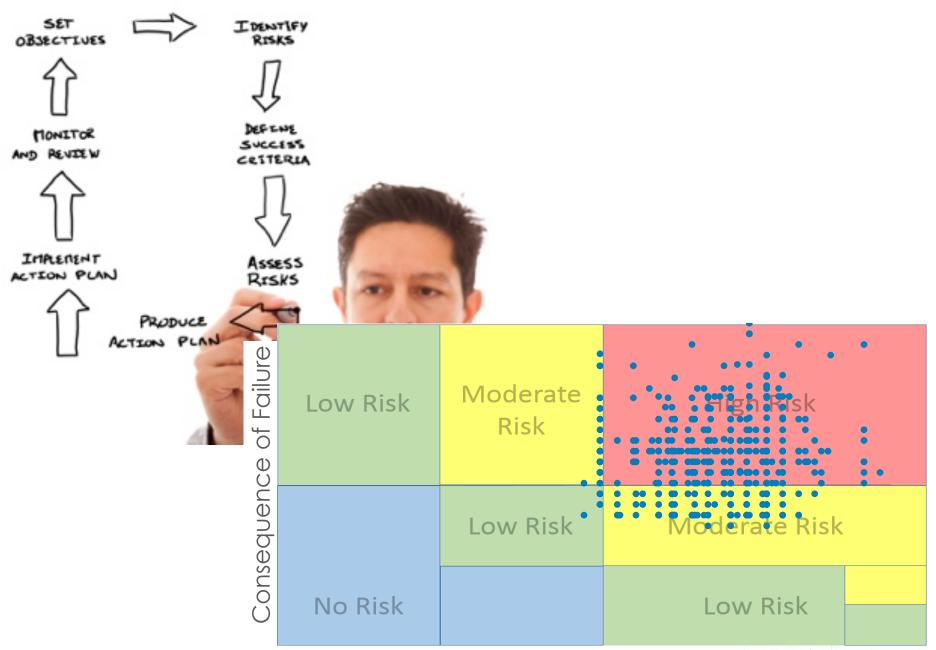
Likelihood of Failure

#### LIKELIHOOD OF FAILURE

- NASSCO Ranking/SPR
- Pipe Material
- Age
- Maintenance History

CONSEQUENCE OFFARE OF = RISK
- Waterways
- Hospitals/Schools
- Sewer Size
- Major Roadways

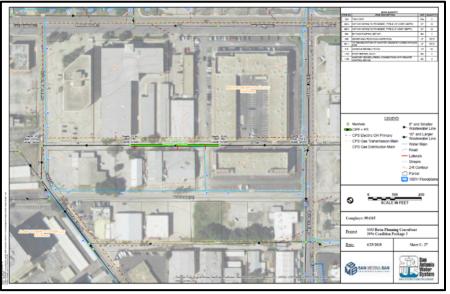
#### **CONSTRUCTION PACKAGES**

- Package 1: Pipes Under Major Road
- Package 2: Pipes >36" in Diameter
- Packages 3-6: Pipes Grouped by Location
