STEP BY STEP:

A Data Collection & Planning Approach for
Addressing Sewer Collection System Improvements
through the Plymouth CMOM Program

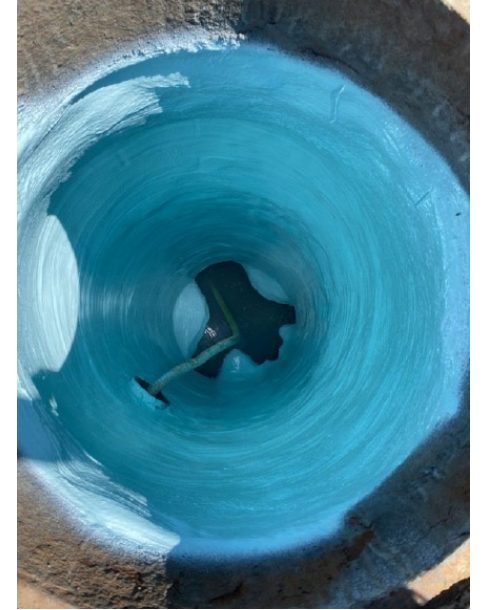
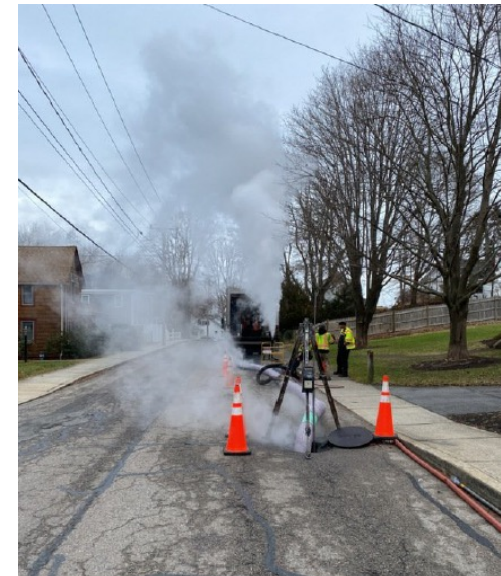
- In September 2021, Town put out to bid the rehabilitation of the Town's sewer collection system along Pleasant Street, Stafford Street, Standish Avenue, and Towns Street
 - Work scope later revised to include other roads
- Project was awarded to National Water Main Cleaning Company and completed in the Spring of 2022
- CIPP lining of gravity sewer and cementitious/epoxy lining of manholes
- Exterior grouting and interior crack sealing to address I/I concerns
- Replacing damaged manhole frames/covers
- Rebuilding of benches/inverts

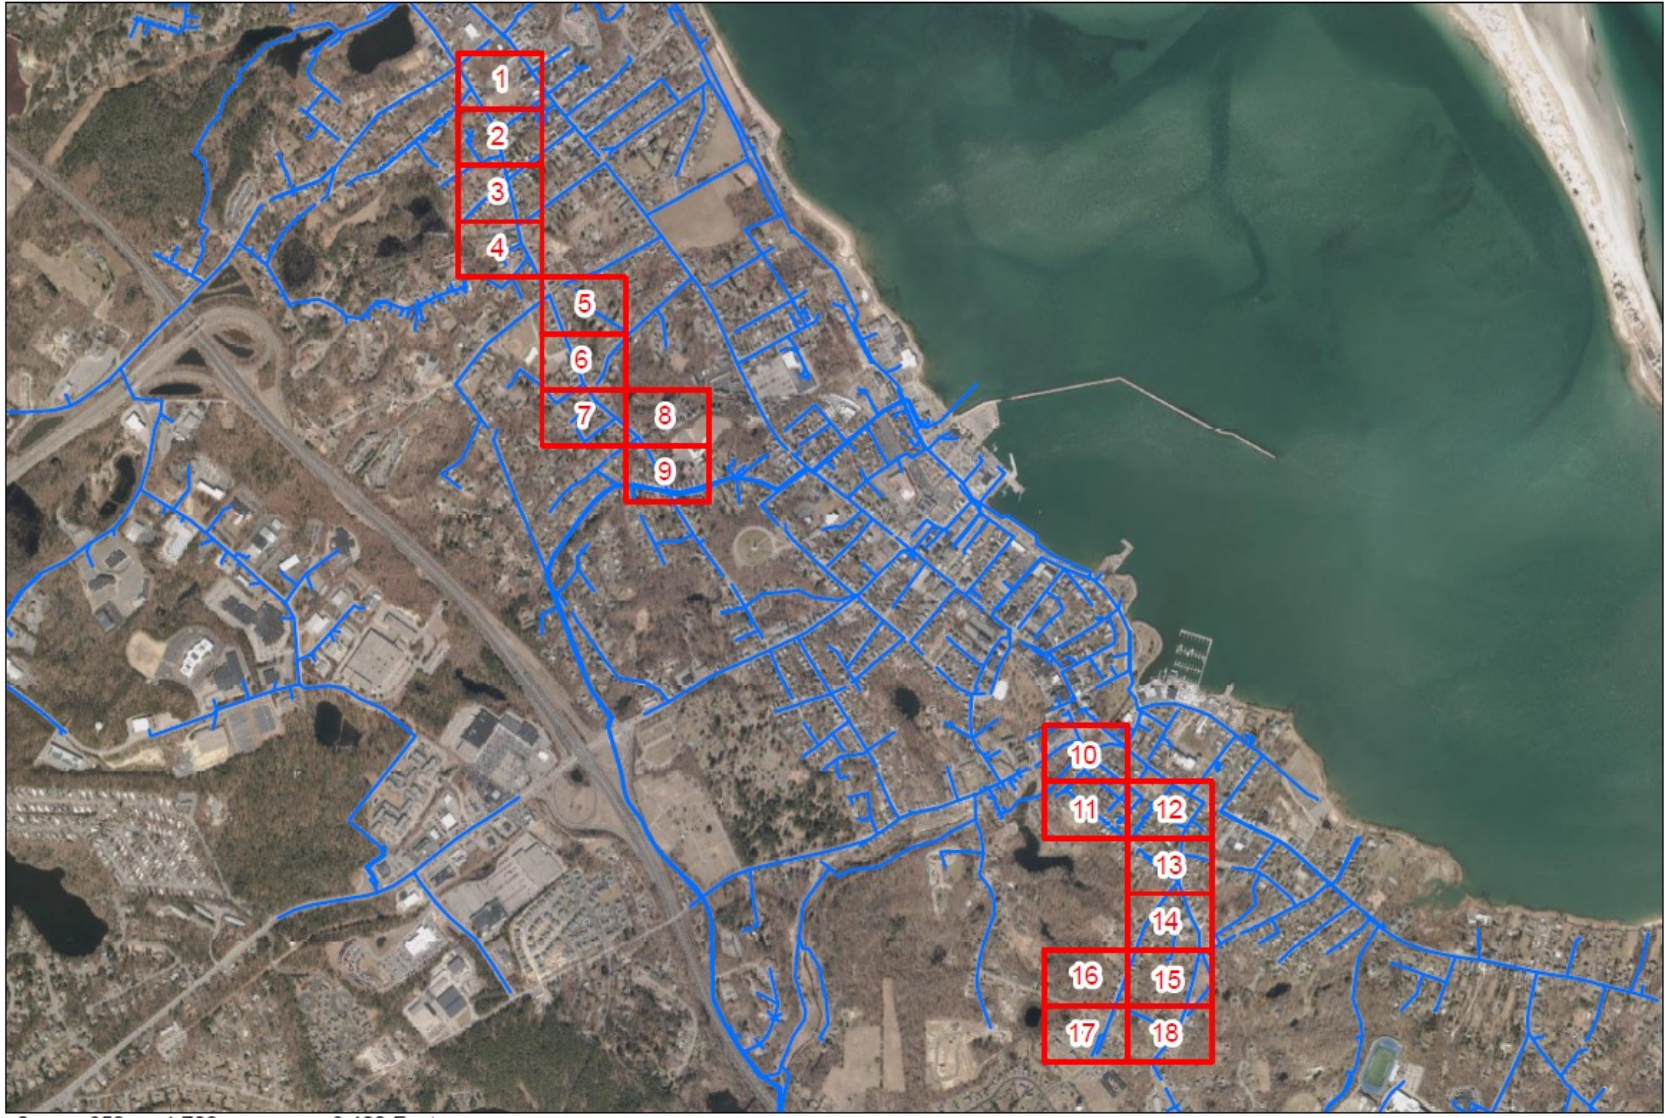
**Sewer Rehabilitation
196-2103
Town of Plymouth**
Sheet Index Page

0 850 1,700 3,400 Feet

1 in = 1,582 feet
ENVIRONMENTAL PARTNERS
