# A Proactive Approach to Assessing and Managing Your Wastewater Collection System

**Stamford, CT WPCA**

Joe Hausmann, PE – Wright-Pierce

Bill Brink, PE – Stamford WPCA

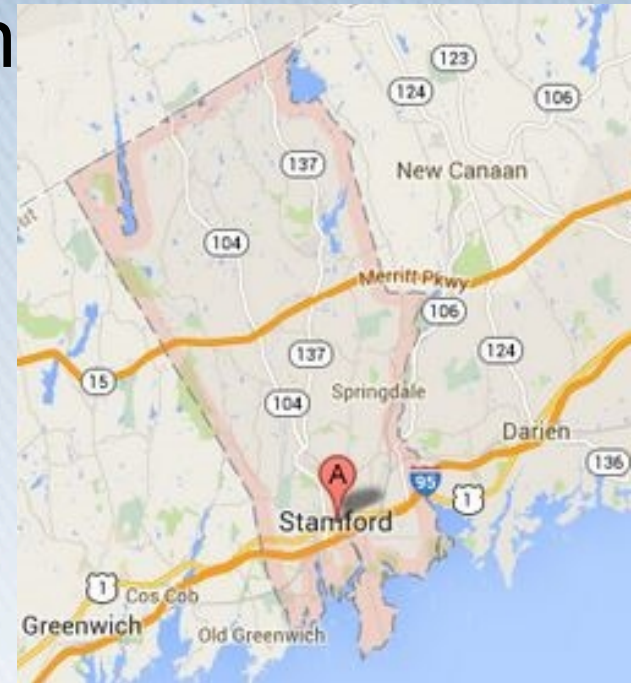
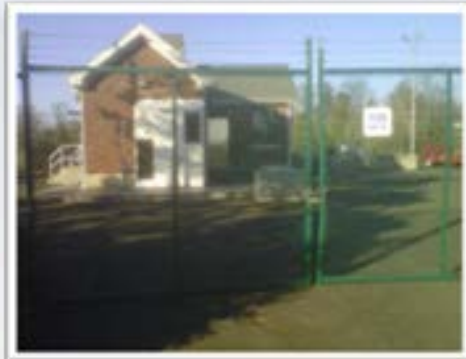
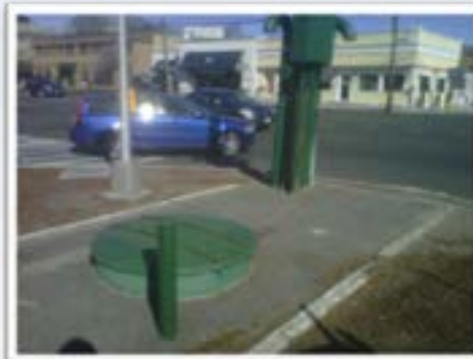
# System Overview

- Serves Stamford and Darien
- ~300 miles of sewer
  - Up to 60" diameter
  - ~20 miles of sewer >24"
- 22 Pump Stations
- 24 MGD WWTF

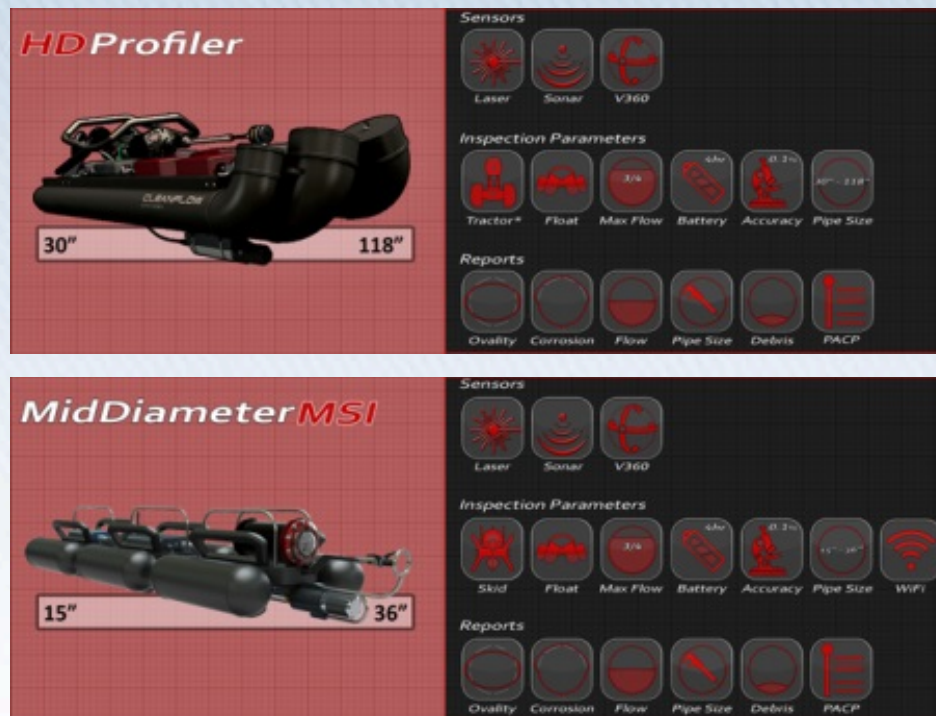
## CCTV/Laser/Sonar Inspection

- RedZone Robotics – Pittsburgh, PA

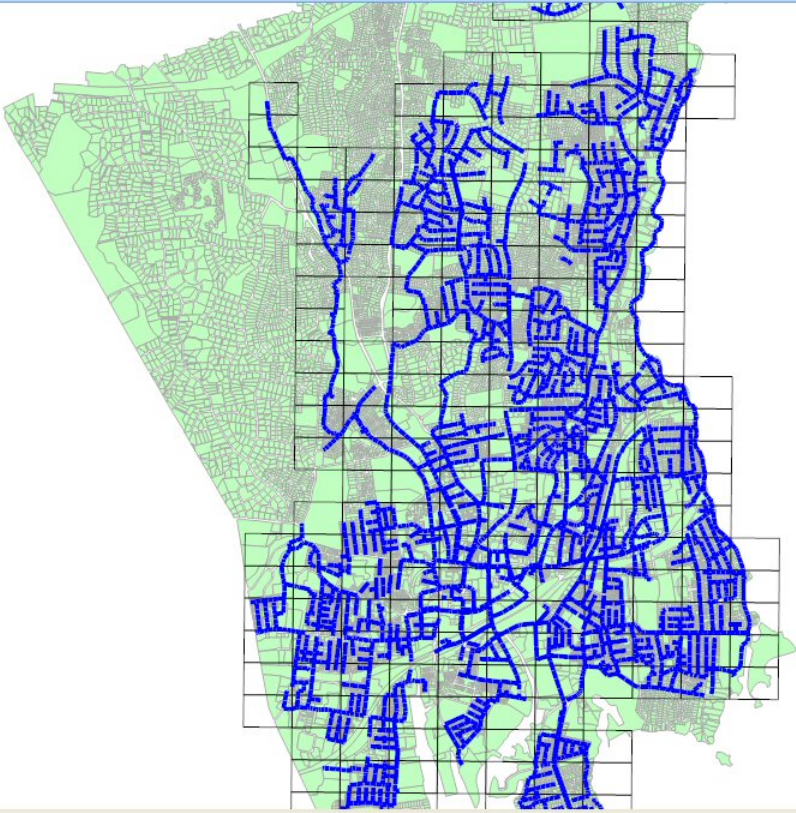
The screenshot displays the ICOM3 V.2 GIS Map application interface. The main window shows a map of Stamford, CT, with a grid overlay. The map features a network of streets and a collection system. A legend on the left side lists various map layers and overlays, with checkboxes indicating their status. The 'Map' section includes 'Collection System', 'Streets', 'Map Pages', and 'Parcels', all of which are checked. The 'Overlays' section lists numerous data layers, including 'Max Sediment Depth', 'Max H2S', 'Overall P&CP Score', 'Avg ASTM Qvality', 'Avg Corrosion', 'Last Cleaning', 'Blockage - Deposit', 'I/I Related', 'Inspection Age', 'Inspection Status', 'Map Changes Required', 'O&M Quick', 'Overall Quick', 'R3 Needed', 'R3 Type', 'Blockage - Roots', '3 Year Service Call', '3 Year SSD', 'Structural Issue', and 'Structural Quick'. The 'Last Cleaning' overlay is highlighted in blue on the map. The application has a menu bar with 'File', 'Tools', and 'Help'. The status bar at the bottom indicates 'Map Loaded', 'Overlays', 'Last Synchronization at: 4:10 PM', and 'Logged in: AVanna'.

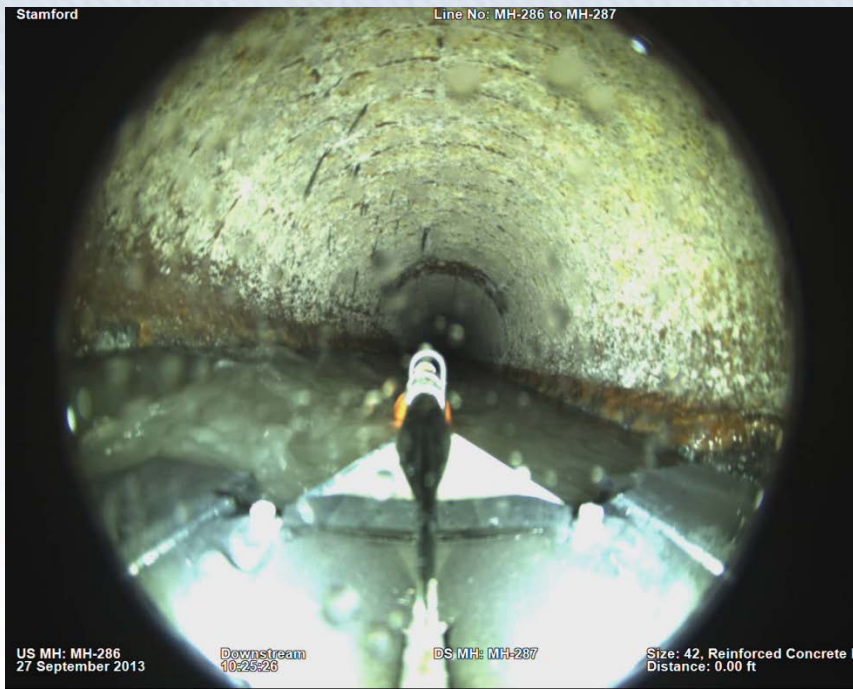
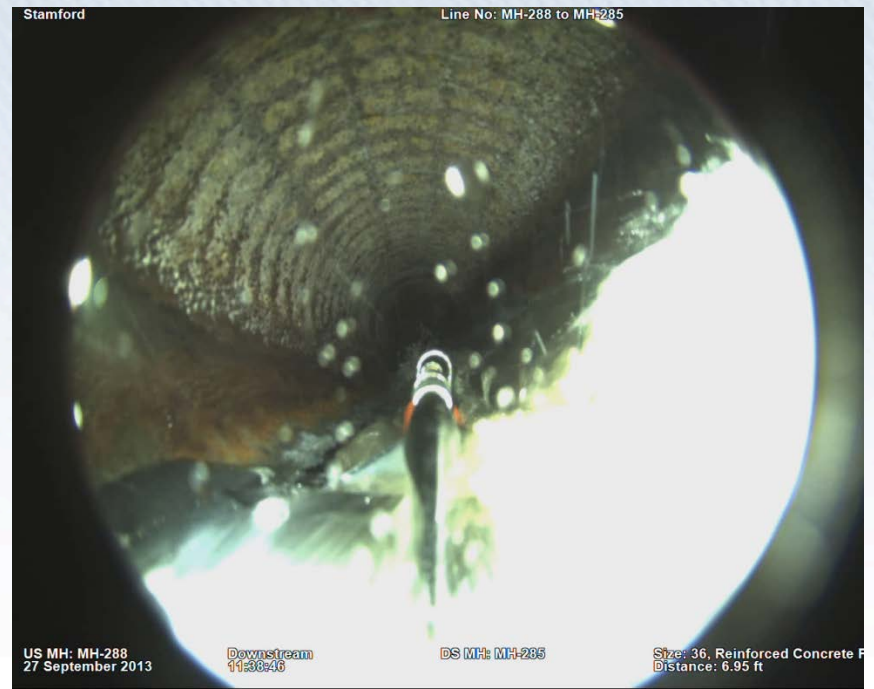
## Soundview Avenue

- 36" and 42" RCP Interceptor
- Rebar visible during inspection
- ~3,000LF of sewer in danger of collapse
