RUNNING BETWEEN RAINDROPS: Corrosion Repair of a Critical CSO Pump Discharge Pipe

**Massachusetts Water
Resources Authority**

Corrosion Probe, Inc.

MWRA PRISON POINT CSO (PPCSO)

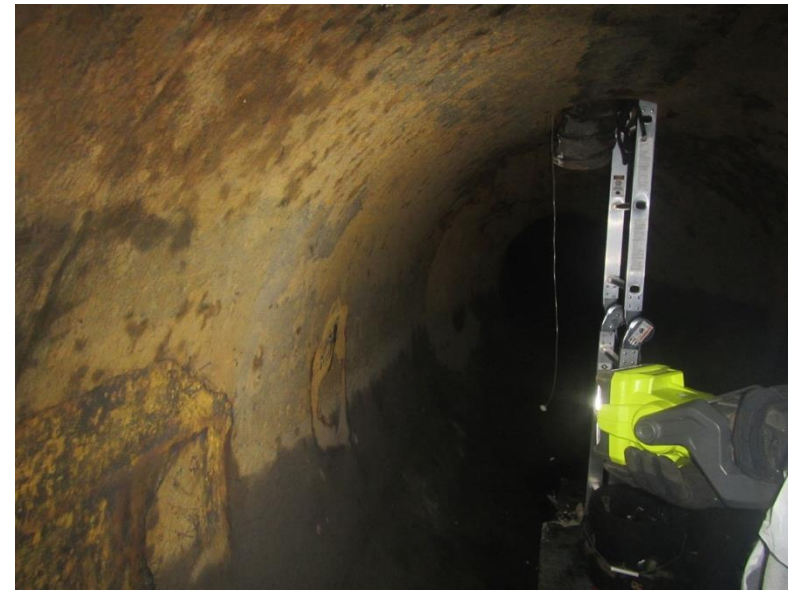
Coating Failure and Carbon Steel Corrosion

External: Isolated

Internal: General

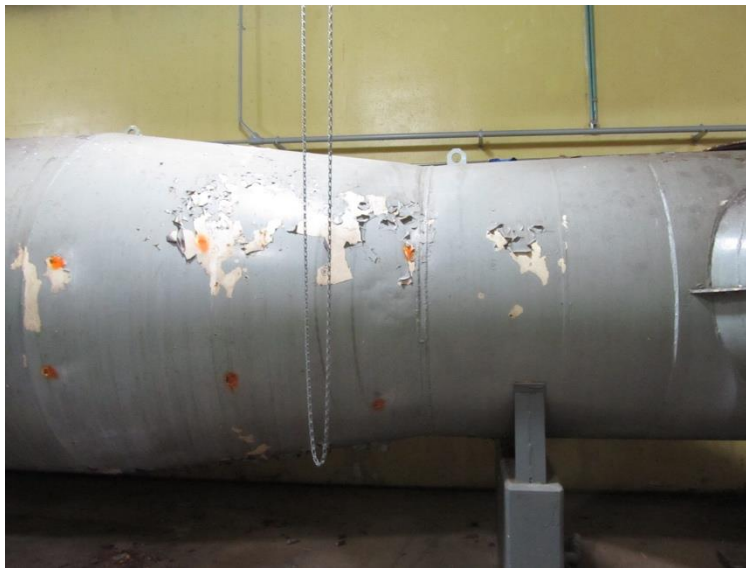
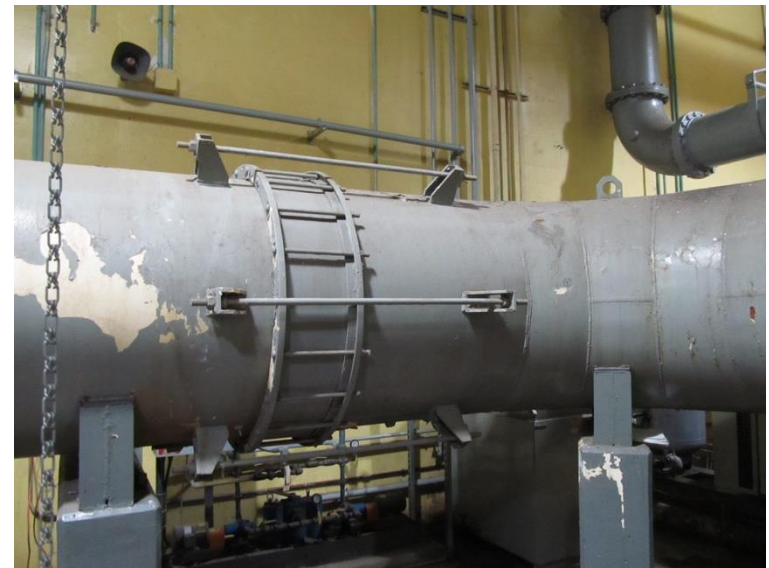
- Structural Analysis
 - Allowable minimum thickness: 1/8" (0.125)
 - Overstressed at pipe saddles

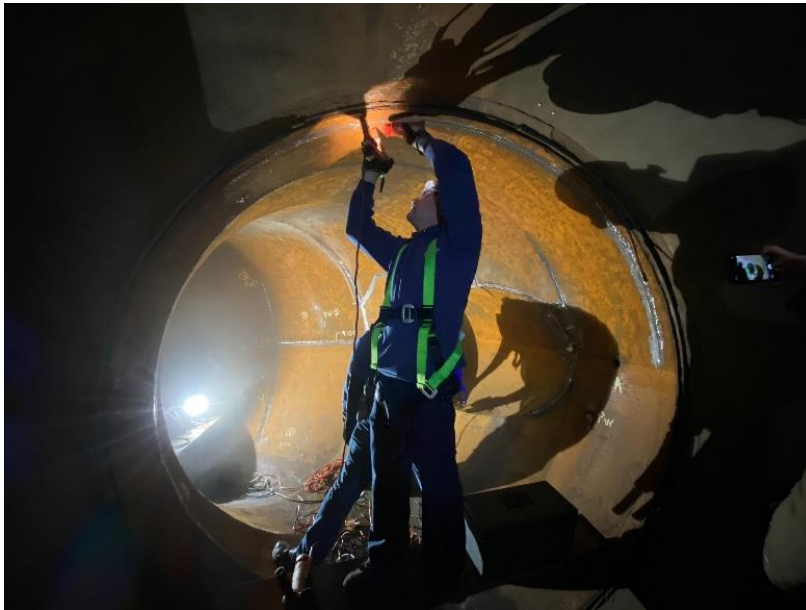
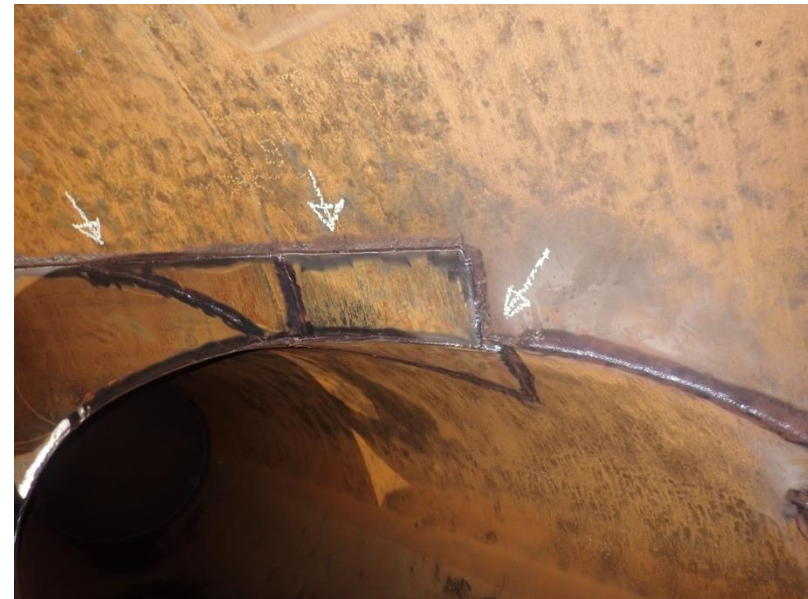
Weld Inspection

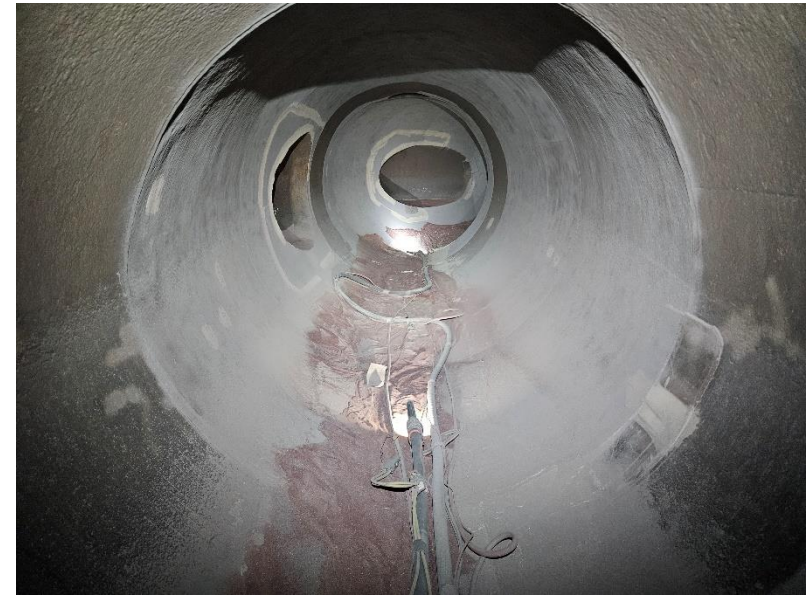
Coating: Final abrasive blasting

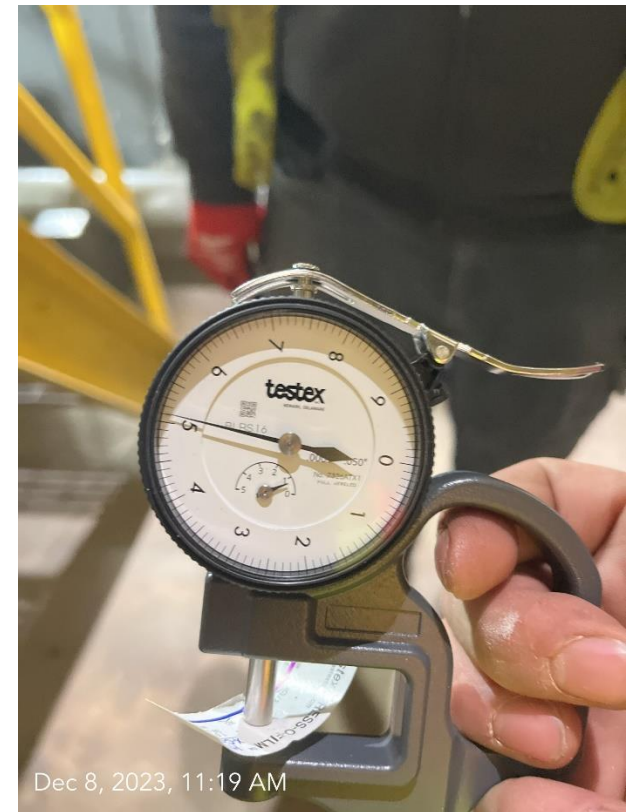
Coating inspection: Surface profile

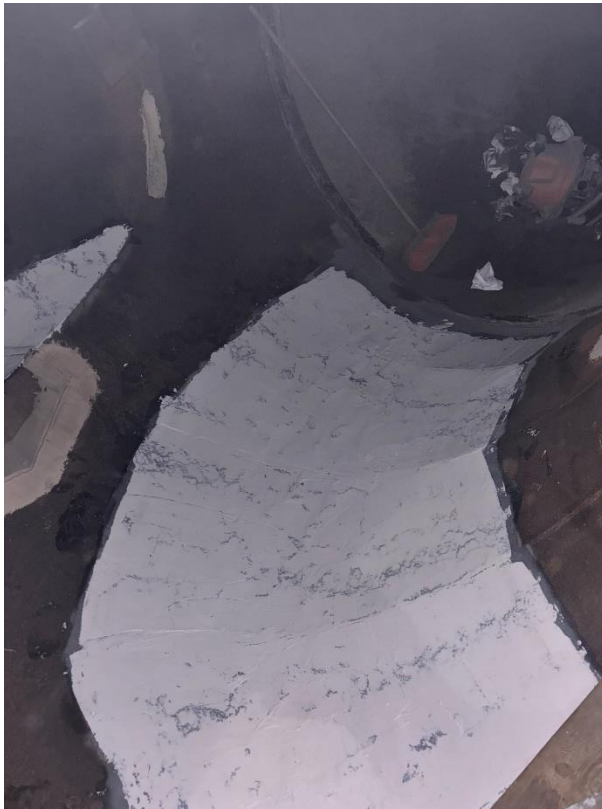
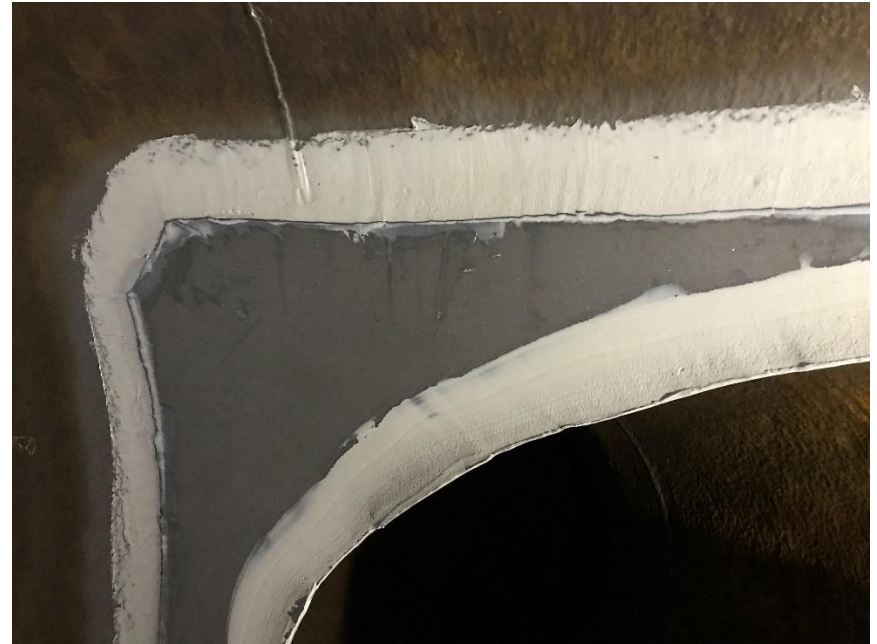
Coating: Pit filling

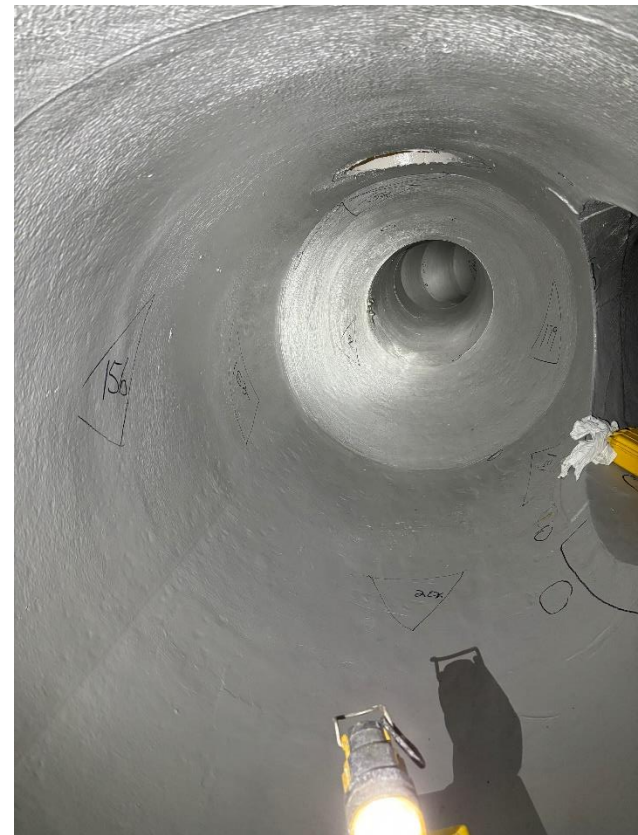
Coating: Interior finish

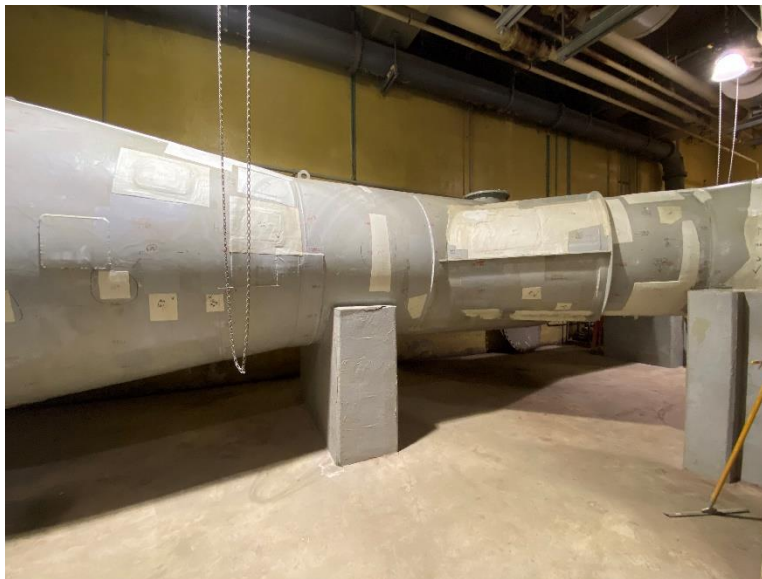
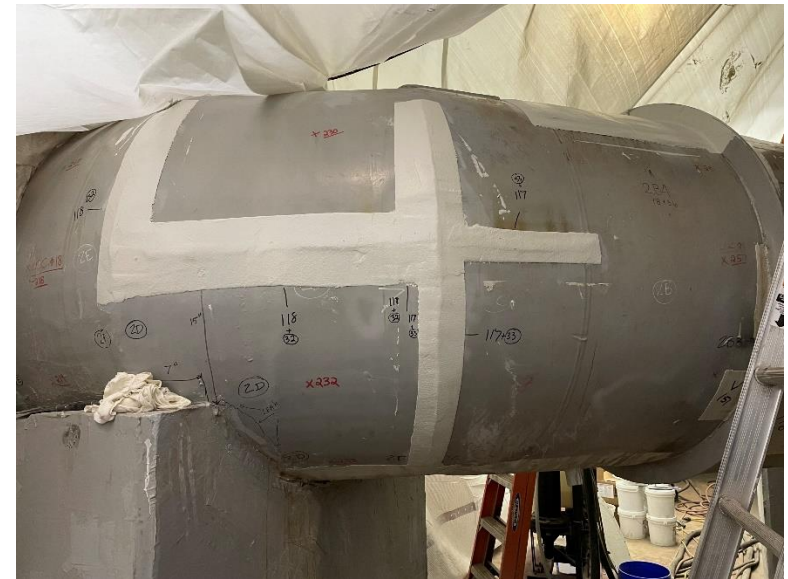
Coating: Exterior finish

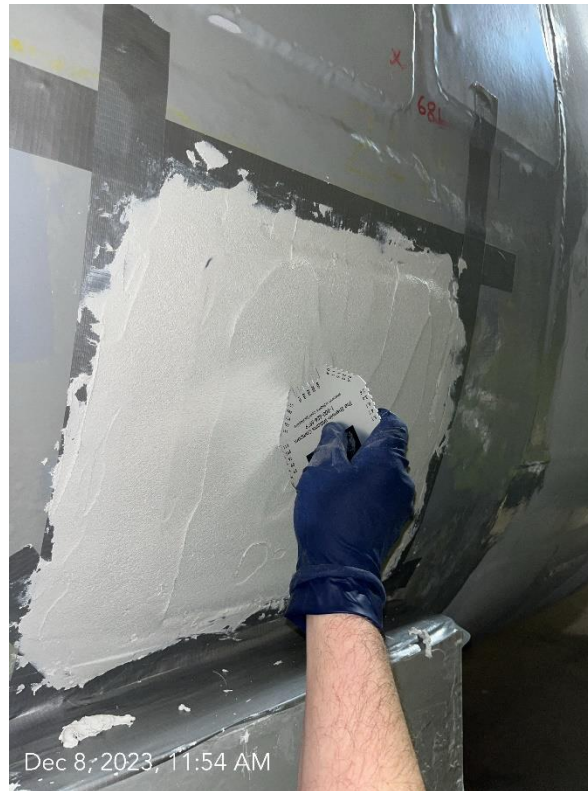
Coating inspection: Film thickness

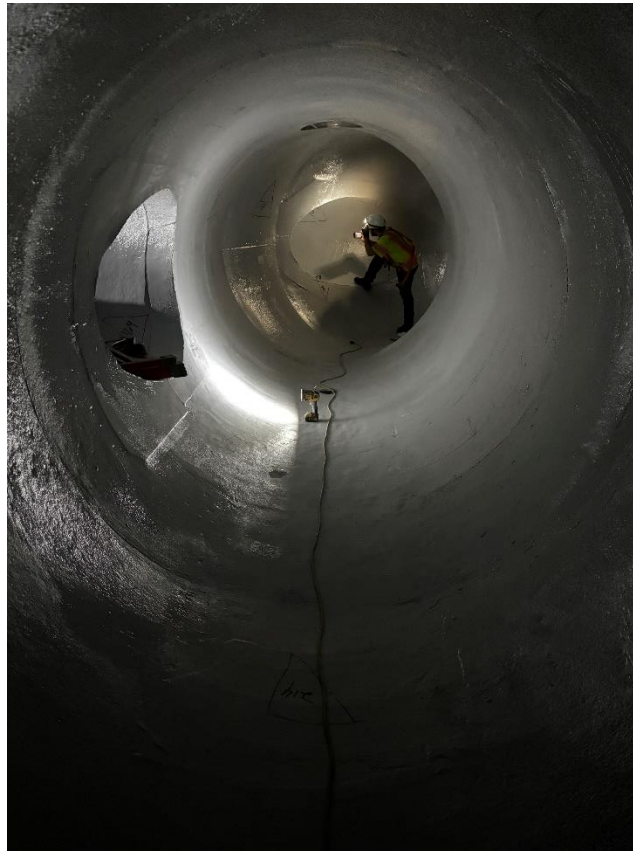
Final Inspection
